Grid Occurrences – 142

I. Details of Grid Disturbances

Detailed Draft Report of grid event submitted by SRLDC:

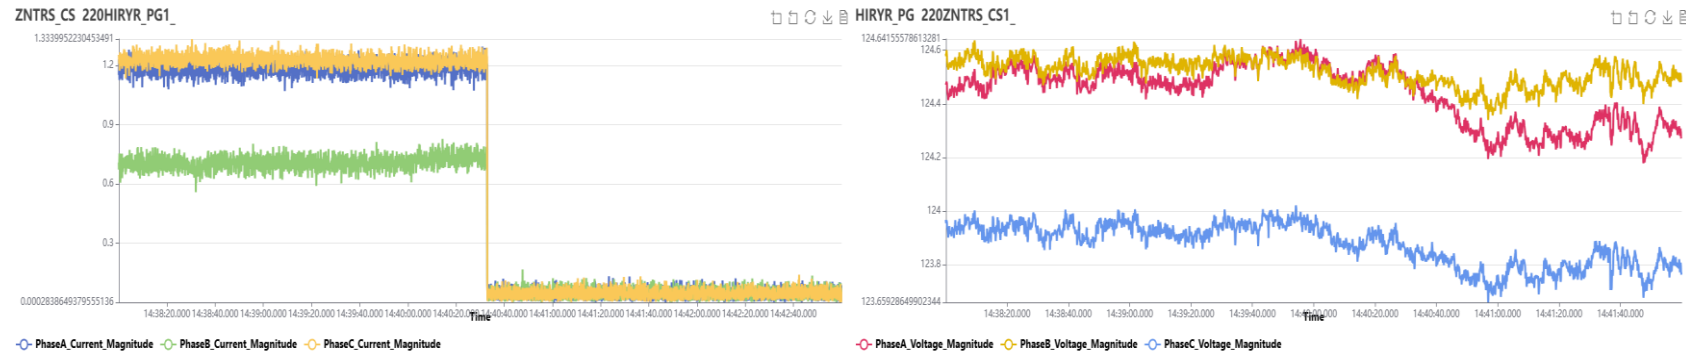
12. A) PMU Analysis:

From the PMU, no fault is observed during the event

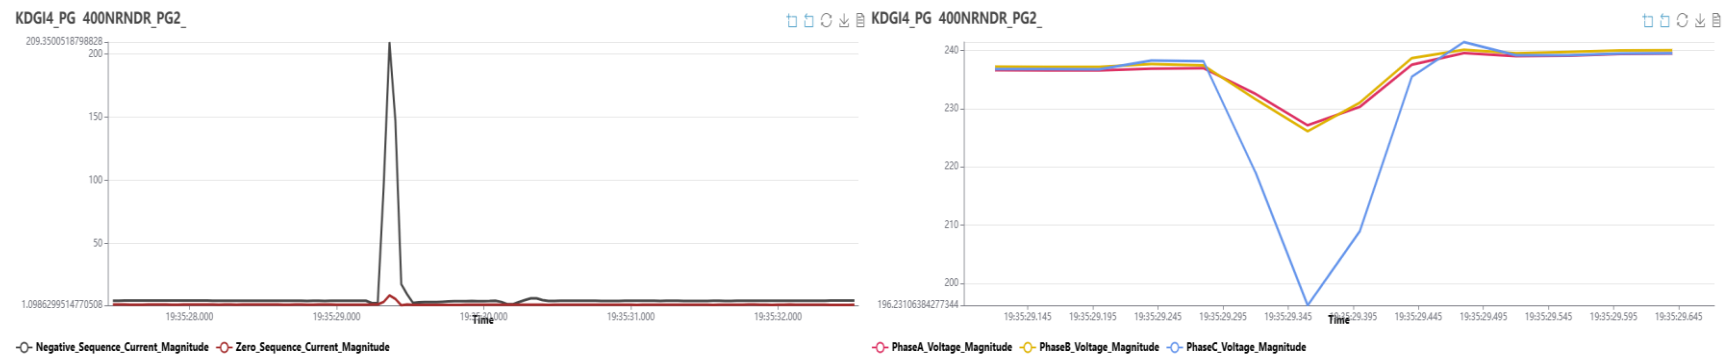
12. A) PMU Analysis:

From the PMU plot, dip in B-phase voltage is observed indicating B-G fault during the event with no delayed fault clearance.

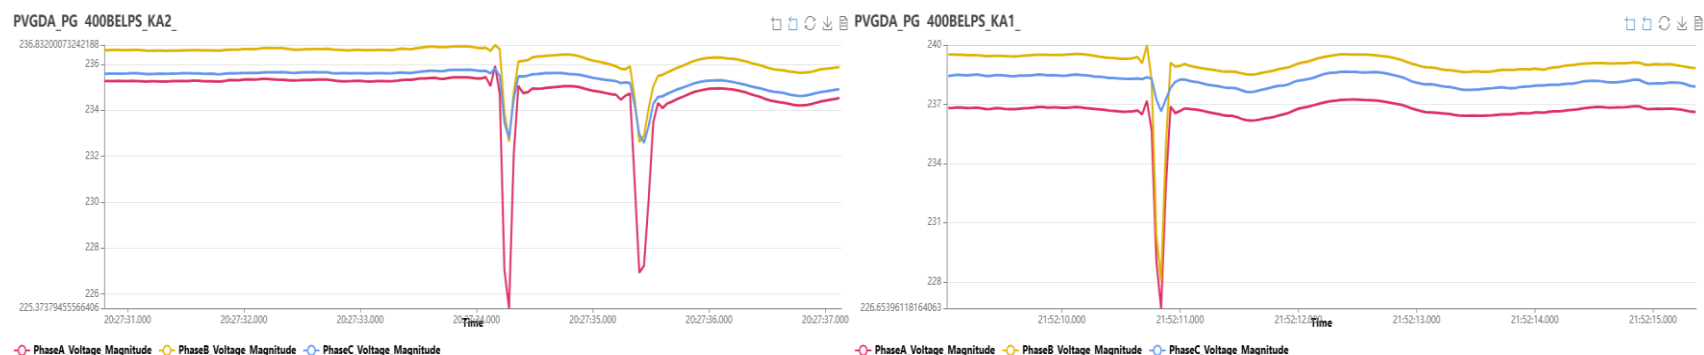
12. A) PMU Analysis:

From PMU, dip in R-phase is observed at 20:57 hrs indicating R-G fault indicating fault in 400kV BPS YTPS Line-1. At 21:52hrs, dip in and R and Y-phases is observed indicating RY fault during the event in 400kV BPS YTPS Line-2.

Remedial Measures Taken (सुधारात्मक सुझाव) : R-Phase conductor snapping was observed between Tower No. 11 & 12 from YTPS station. The rectification work was carried out by KPTCL-TLM division on 19.03.2026 and line was restored on 19.03.2026 at 20:08 hrs.

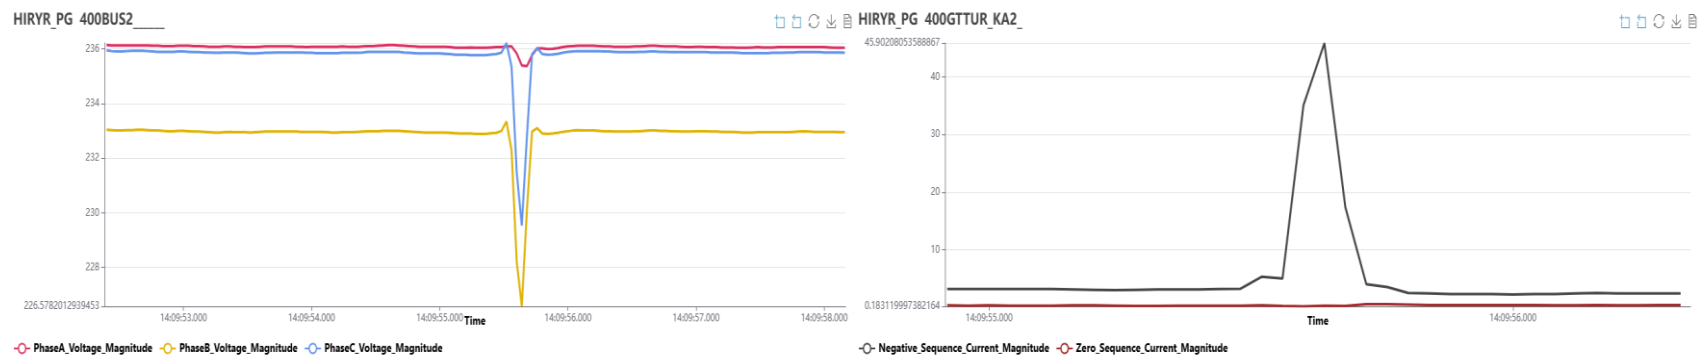
12. A) PMU Analysis:

From the PMU plot Y-B fault can be observed without any delayed clearance.

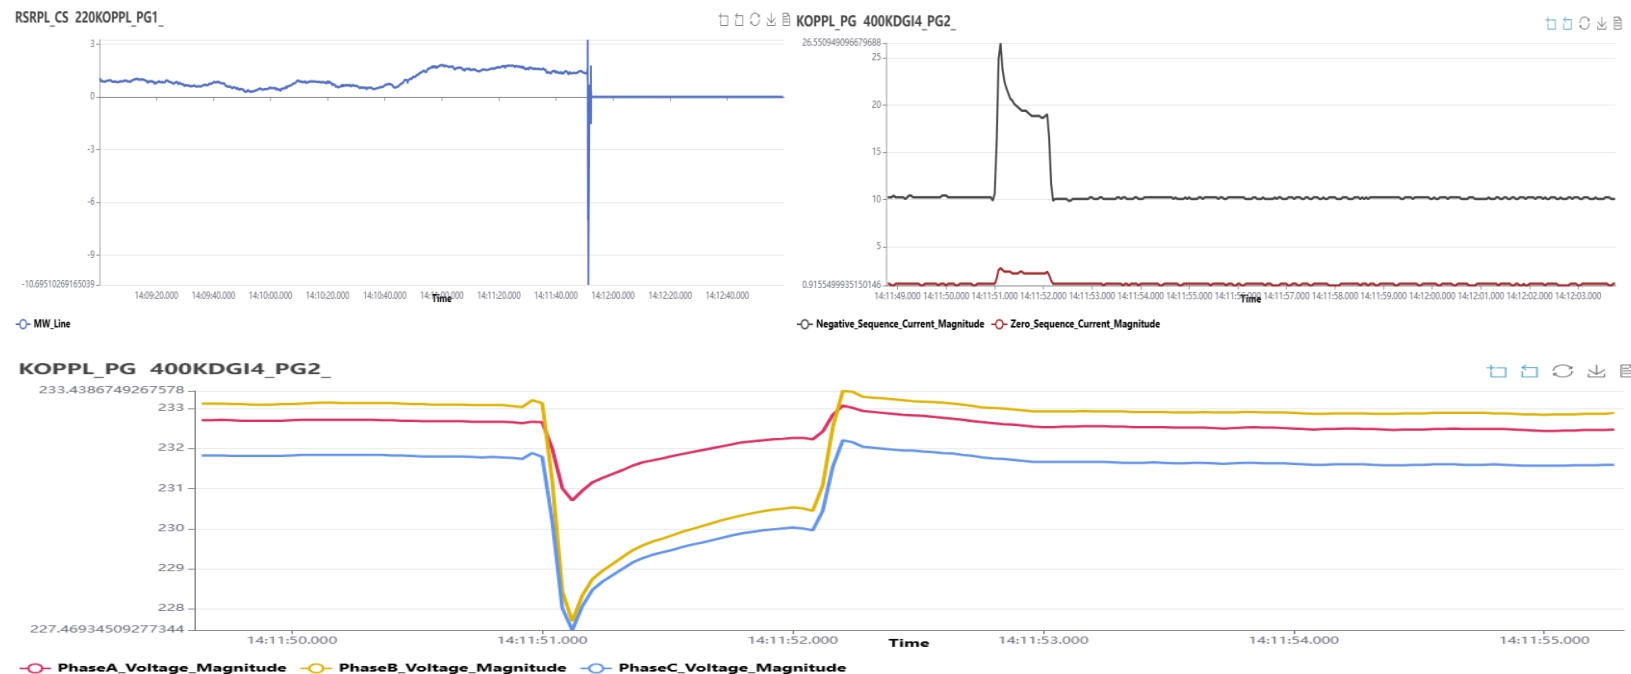
11. A) PMU Analysis:

From the PMU dip in voltages is observed indicating transformer inrush current during the event.

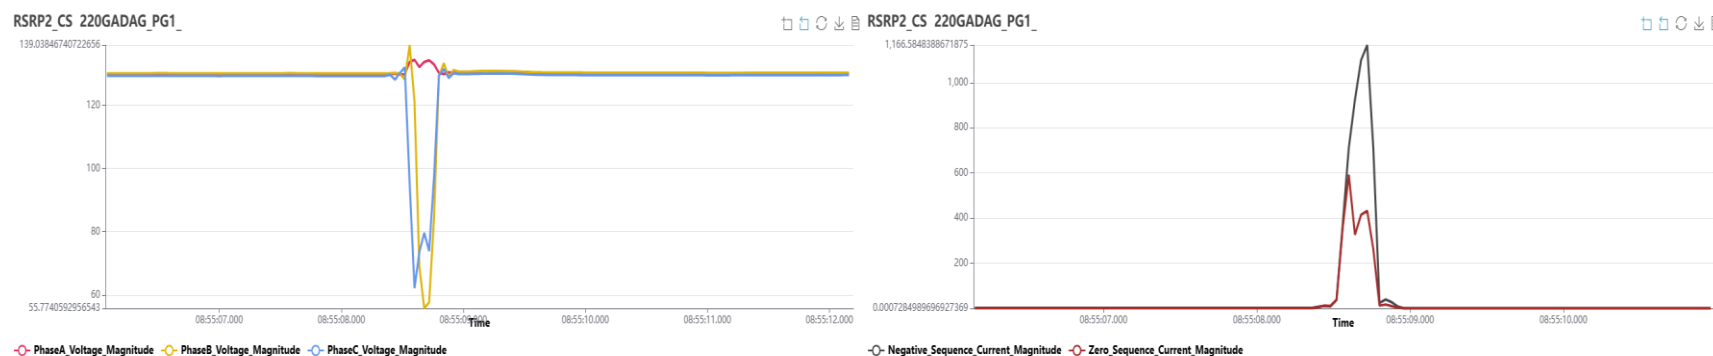
12. A) PMU Analysis:

From the PMU, dip in Y and B-phases is observed indicating Y-B-G fault during the event with a delayed fault clearance of around 200ms.

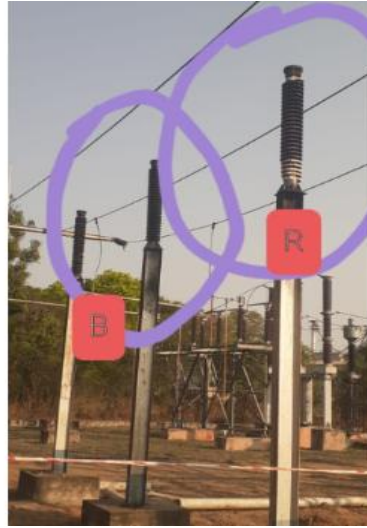
The triggering incident is the 110kV Y-ph bus PT failure at Arani (as per FIR) causing 110 kV Bus Fault. As the BBP protection is not available at 110kV level, the fault was not isolated instantaneously. It can be observed that initially the fault was sensed in R-ph and further developed into R-Y ph fault after around 350ms.

The R-ph fault can be observed from 23:39:35.280 Hrs, and further developed into R-Y fault at around 23:39:35.640. The fault was not isolated by the high set protection of the 230/110kV PTRs and was fed through the connected lines. At remote ends (Kanchipuram, Singarpet) the fault was sensed in Z3. At Kanchipuram end the fault started sensing in Z3, from the fault instance, and tripped after around 850ms at 23:39:26.160 Hrs. At Singarpet end the fault was sensed in Z3 after the fault was developed into R-Y ph fault and tripped after around 850ms in Z3.

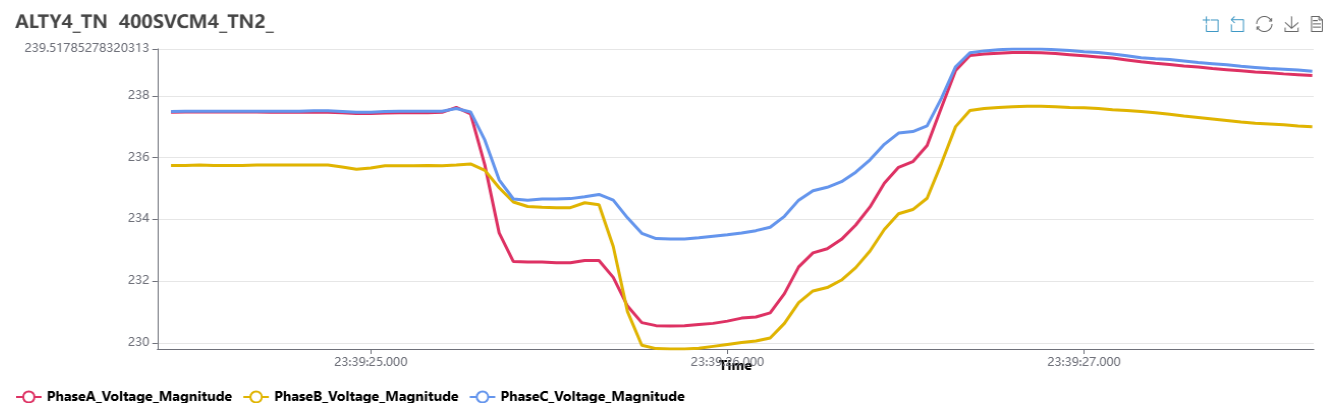
12. A) PMU Analysis:

From the PMU plot initial R-ph fault can be observed and further developed into R-Y fault with delayed fault clearance of around 1.2s

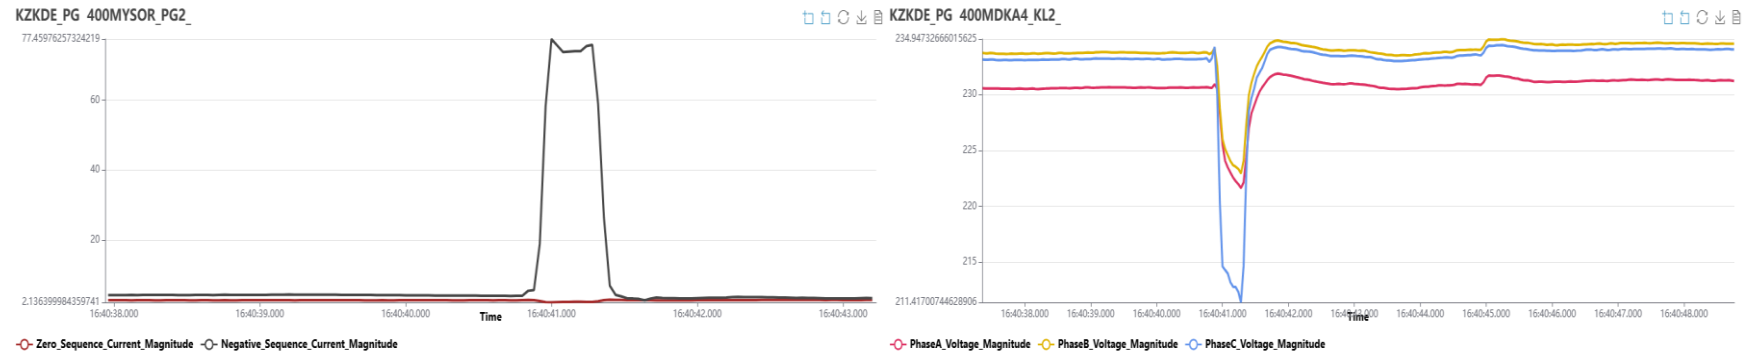
12. A) PMU Analysis:

From the PMU plot , B-G fault can be observed in the Pallom-New Pallom line with delayed clearance of around 400ms.

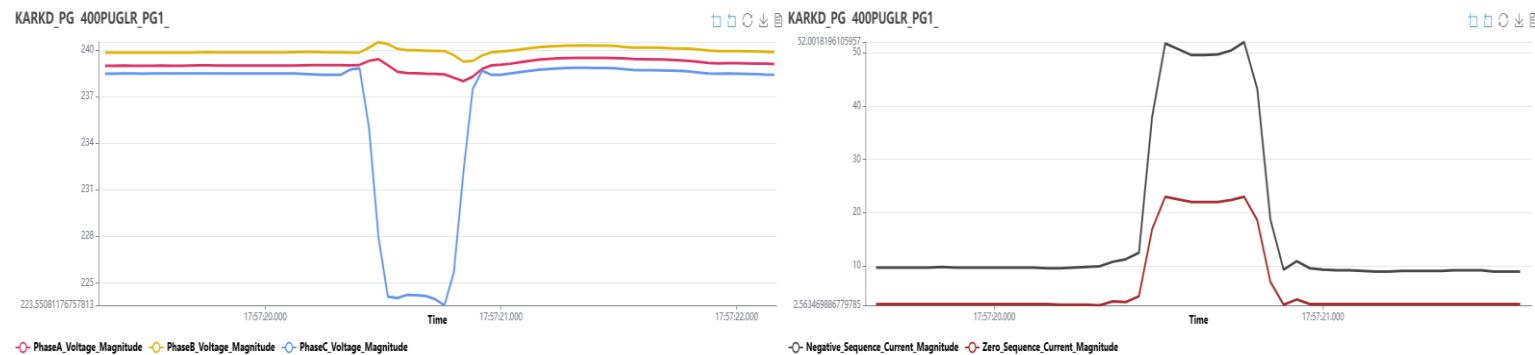
From the PMU analysis, B-G fault can be observed during the event with delayed fault clearance.

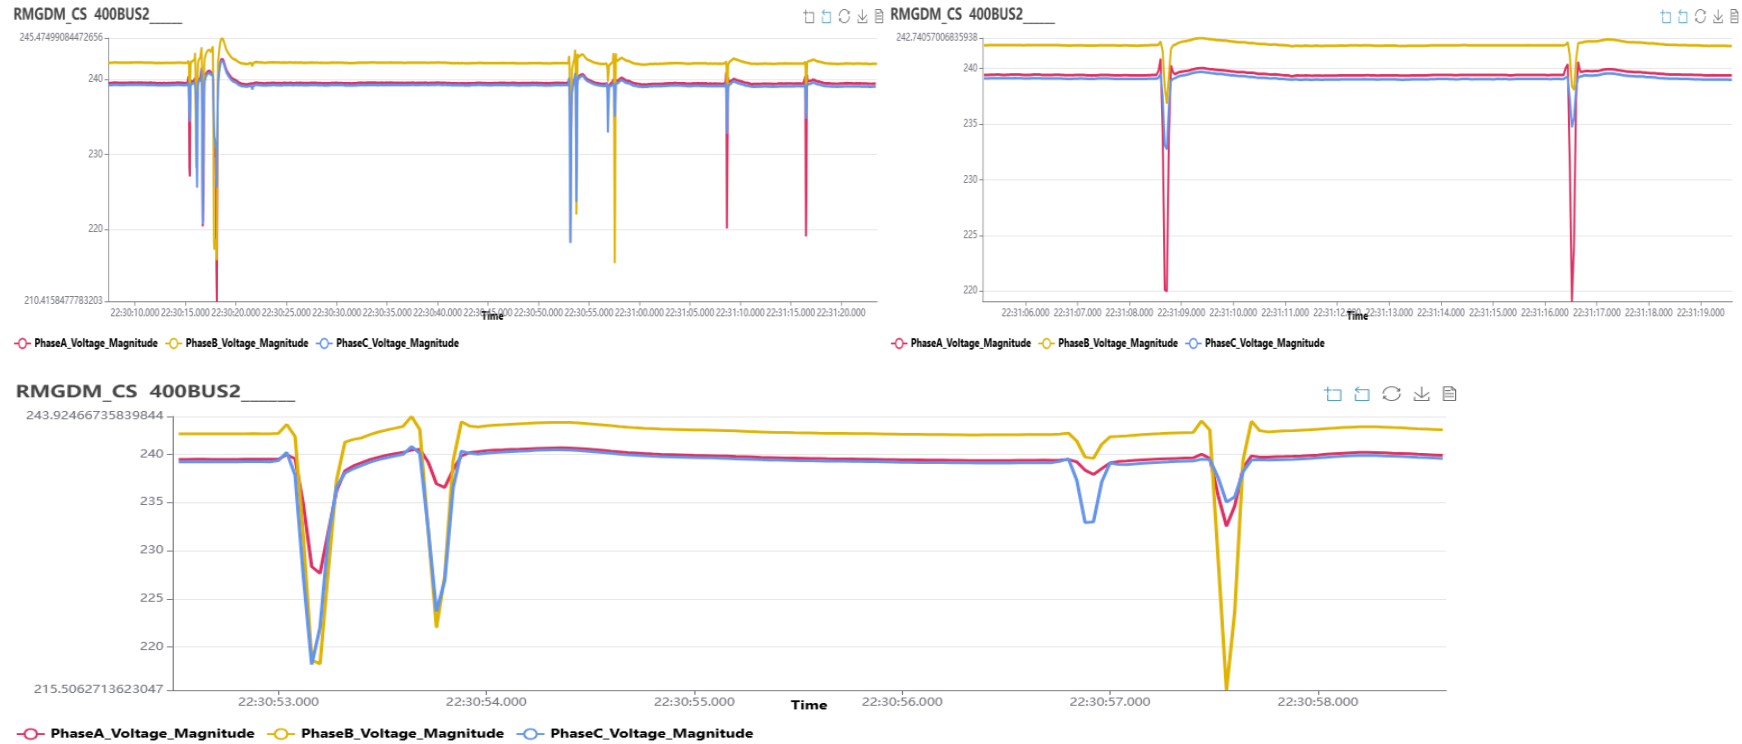
From the PMU data multiple faults can be observed during the event and prior to the event

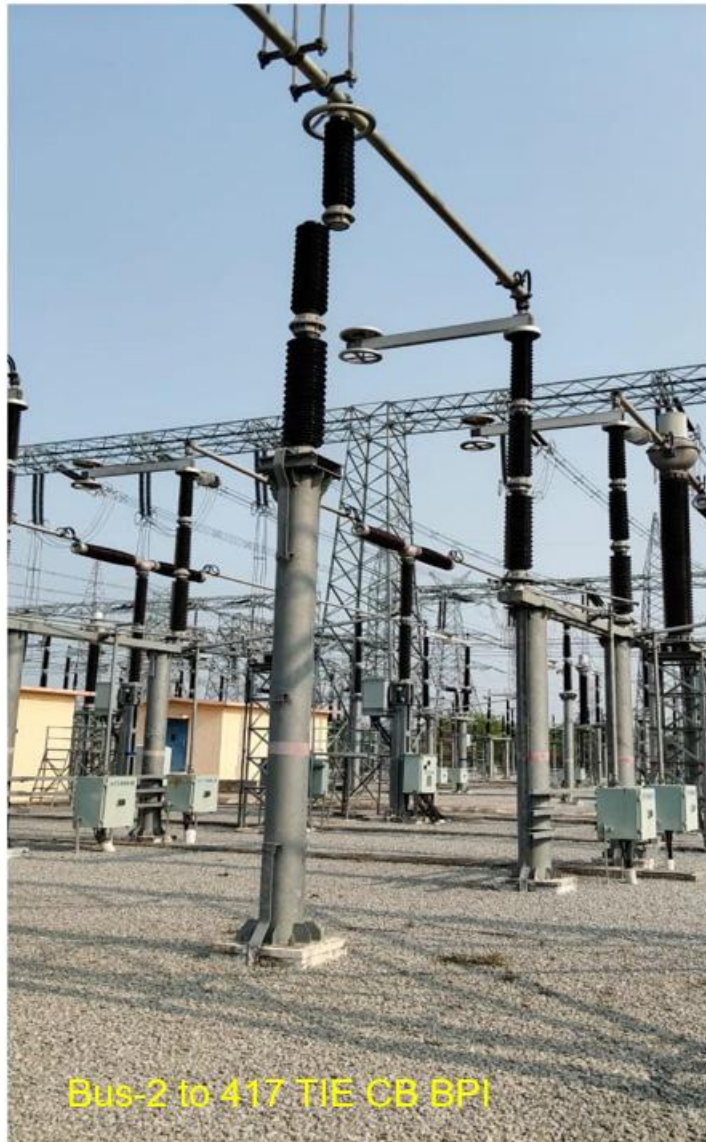
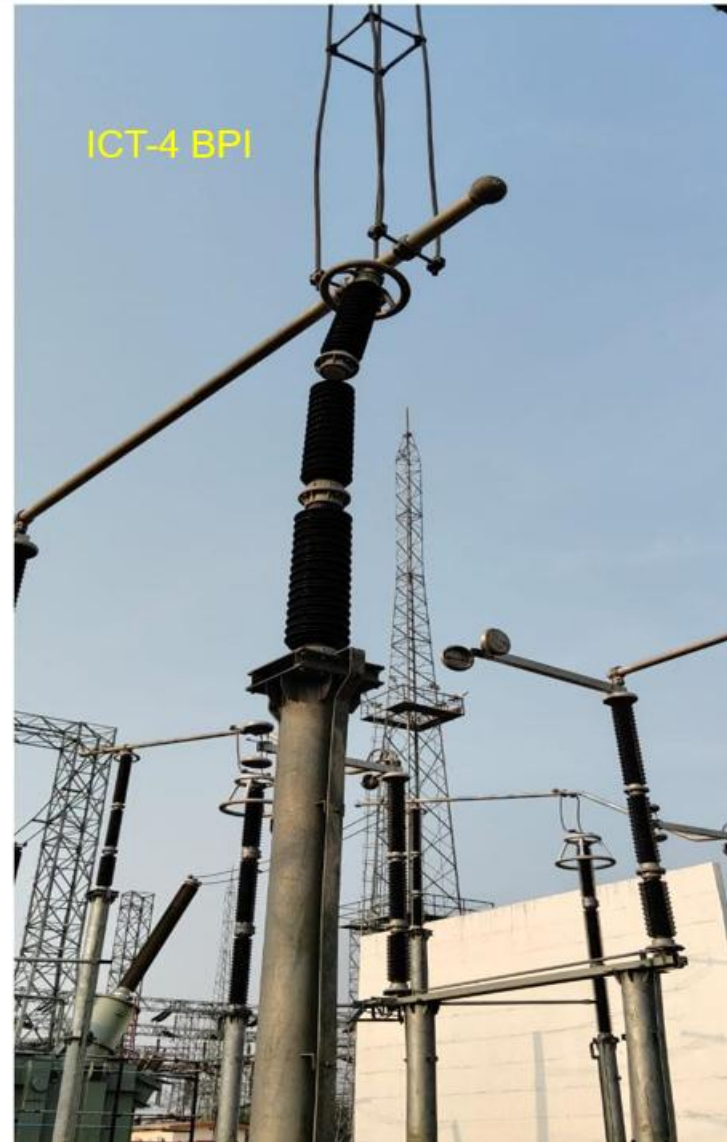
2. TGTRANSCO informed that 400 kV Busbar Zone-2 protection operated and tripped all breakers connected to Bus-2, due to damage of R-phase Bus Post Insulator (BPI) connecting Nirmal-2 Tie Circuit Breaker-417 to Bus-2. It was further informed that 500 MVA ICT-IV tripped on Differential Protection and HV Overcurrent Highest Protection, due to damage of ICT-IV HV side R-phase Bus Post Insulator. Further, 400 kV Dichpally–Nirmal-1 feeder had tripped on B-phase to ground fault, due to damage of Y and B phase line isolators. TGTRANSCO also informed that GPS time synchronisation was not available during the incident.
