## III. Single/Multiple Element Tripping with Protection Violation

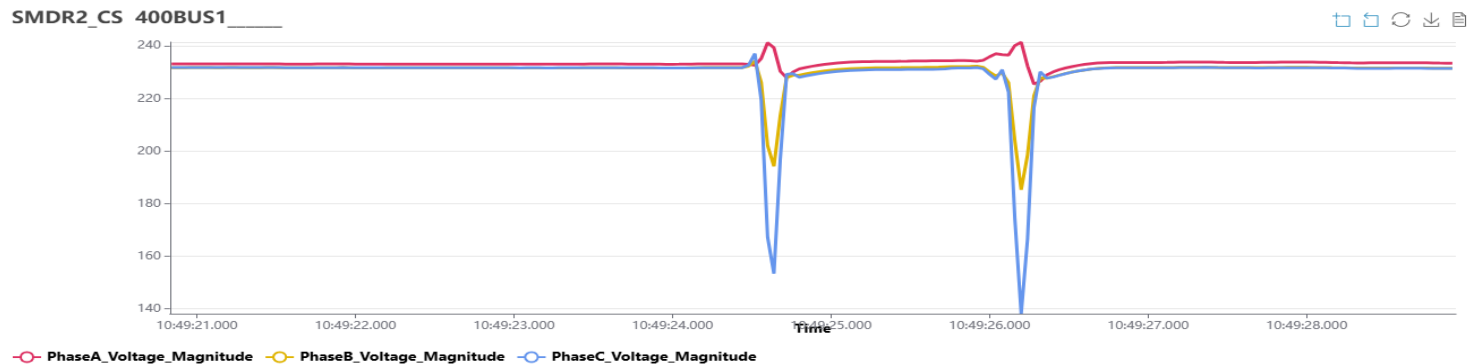
- From the PMU plot, B-G fault can be observed during the event without any delayed fault clearance

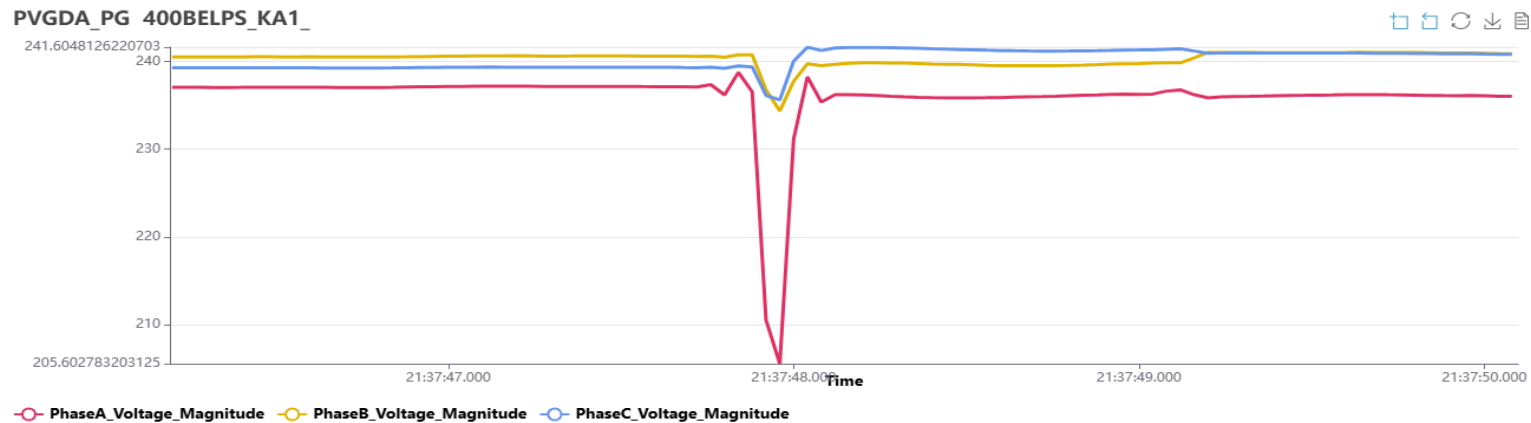
- From PMU, R-G fault is observed during the event.

1. JSW stated that, as per the reports submitted, the initiating event was a Zone-1 R-phase-to-ground fault on the 400 kV BPS–Pavagada line. The fault was successfully cleared through auto-reclosure (AR). Simultaneously, the 400 kV Jindal–BPS-3 and 400 kV Jindal–BPS-4 lines tripped at the Jindal (JSW) end, whereas the corresponding breakers at the BPS end remained closed. During the disturbance, Zone-3 start indications were observed in both Main-1 and Main-2 relays; however, no master trip was initiated. JSW further informed that the tripping of the 400 kV Jindal–BPS-3 and 400 kV Jindal–BPS-4 lines at the Jindal end is suspected to have occurred due to Ground Potential Rise (GPR) associated with the fault on the 400 kV BPS–Pavagada line.

- ✚ SRPC advised JSW Thermal to comply with all the recommendations of the expert committee pertaining to the Ground Potential Rise (GPR) issue, which were made during the site visit conducted on 12.06.2026 and 13.06.2026, and to submit the compliance report to SRPC at the earliest.

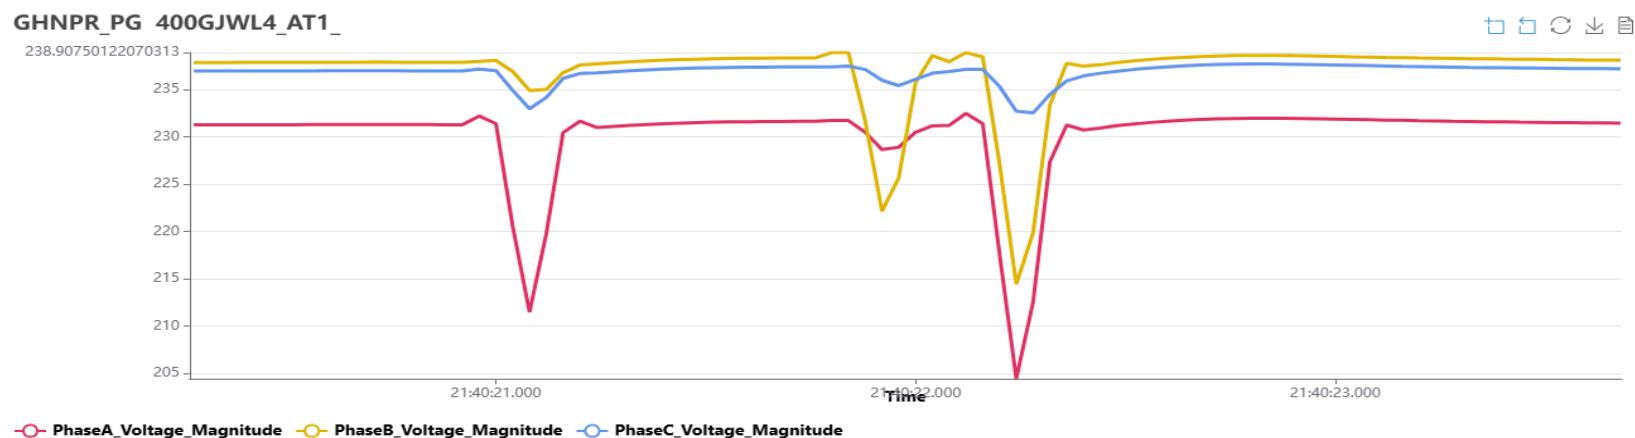
- From PMU data, an R-G fault was initially observed with delayed fault clearance. Subsequently, a Y-G fault was recorded during A/R dead time

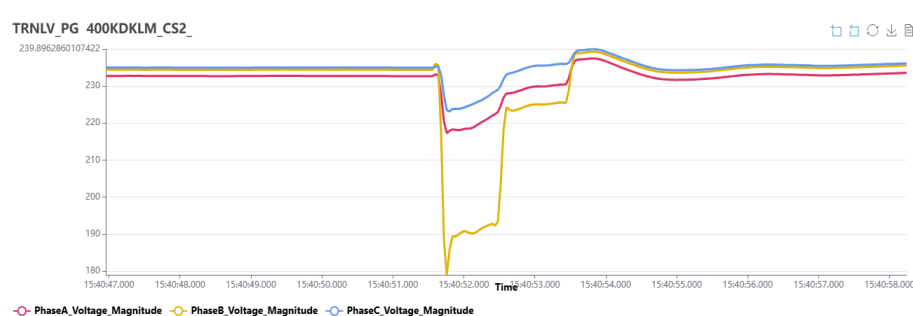
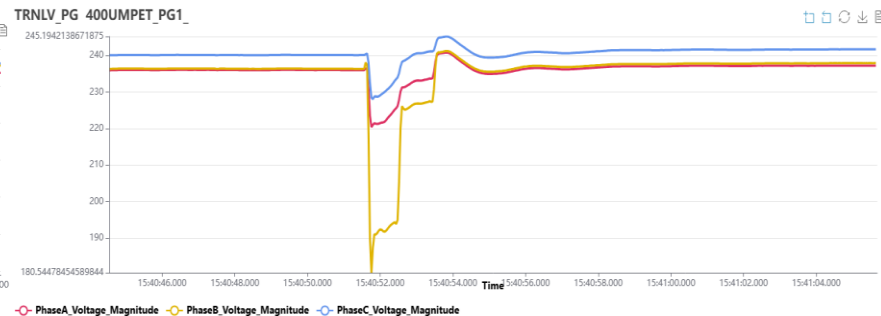
➤ From the PMU plot, Y-G fault can be observed with delayed fault clearance

- TANTRANSCO further informed that the DR recorded a fault current of 8.1 kA in the Y-phase along with a significant dip in the Y-phase-to-neutral voltage to 75 kV (33%). However, despite the Y-phase trip command being issued by the relays, the R-phase breaker pole was found to have opened, as indicated by the reduction of the R-phase-to-neutral voltage to zero, while the fault current in the Y-phase continued to persist.

- TANTRANSCO further informed that, as no protection elements remained active after the inadvertent opening of the R-phase pole, the Y-phase breaker-failure initiation signal to the LBB relay also dropped. Accordingly, the breaker failure protection did not operate. TANTRANSCO also informed that the directional earth-fault protection did not operate, as it was blocked by the pole-open logic in the Main-2 relay and, in the Main-1 relay, due to the non-availability of polarization voltage.

- The wiring was set right, the breaker single pole trip from both Main-1 & Main-2 relays were checked and operation of the correct breaker pole for each trip was ensured.
- The operation of Auto-reclosure & LBB functions was also tested and found to be in order.

- ✚ TANTRANSCO to carry out a comprehensive review of the protection coordination, breaker wiring schemes, auto-reclosure logic and breaker failure protection associated with the affected feeders and submit the compliance report to SRPC.

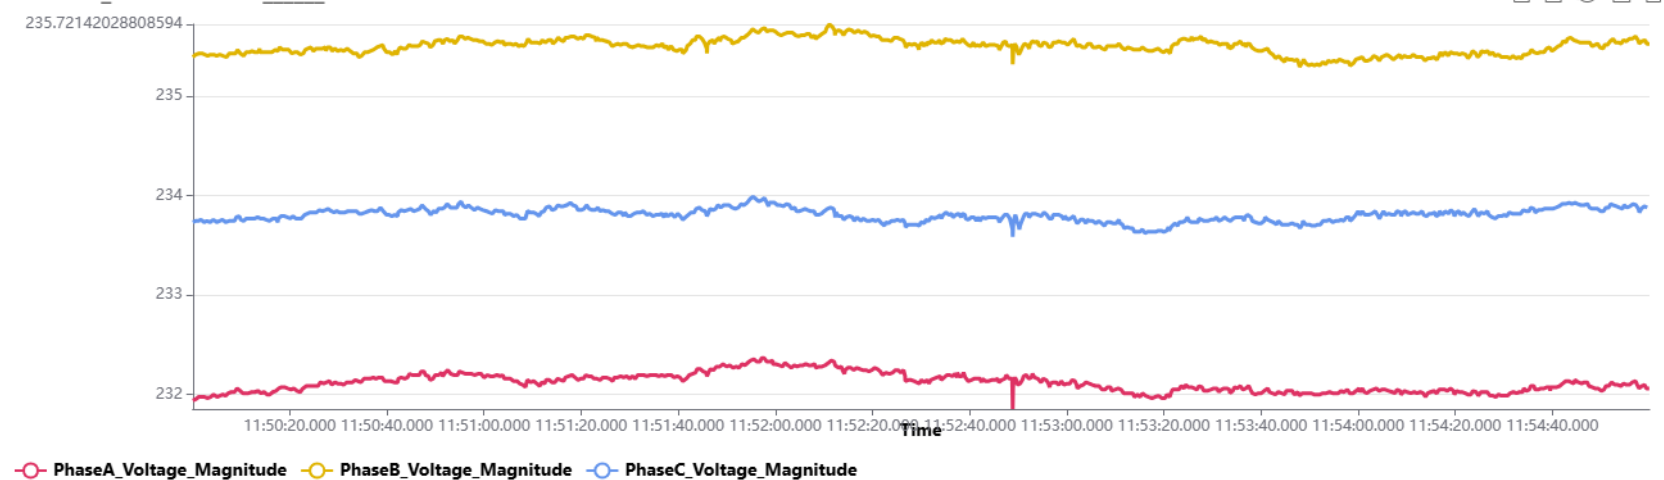
GHNPR\_PG 400BUS2 \_\_\_\_\_

➤ From the PMU plot, No fault was observed

1. TGTRANSCO stated that the 400 kV Chandulapur–Gajwel Line-2 tripped spuriously at the Chandulapur end without any protection indications during the pilot cell measurement of DC Battery Source-1.
2. TGTRANSCO further informed that 47 cells in Battery Set-1 were found to be open-circuited.
3. TGTRANSCO informed that the defective cells were rectified and the feeder was subsequently charged.
4. As a remedial measure, TGTRANSCO observed an issue with the off-time delay contactor of 63GLX1, which is connected in parallel with the 63GLX2 contactor, in the CGL make circuit breakers.
5. TGTRANSCO further informed that the time delay setting of the contactor had been increased to the maximum value from the earlier setting of 1 second.

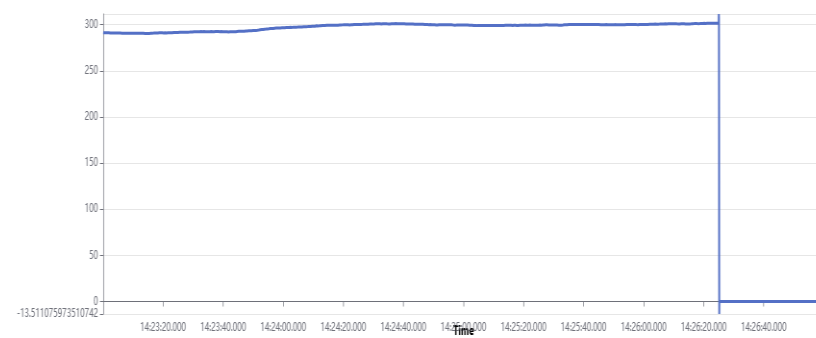
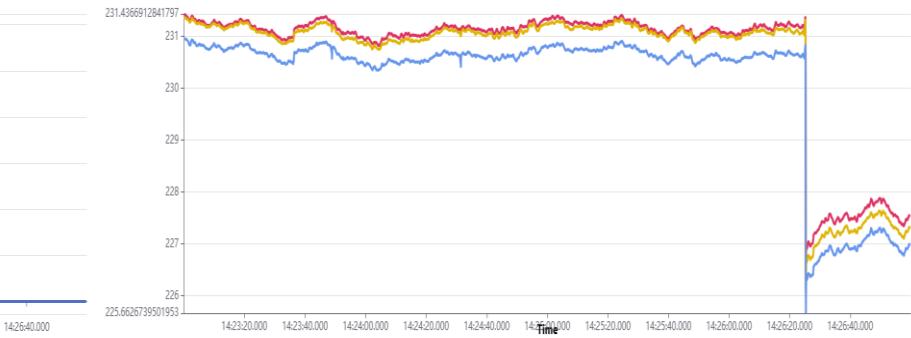
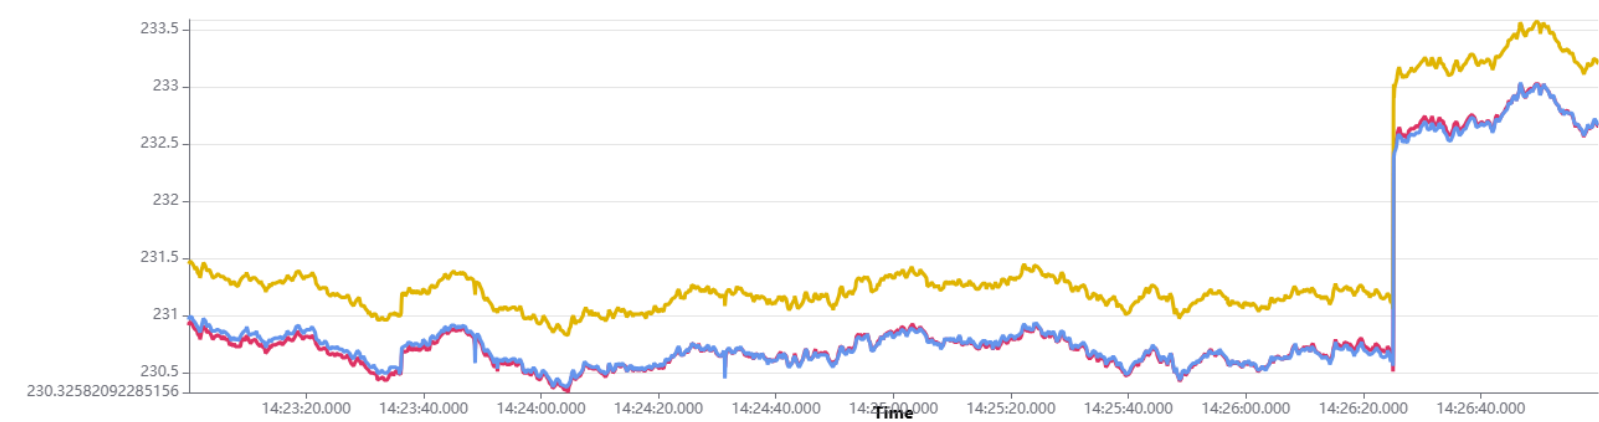
➤ From the PMU plot, tripping of the line can be observed

5. PGCIL SR-II stated that the standard operating procedure (SOP) for busbar relay testing had already been shared with M/s Adani and the testing agency. However, due to improper feedback to the testing kit during busbar relay testing by the agency deployed by M/s Adani, the LBB protection operated, leading to the tripping incident.

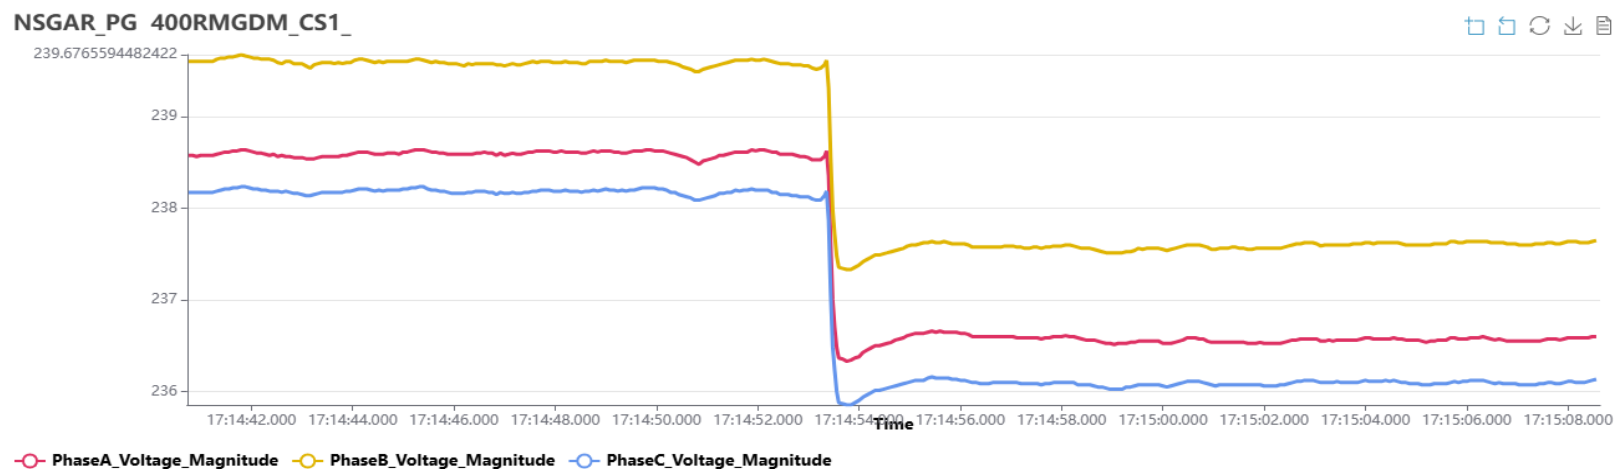
➤ From PMU data 400KV-NAGARJUNASAGAR\_PG-RAMAGUNDAM-1 incident is observed at 17:14:53 hr on the same day.

6. Upon verification of the internal event records, PGCIL SR-I observed that the RL-03 contact had extended the tripping command even when the relay was in overhaul (test) mode. PGCIL SR-I further informed that, in the other feeders connected to Bus-1, RL-03 had been kept as a spare contact and, accordingly, those feeders did not trip.

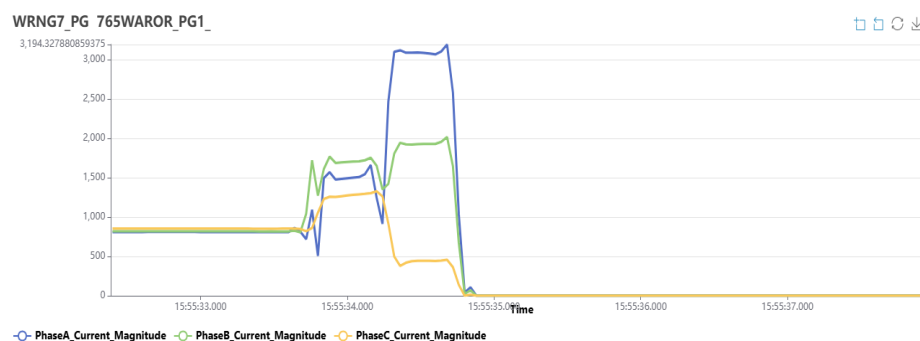
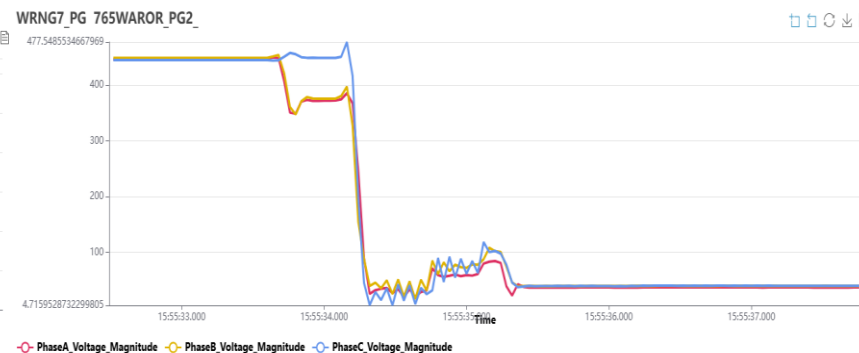
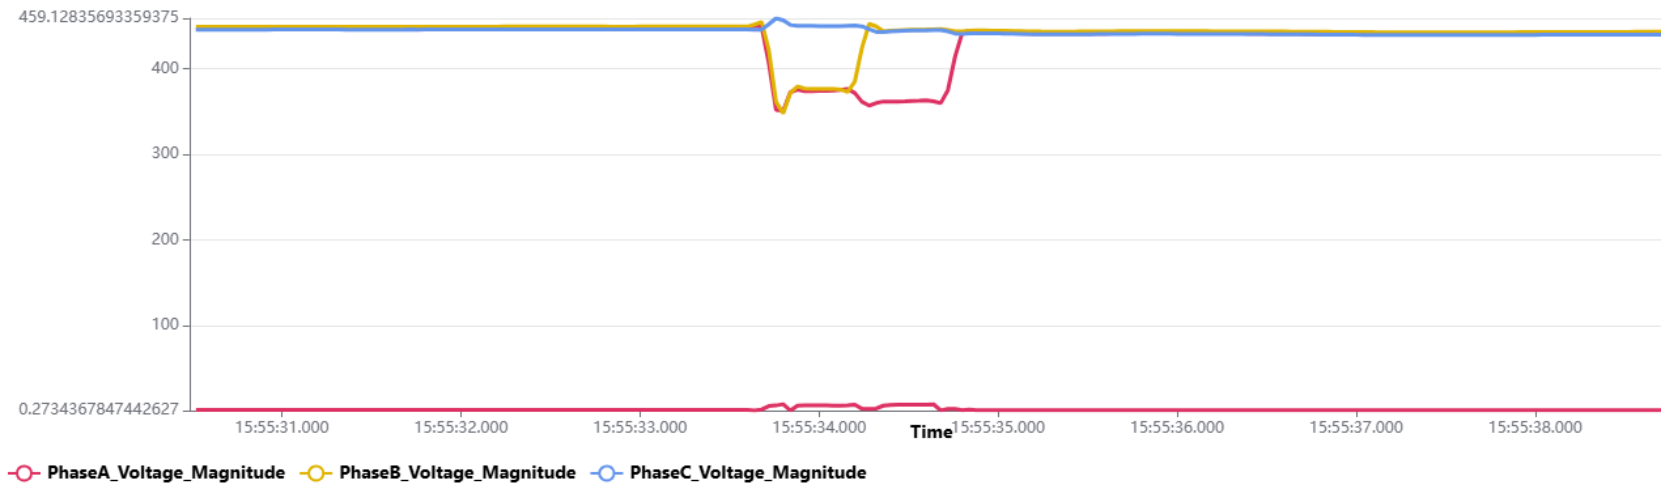
- From OMU, B-G fault can be observed with a delayed fault clearance of around 440ms.

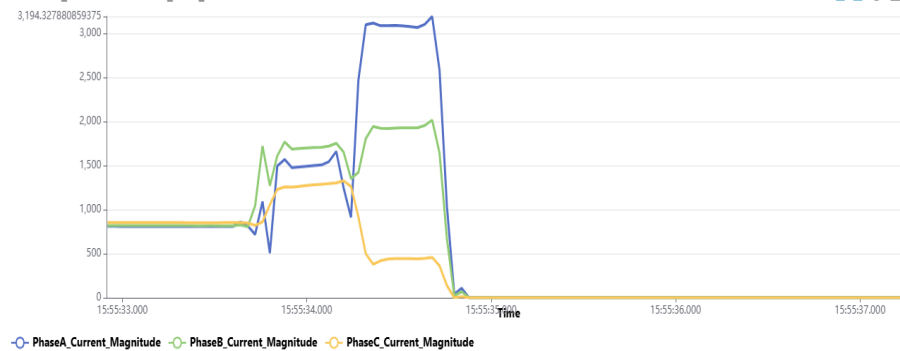
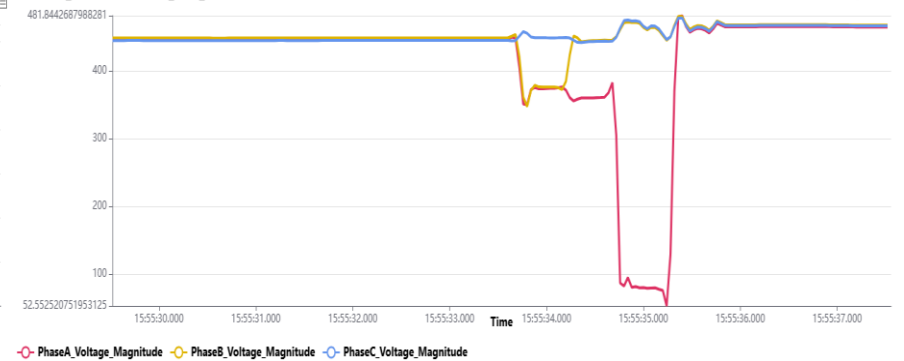
WRNG7\_PG 765WAROR\_PG1\_

- From the PMU plot, RY fault can be observed with delayed fault clearance of around 450ms.

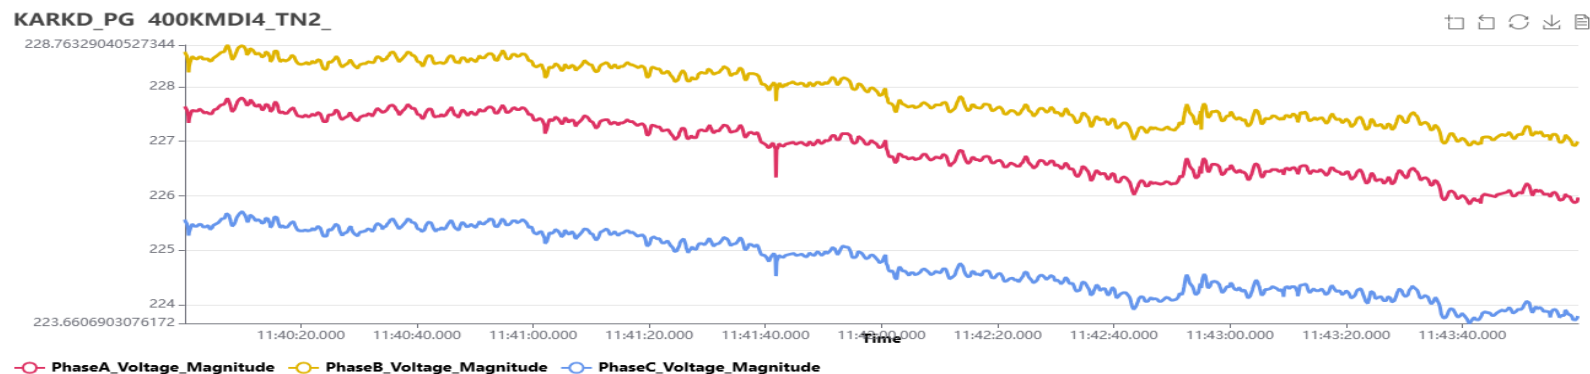
➤ From the PMU plot, It can be observed that there is no fault

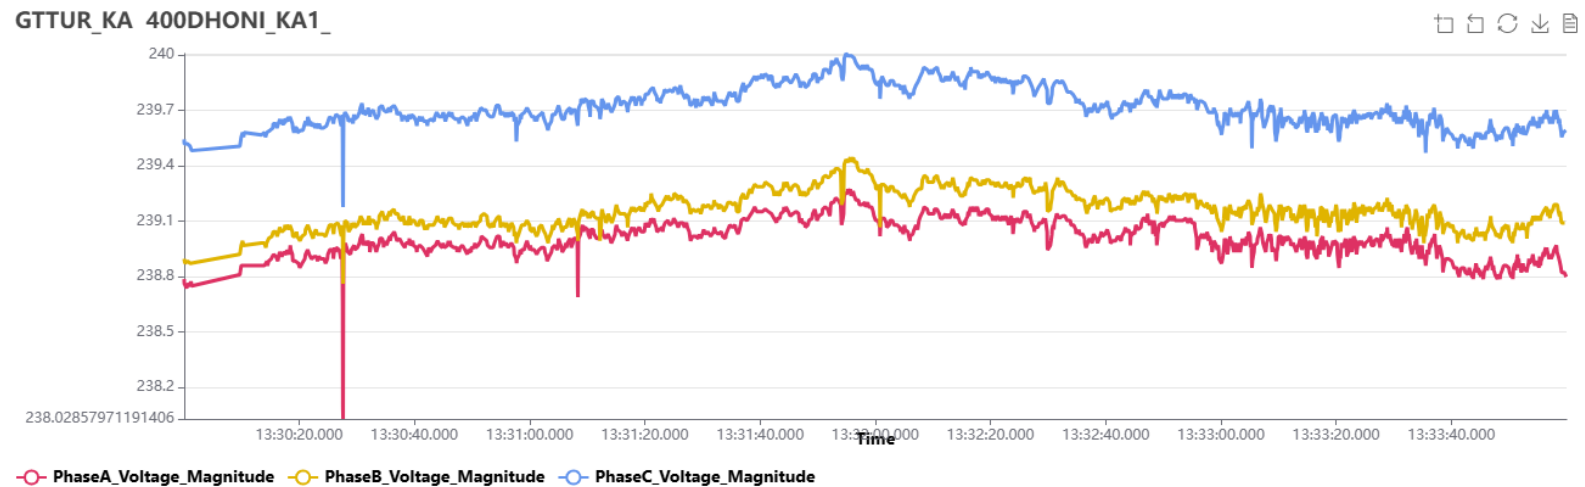
➤ No fault can be observed from PMU plot

1. KPTCL stated that, as per the reports submitted, the circuit breaker tripped only at the Guttur end, while the line remained charged from the Doni end. KPTCL further informed that the tripping was suspected to have been caused by the malfunction of the SF<sub>6</sub> safe-trip contactor due to a loose contact.
2. KPTCL informed that the line had tripped at the Guttur end due to the sudden drop out of the SF<sub>6</sub> safe-trip contactor (trip-before-lockout contactor) in the R-phase pole of the 400 kV Doni line circuit breaker.
3. As a temporary remedial measure, KPTCL informed that the trip-before-lockout contacts associated with the R-phase pole had been isolated to avoid spurious tripping. KPTCL further informed that action is being taken to replace the density monitor switch of the R-phase pole of the 400 kV Doni line circuit breaker.

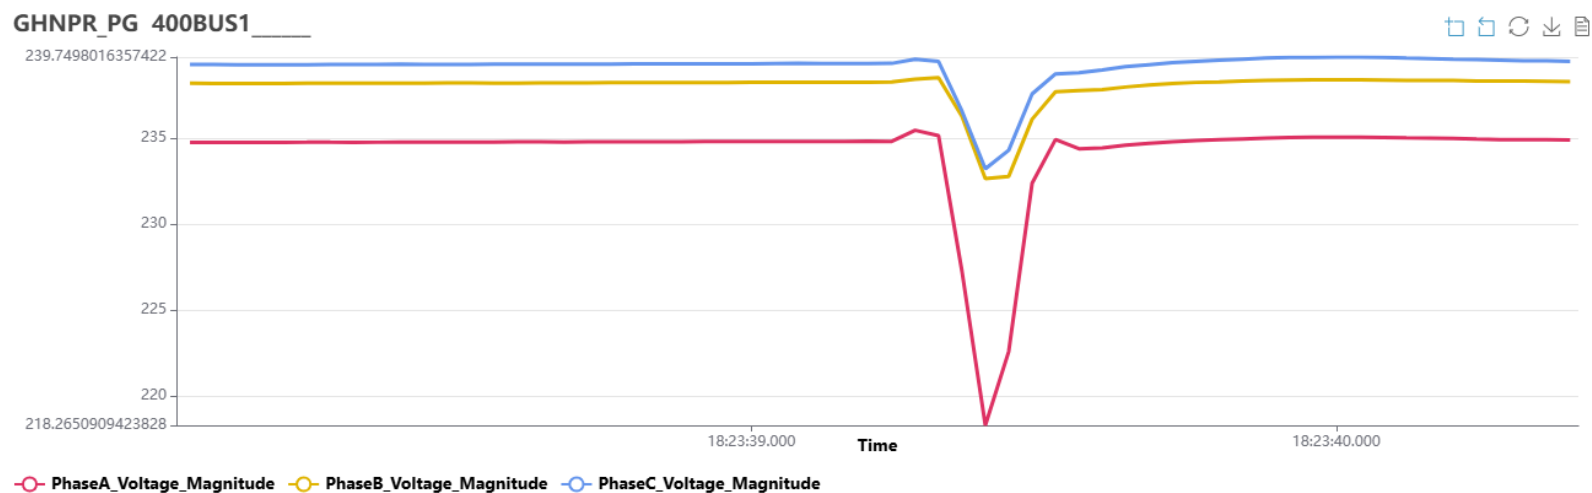
- From the PMU plot, R-G fault can be observed during the event without any delayed fault clearance

2. TGTRANSCO further informed that the 315 MVA ICT-III had tripped on the operation of differential protection.
3. TGTRANSCO stated that relay testing and all the necessary transformer tests were carried out, and all test results were found to be satisfactory. Subsequently, the ICT was charged.

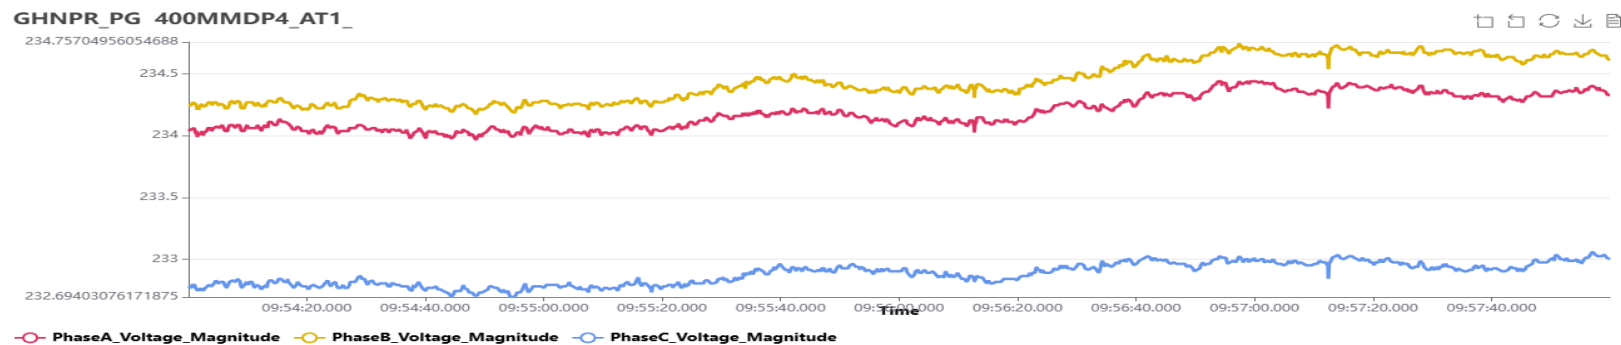
- From PMU, no fault is observed during the event.

3. TGTRANSCO stated that the tripping of the LV breakers was observed during the restoration of the DC supply.
4. TGTRANSCO further informed that an issue was identified with the off-time delay contactor of 63GLX1, which is connected in parallel with the 63GLX2 contactor, in the CGL make breakers.

5. As a remedial measure, TGTRANSCO informed that the wiring associated with the 63GLX1 contactor has been modified. TGTRANSCO further stated that discussions have been held with the OEM regarding the replacement of the faulty contactor and the modification of the wiring scheme.

- ✚ TGTRANSCO to submit the compliance report on the modifications carried out in the wiring scheme and the replacement of the faulty 63GLX1 contactor in the CGL make breakers at 400KV JULURUPADU.

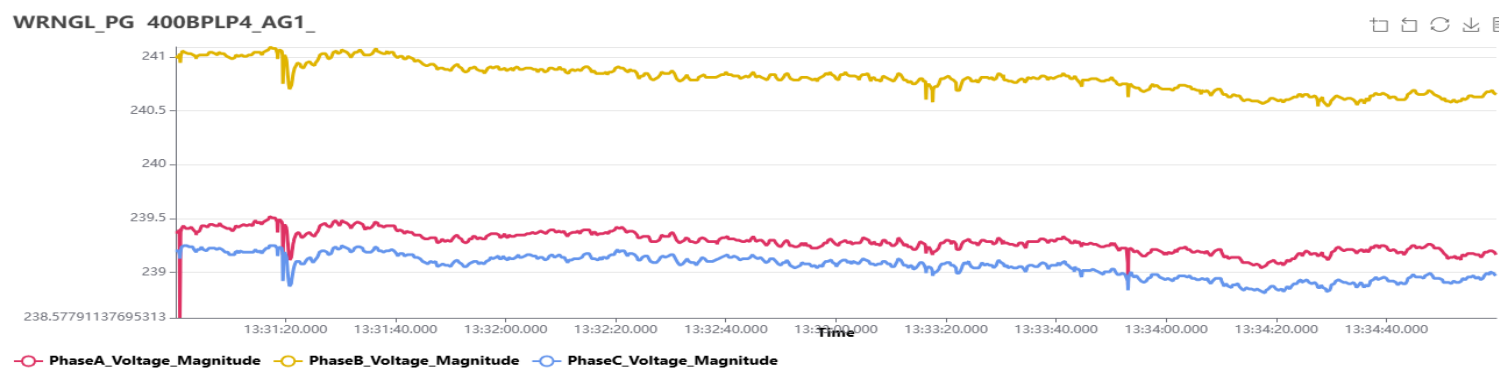
➤ From the PMU plot, It can be observed that there is no fault

1. TGTRANSCO stated that, as per the reports submitted, the 500 MVA ICT-II LV breaker at the 400/220 kV Bhupalapally substation tripped without any protection indications due to suspected DC earth leakage.

2. TGTRANSCO reported that DC earth leakage was identified in Bay No. 204 associated with the 100 MVA PTR-II and that the leakage was subsequently rectified.

3. As a remedial measure, TGTRANSCO informed that the DC earth leakage in Bay No. 204 (100 MVA PTR-II) had been rectified and the ICT was subsequently charged.

- ✚ TGTRANSCO to thoroughly examine the healthiness of the DC supply system at the 400kV Bhupalapally substation, including the DC cables, wiring schemes, wiring diagrams, contactors and associated auxiliary circuits, and to identify and rectify any deficiencies to prevent recurrence of such incidents. TGTRANSCO was further advised to submit the status of the corrective measures taken to SRPC.

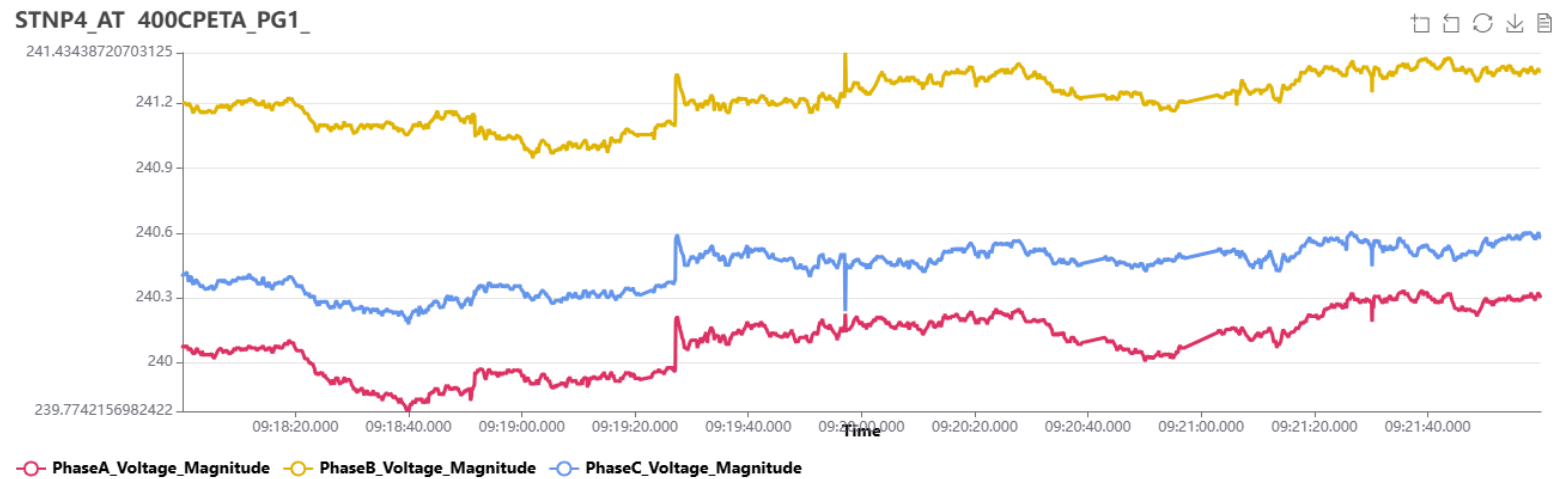
➤ From the PMU plot, it can be observed that there is no fault

1. APTRANSCO informed that, on 13.06.2026 at 09:18 hrs, the 400/220 kV, 500 MVA ICT-3 (Toshiba make) tripped due to the operation of the Sudden Pressure Relay (SPR).
2. APTRANSCO further informed that, in accordance with the recommendations of the OEM, Dissolved Gas Analysis (DGA) and Insulation Resistance (IR) tests were carried out and the test results were found to be satisfactory. The same was communicated to the OEM.
3. APTRANSCO informed that, in response, the OEM opined that the operation of the SPR might have been caused by vibrations or transient disturbances in the system, indicating a possible mal-operation of the relay, and accordingly accorded clearance for charging of the ICT.

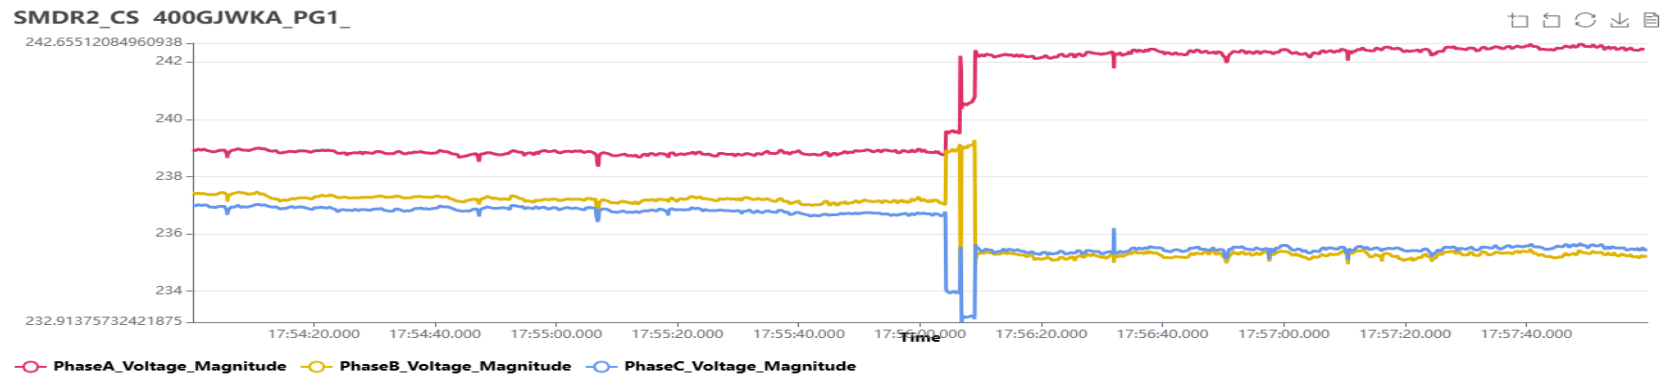
➤ No fault is observed from the PMU plot of the event.

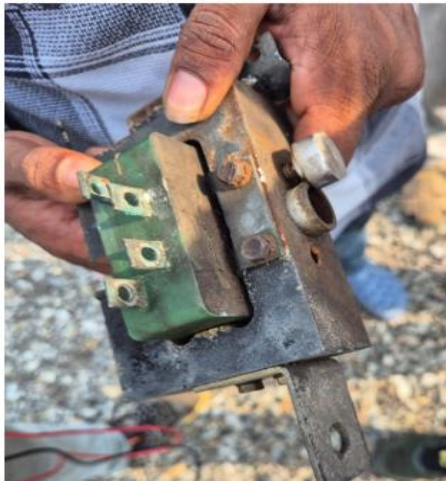
TC-1 & 2 Assembly (Faulty)

- Trip coil-1 & trip coil-2 in R-Ph also got failed due to which DC mixing has happened.
- Cracks Observed on R Phase Close coil. The coil is found to be earthed.

- It was verified the DC voltages were very stable prior to the tripping.
- At the time of tripping, fluctuations were noticed in both sources initially it was presumed to be AC & DC mixing, but later after detailed analysis it is confirmed that the fluctuations were due to failure of Trip coils in 252 CB.

- However, in 1152 CB, suspected close contactor in control room is replaced as precautionary measure and 1252 CB all wiring were tightened.
- The issue in 252 CB was rectified and CB taken into service and there was no issue observed since then.

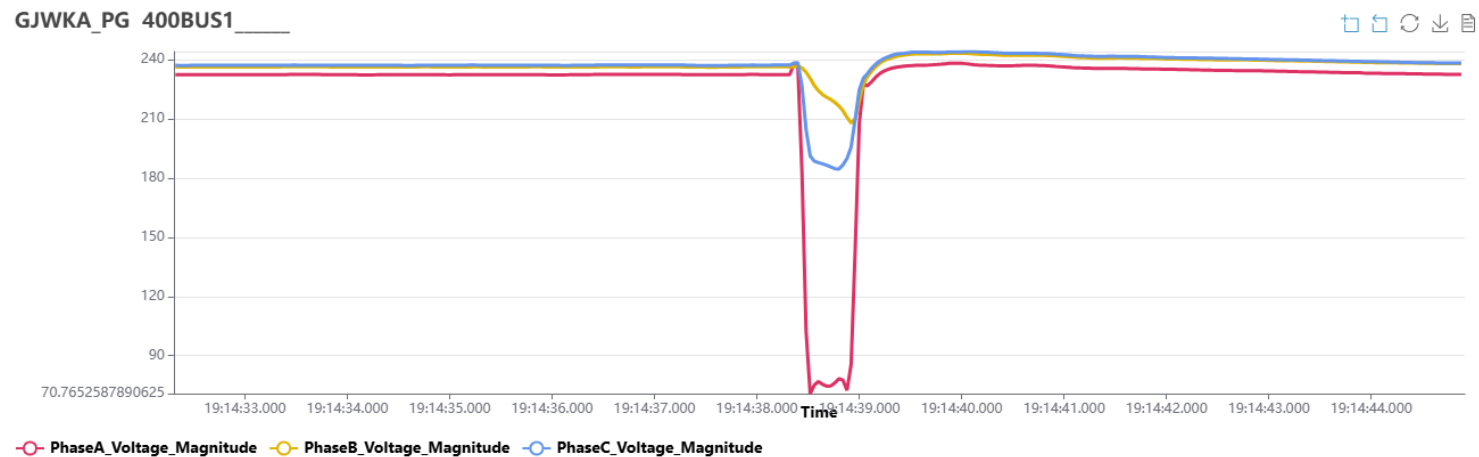
- From the PMU plot, R-G fault can be observed during the event with a delay of around 480ms.

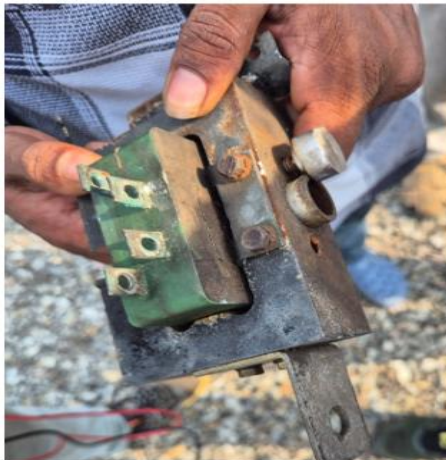
TC-1 & 2 Assembly (Faulty)

- Trip coil-1 & trip coil-2 in R-Ph also got failed due to which DC mixing has happened.
- Cracks Observed on R Phase Close coil. The coil is found to be earthed.

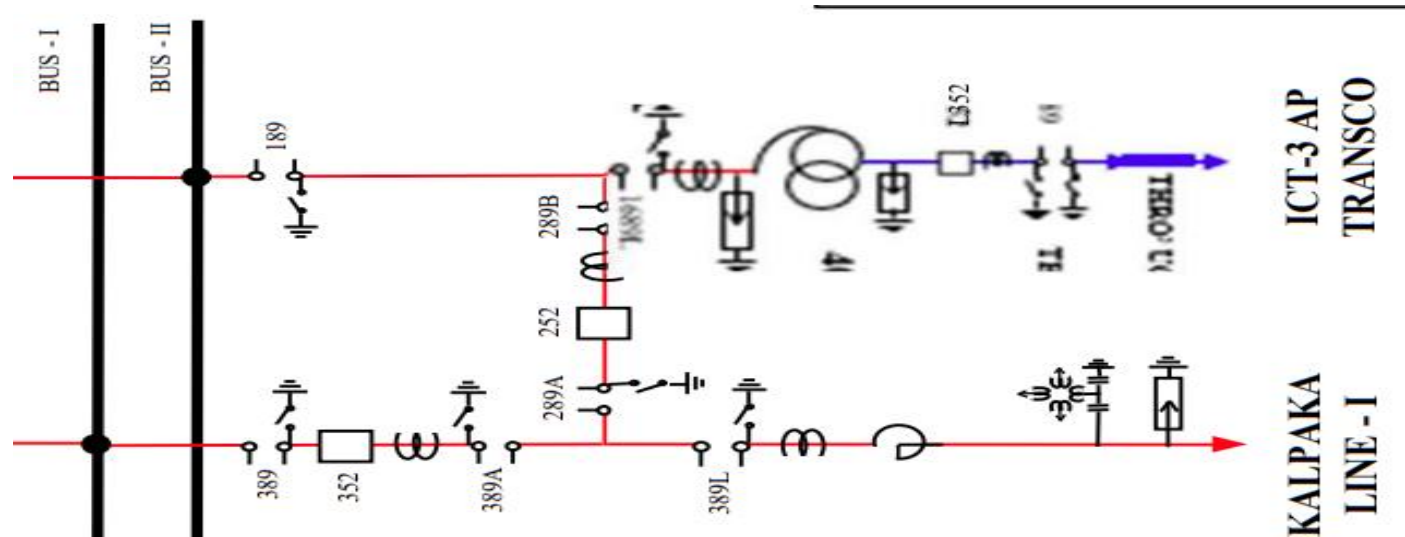
- At 17:10 hrs Kalpaka-1 tripped due to OPGW (Optical Ground Wire) snapping and ICT-3 remained in service and did not trip during this event.
- At 19:14 hrs To isolate DC fluctuations, DC supply to 252 CB was switched off. The fluctuations stopped.
- But, the R-phase pole of breaker 252 closed unintentionally.
- This inadvertent closure energized/fed the faulted section.
- As a result, fault current flowed through ICT-3.
- ICT-3 tripped on IV over current ( $I > 1$ ) protection as per the adopted settings.
- Tripping of ICT-3 is as per the adopted settings. The tripping is in order.

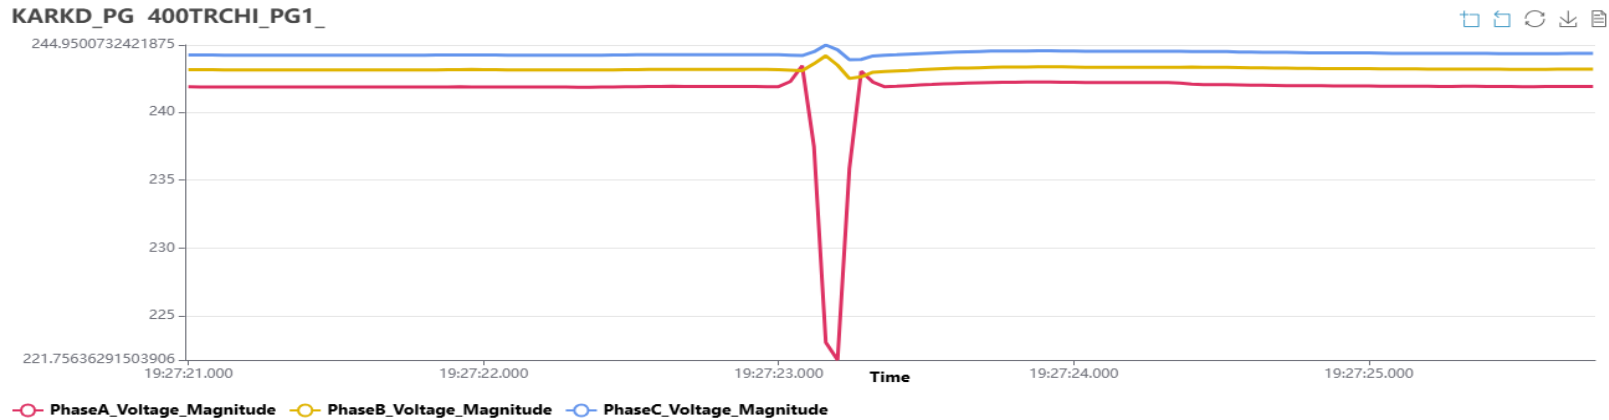
➤ From PMU, R-G fault is observed during the event.
