# Detailed Report

HOOTAGALLI - 220KV tripped at 22-07-2026 16:23 and restored at 22-07-2026 16:59

Summary of Event (घटना का सारांश) :

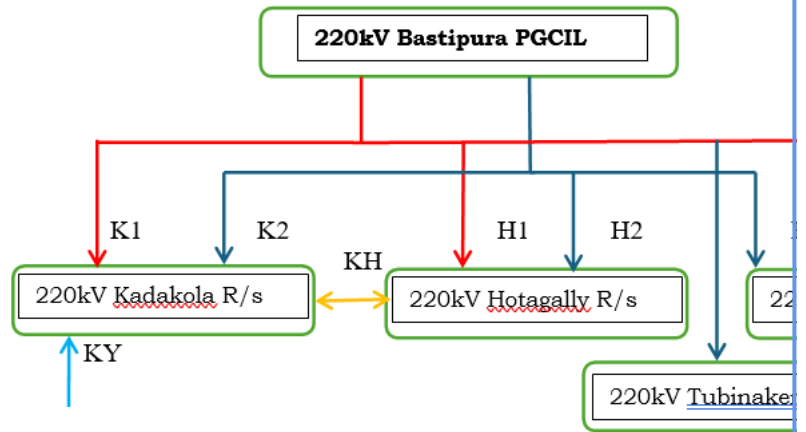
The affected 220 kV transmission network is as shown below.

- H1, H2 – Bastipura–Hootagally Lines 1 & 2
- K1, K2 – Bastipura–Kadakola Lines 1 & 2
- Hu1, Hu2 – Bastipura–Hunsur Lines 1 & 2
- KY – Kadakola–Kannyambetta Line
- KH – Kadakola–Hootagally Line
- Red Bus – Bus Bar-I; Blue Bus – Bus Bar-II
