## Grid Occurrences – 145

### I. Details of Grid Disturbances

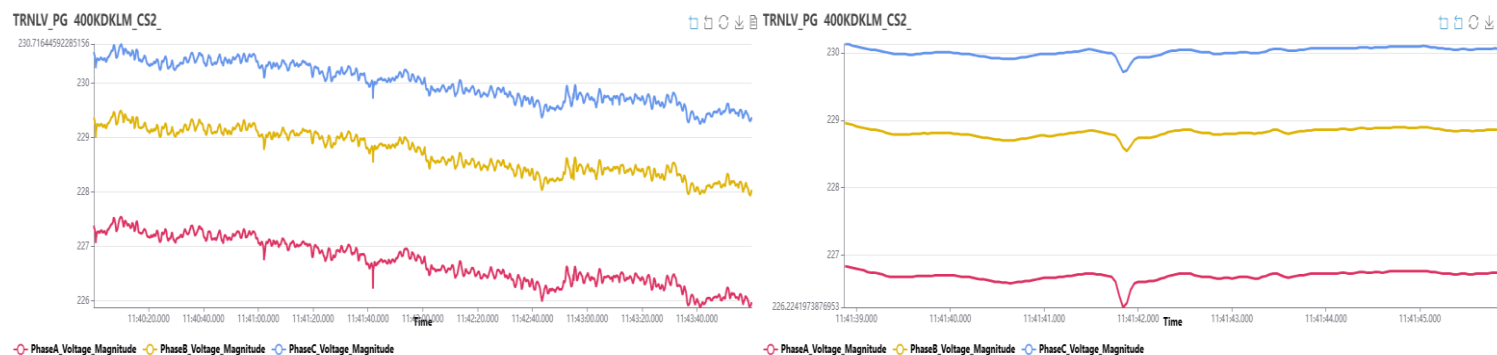
From the PMU plot, no fault can be observed during the event

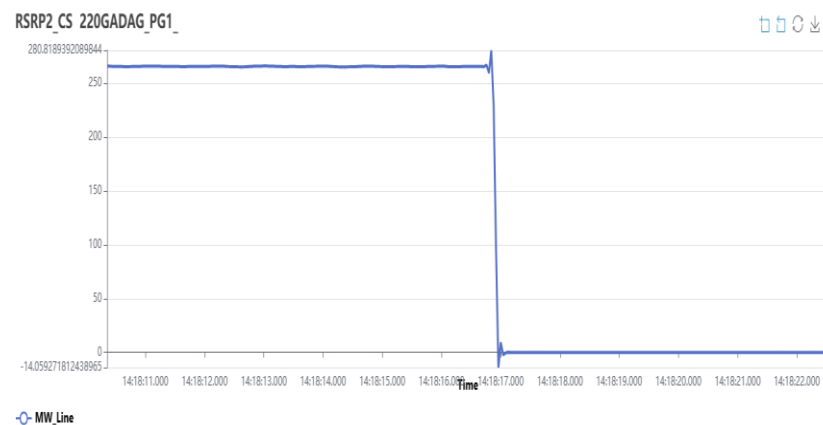
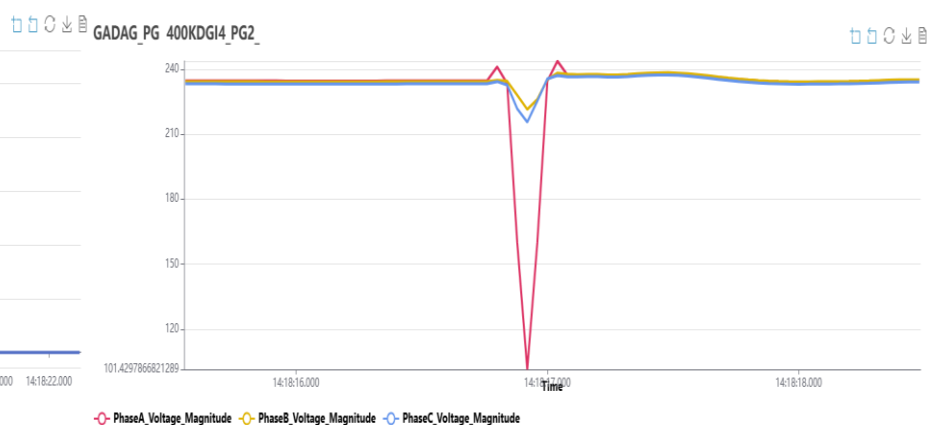
From the PMU plot, R-G fault can be observed without any delayed fault clearing.

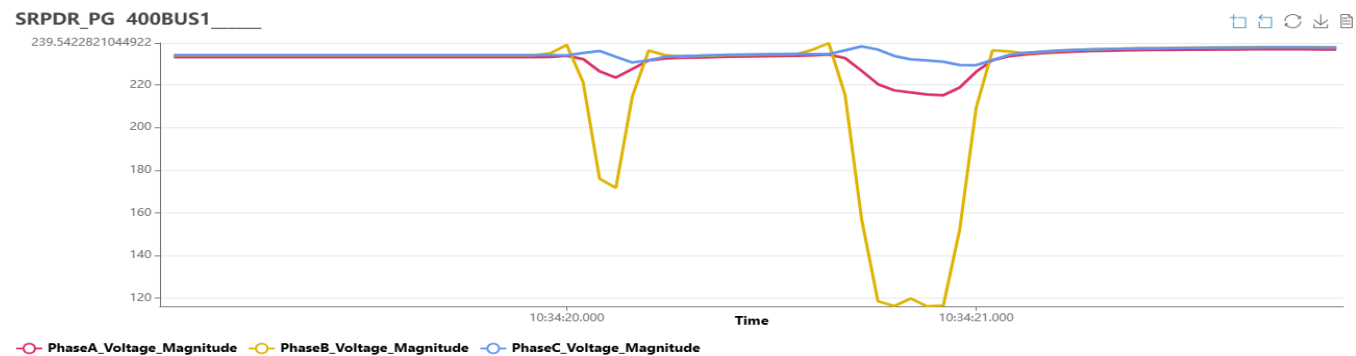
From the PMU data, a Y-G fault is observed with delayed fault clearance. Subsequently, within the reclaiming time, another Y-G fault is observed.

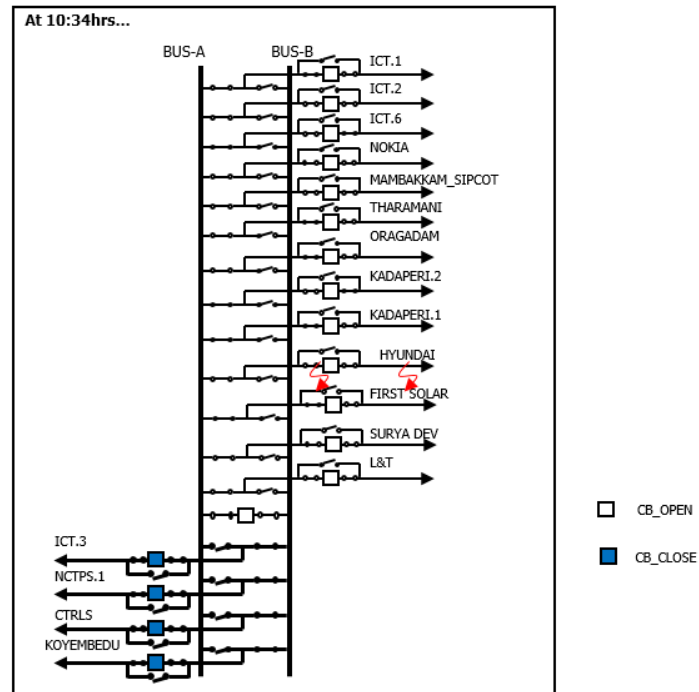
6. TANTRANSCO stated that on detailed analysis they found that Jumper cut & hanged in between feeder 211-89C isolator and feeder breaker Then hanging jumper fell on the structure caused sensing of continuous fault current by the feeder CT until fault is cleared by the feeder LBB protection. All elements connected in Bus A got tripped

- Feeder breaker timing test carried out
  - Feeder CB IR value checked when CB is in open condition as well as in closed condition.
  - Defective Y polymer insulator at take off tower attended.
  - Jumper cut in between breaker & 89C isolator attended.
  - Feeder CB LOCAL/REMOTE operation checked and found in order.
8. SRPC enquired about the bus configuration at Hyundai SS. TANTRANSCO stated that Hyundai SS is having 2 sources one is from Sriperumpudhur Bus A as radial feeder (since load). Alternate source is tapped off from 230kV Sriperumpudhur-Koyembedu feeder Which is always open condition

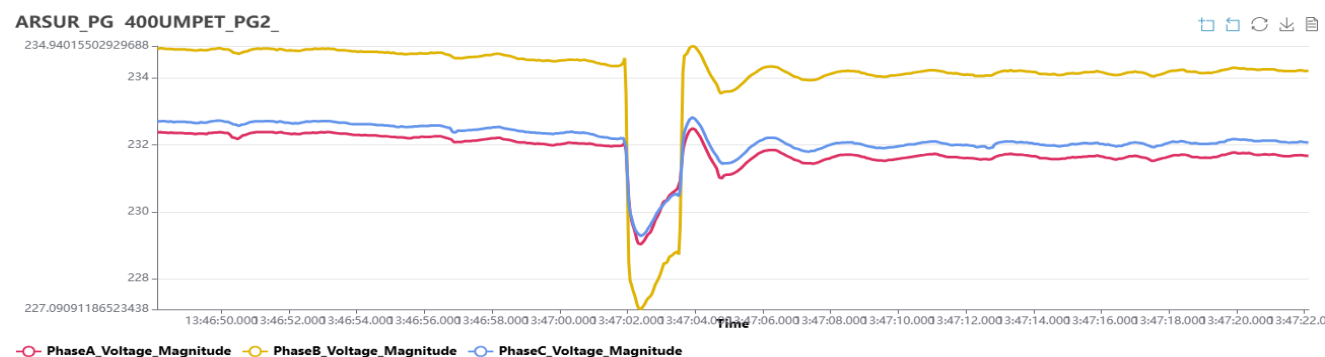
From the PMU data, Y-G fault is observed with delayed fault clearance.

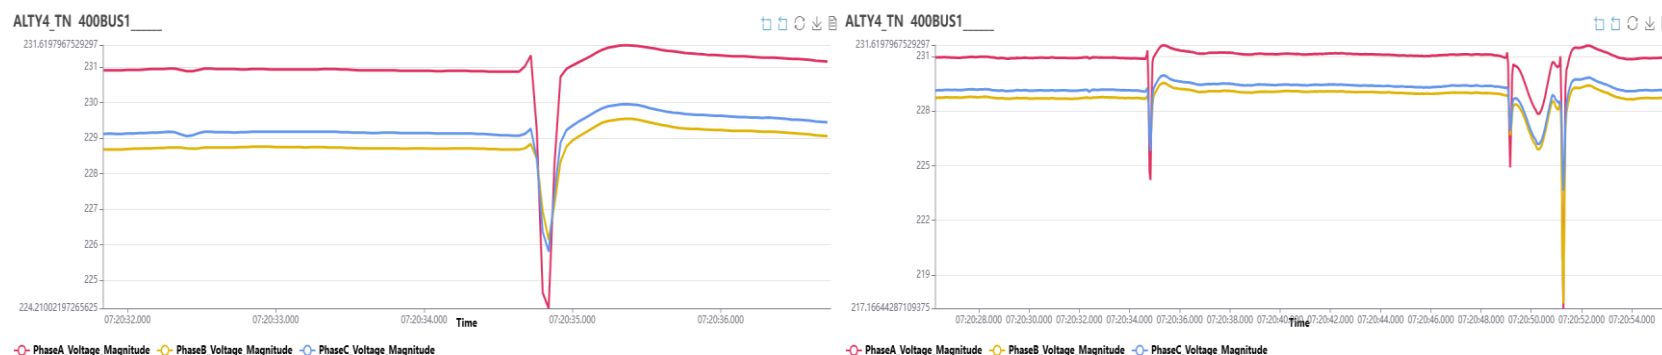
From the PMU Analysis, R-G fault can be observed during the event without any delayed fault clearance

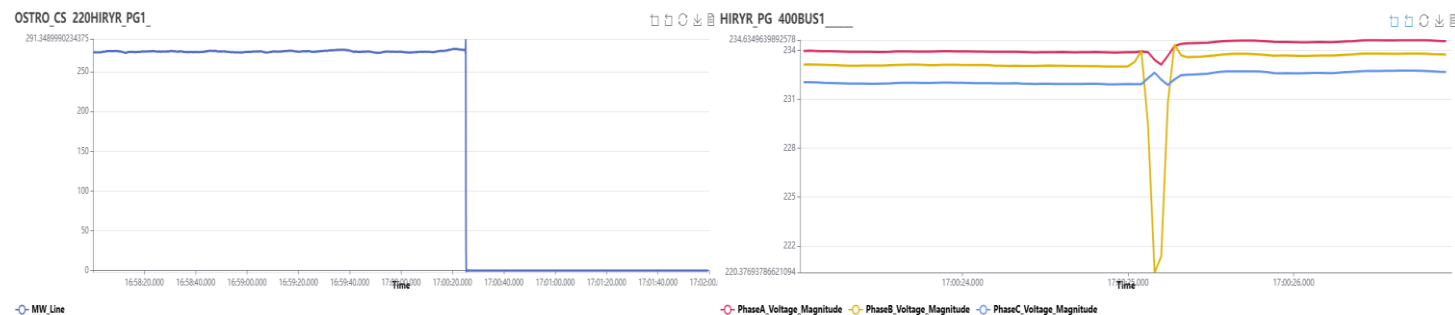
From the PMU Analysis, Y-G fault can be observed during the event without any delayed fault clearance

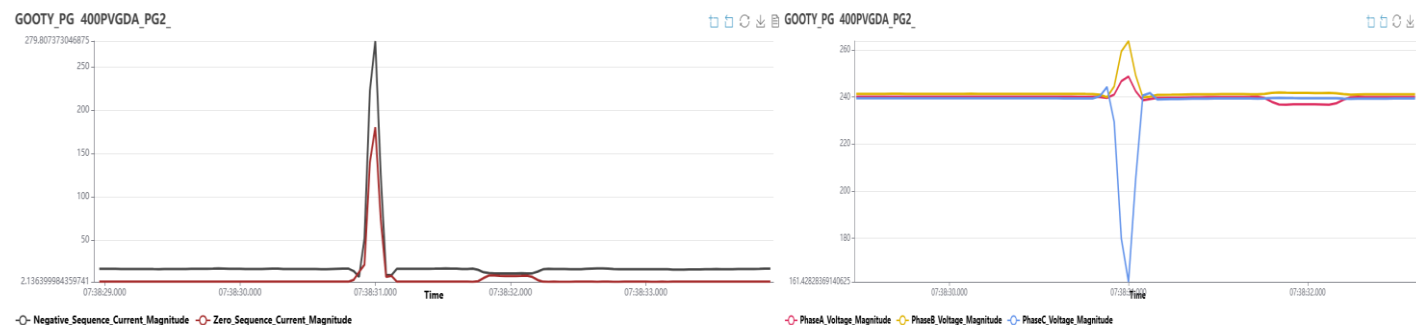
From PMU, dip in B-pole is observed followed by RYB fault during the event.

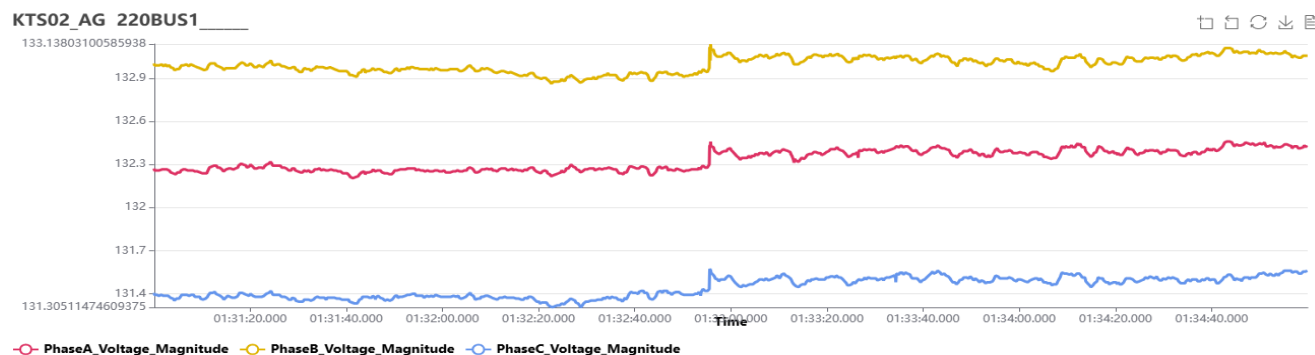
From the PMU plot, there is no fault during the event

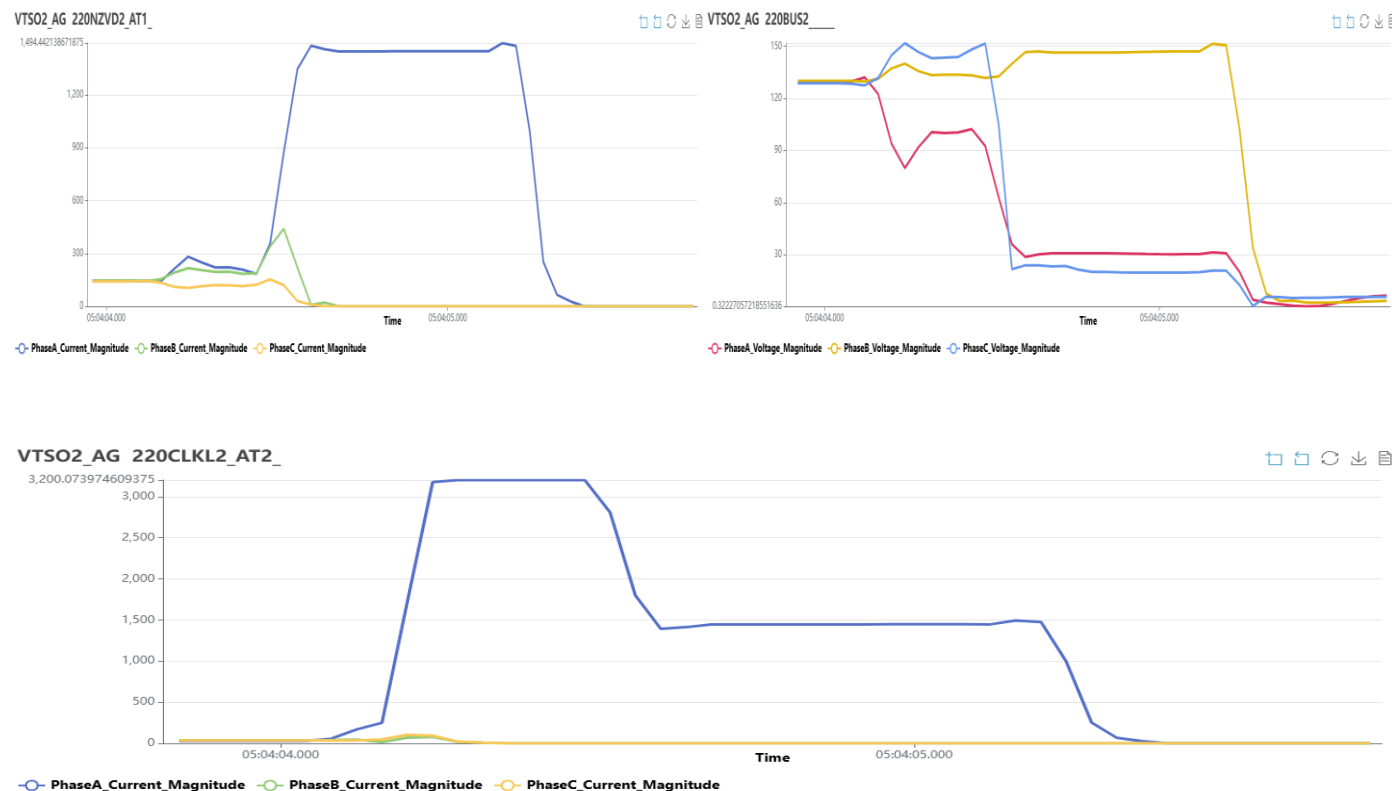
From the PMU plots, R-G fault can be observed with delayed fault clearing. Also, delayed tripping of 220KV-VTPS-NUZVID-1 line can be observed.

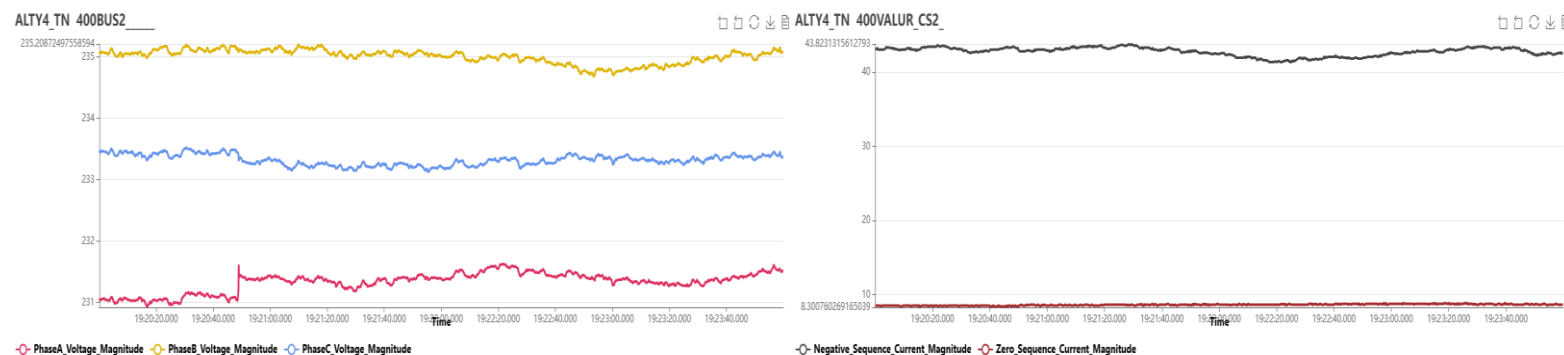
From the PMU data, no fault was observed during the event.

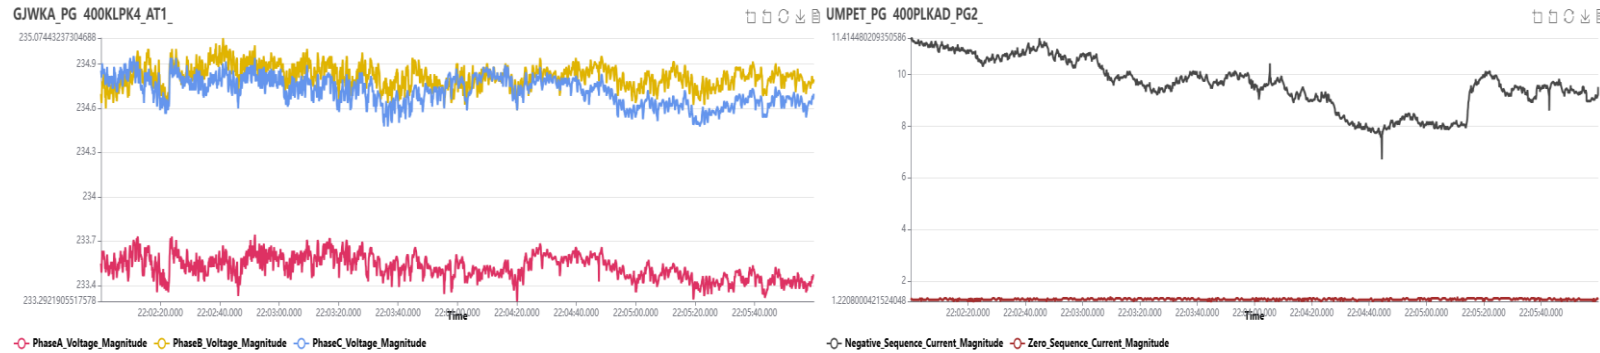
From the PMU data, no fault is observed during the event.

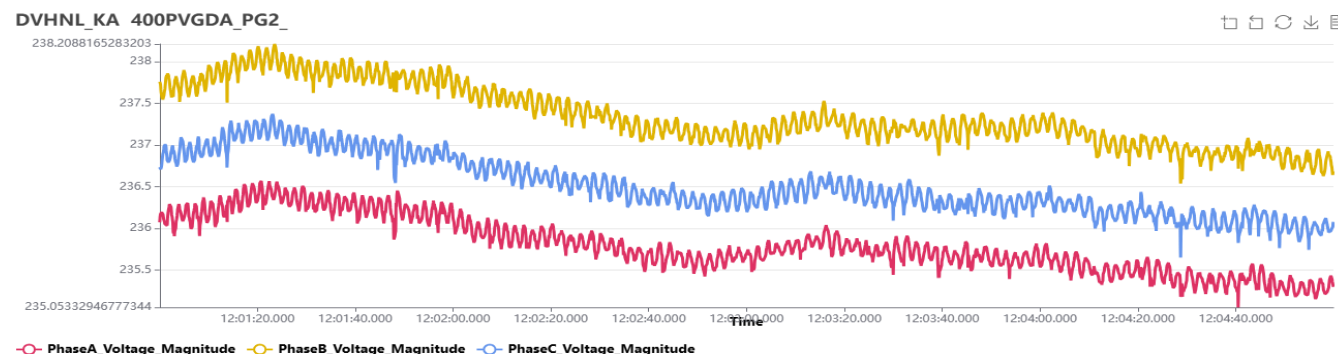
From PMU data, no fault was observed during the event

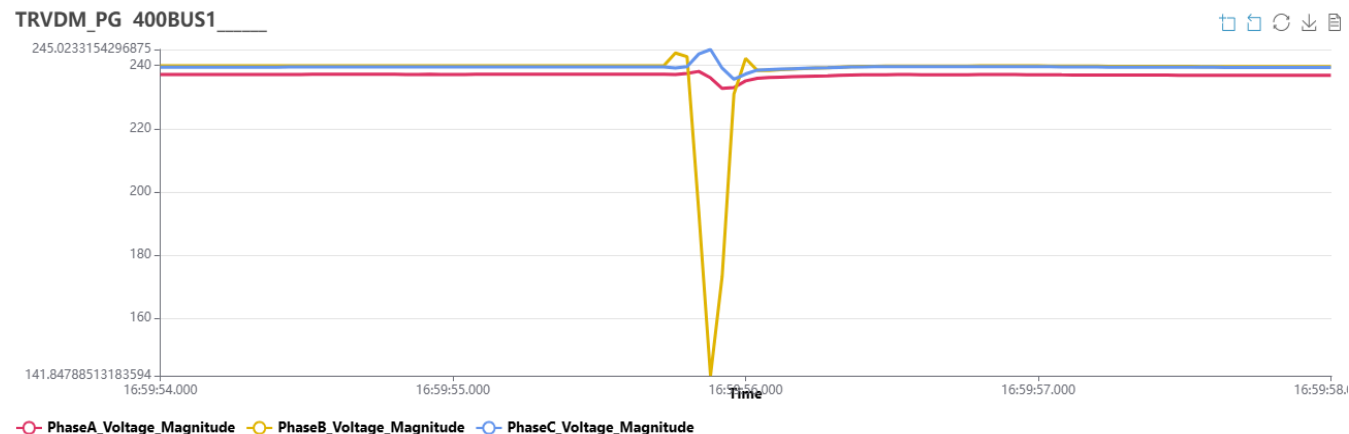
From the PMU plot, Y-G fault can be observed without any delayed fault clearance.

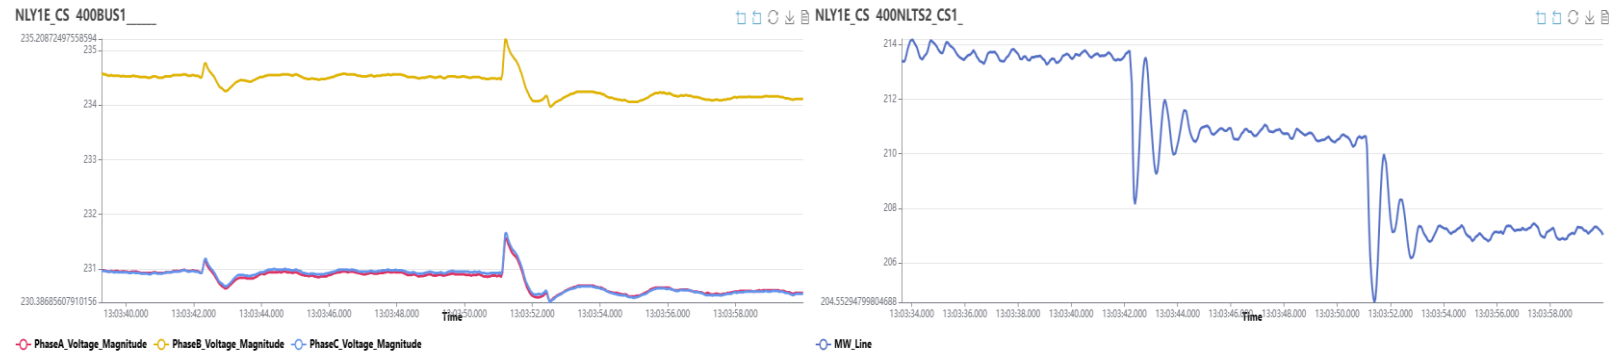
From PMU, no fault is observed during the event.

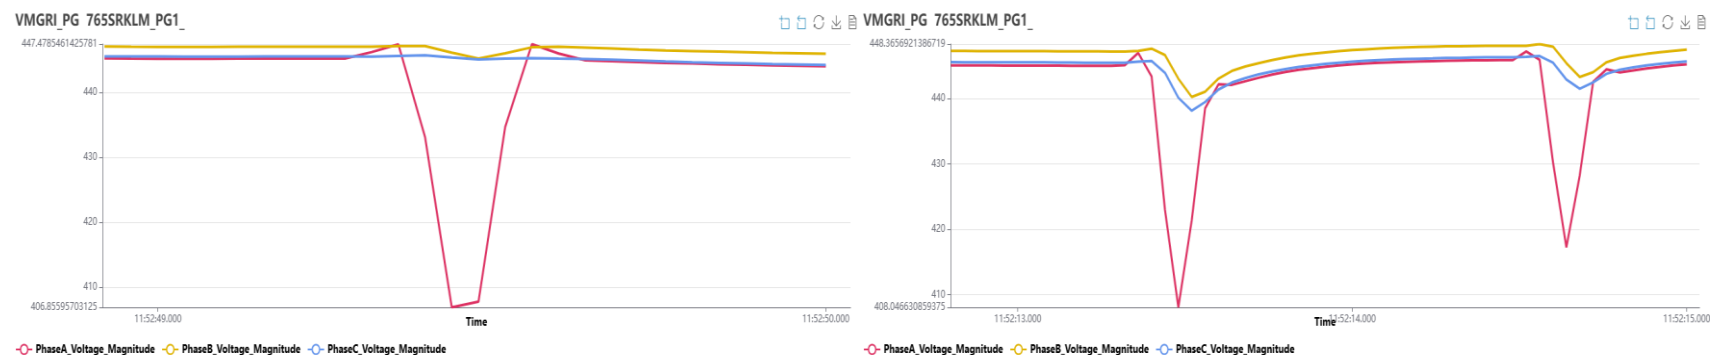
From PMU plot, R-G fault is observed at 11:52:49hrs indicating R-G fault in 220kV Vemagiri Bus coupler.
