## III. Single/Multiple Element Tripping with Protection Violation

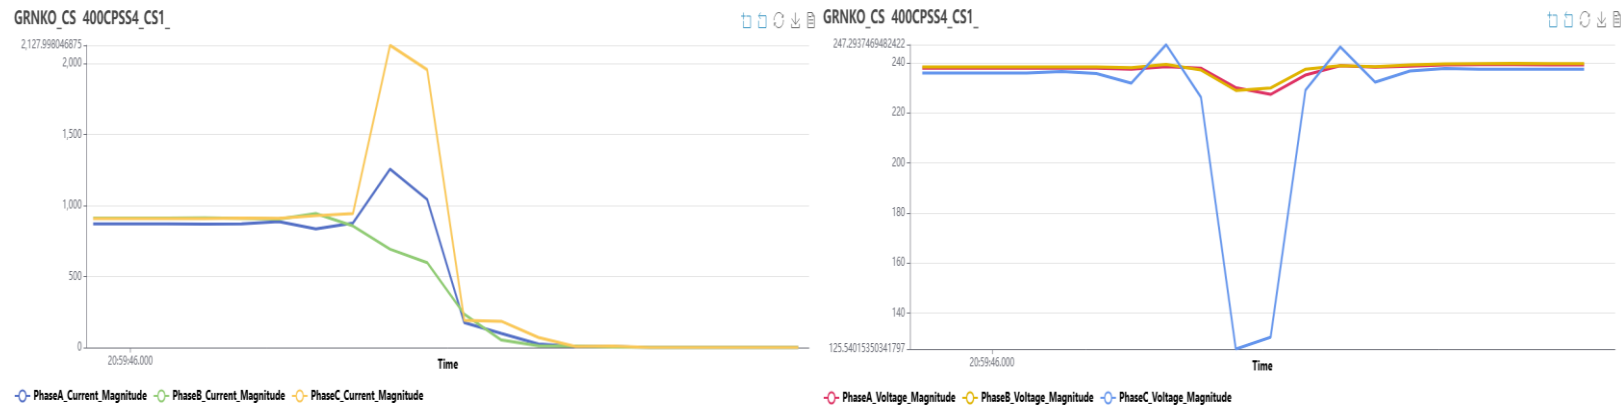
| S. No. | Event | Event Analysis | Outage Date & time | Points for Review | Remedial Actions Furnished |
|---|---|---|---|---|---|
| 1 | 400KV-GREENKO_CPSS-GREENKO_PSP-1 | As per the reports submitted, B-G fault was sensed in Z3 at GREENKO_CPSS end in the line. As the voltage dipped to 36% and SOTF threshold was set to 40%, SOTF got triggered and the line was 3-ph tripped. | 05-06-2026<br>20:59 | <b><u>GREENKO</u></b> : SOTF trip for an external fault needs review. | |

**From the PMU plot, B-G fault can be observed without any delayed fault clearance.**

2. M/s Greenko further informed that Main-2 relay with the Zone-3 pickup initiated SOTF trip signal after 36 mSec on fault detection resulting in the opening of the circuit breaker in 42 ms.

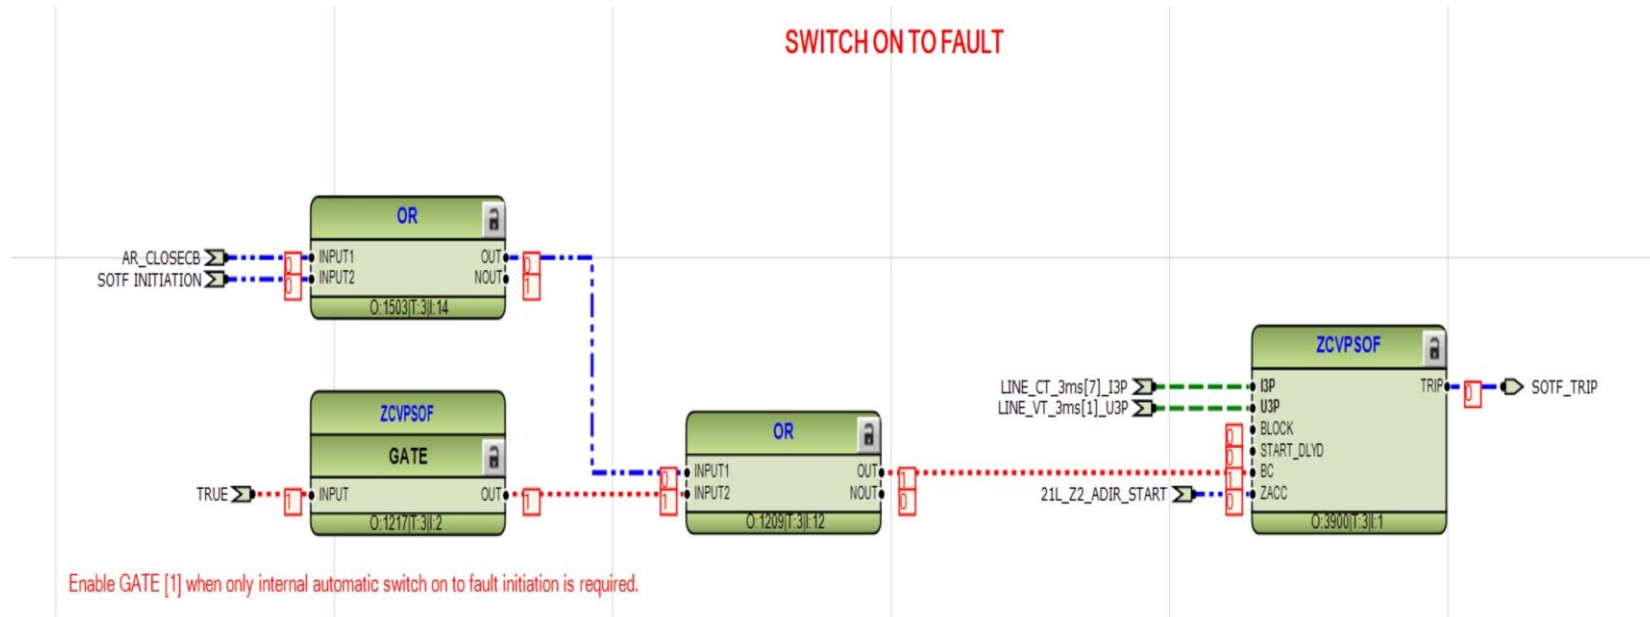
## Before Modification SOTF LOGIC

3. Upon detailed investigation, M/s Greenko identified that the SOTF (Switch-On-To-Fault) function logic had been incorrectly configured. A continuous high input signal (Fixed TRUE) was mapped to the SOTF enable input instead of the appropriate SOTF initiation signal.

4. Due to the incorrect logic configuration, the SOTF function remained continuously enabled. Subsequently, during the Zone-3 fault, the SOTF operating conditions were satisfied, resulting in the unintended initiation of the SOTF trip command.

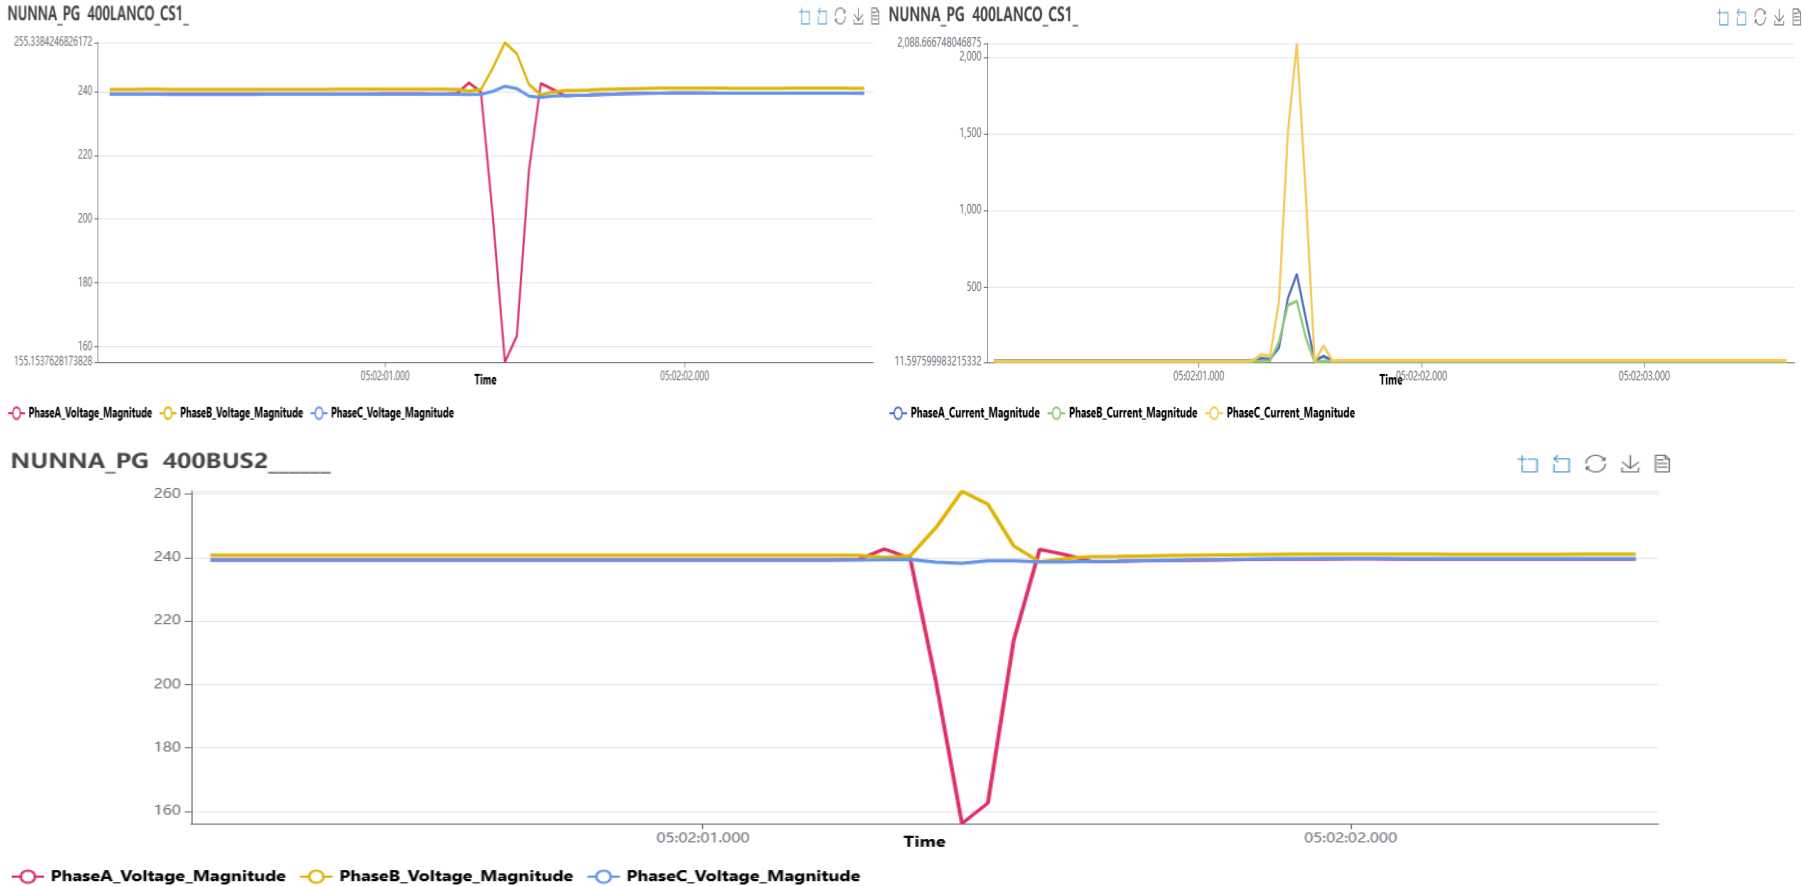
From the PMU plot, R-G fault can be observed during the event without any delayed fault clearance

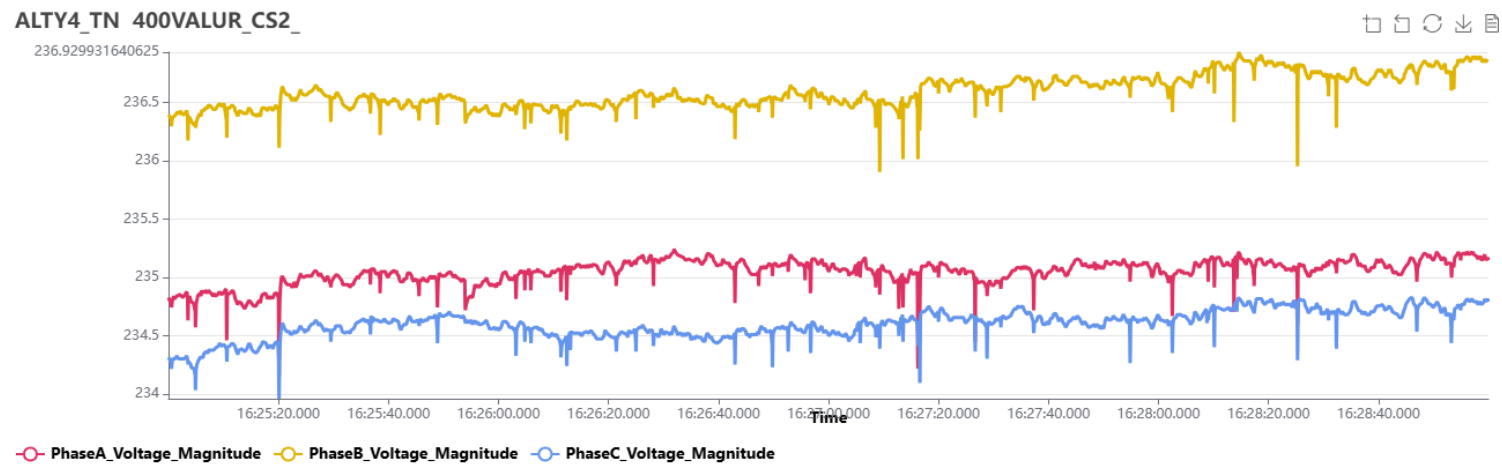
ALTY4\_TN 400VALUR\_CS2\_

**From the PMU, no fault is observed during the event.**

1. NTECL Vallur informed that the 400 kV Vallur–Alamathy-1 line tripped on 18.06.2027 at 16:27 hrs, suspected to be due to maloperation of the Pole Discrepancy (PD) relay at Vallur end, while the line remained in service from the Alamathy end.
2. NTECL Vallur informed that only PD alarm was observed during the incident, with no other protection indications.
3. NTECL Vallur further informed that light drizzle was prevailing at the time of the incident, no fault current was observed, no other alarm was recorded, and the line remained charged at Alamathy end.
4. NTECL Vallur informed that all circuit breaker NO/NC contacts and the associated control cables were checked and found healthy.
5. NTECL Vallur further informed that, after verification of the control cables and associated circuitry, the line was charged successfully.

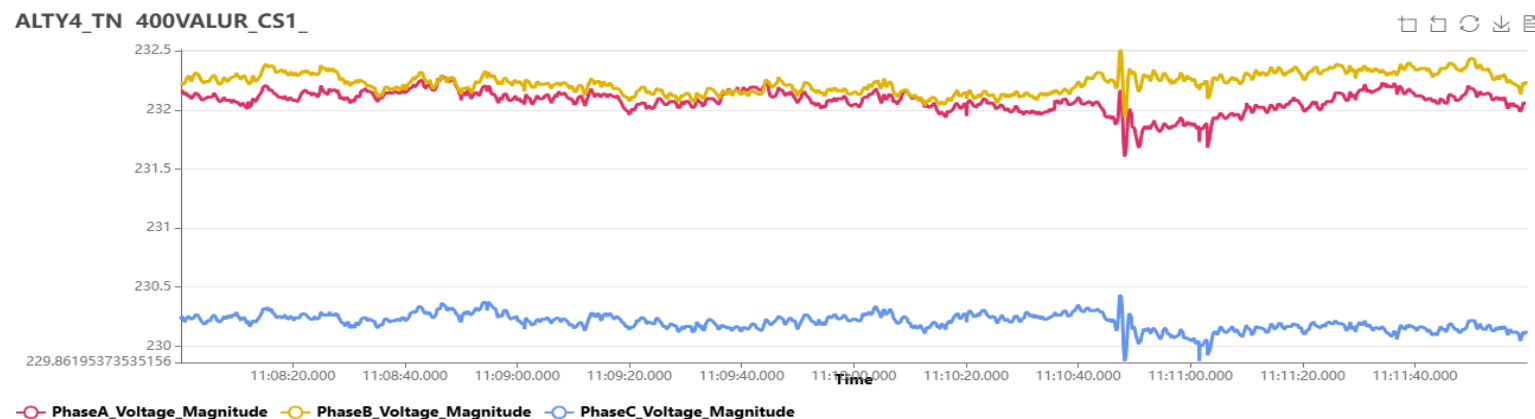
From PMU analysis, it can be observed that there is no fault

1. NTECL Vallur informed that, after successful charging of the 400 kV Vallur–Alamathy Line-1 on 18.06.2026, the line tripped again on 19.06.2027 due to suspected maloperation of the Pole Discrepancy (PD) relay at Vallur end, attributed to a DC earth fault. During the event, no fault was observed on the line and the line remained in service from the Alamathy end.
2. NTECL Vallur further informed that a DC earth fault was observed and traced to Bay-410 (GT-2), which was under shutdown. It was also observed that the PD protection of Bay-414 operated whenever a DC earth fault occurred in the station.
3. As a corrective measure, the PD relay was replaced, following which the incident has not recurred.

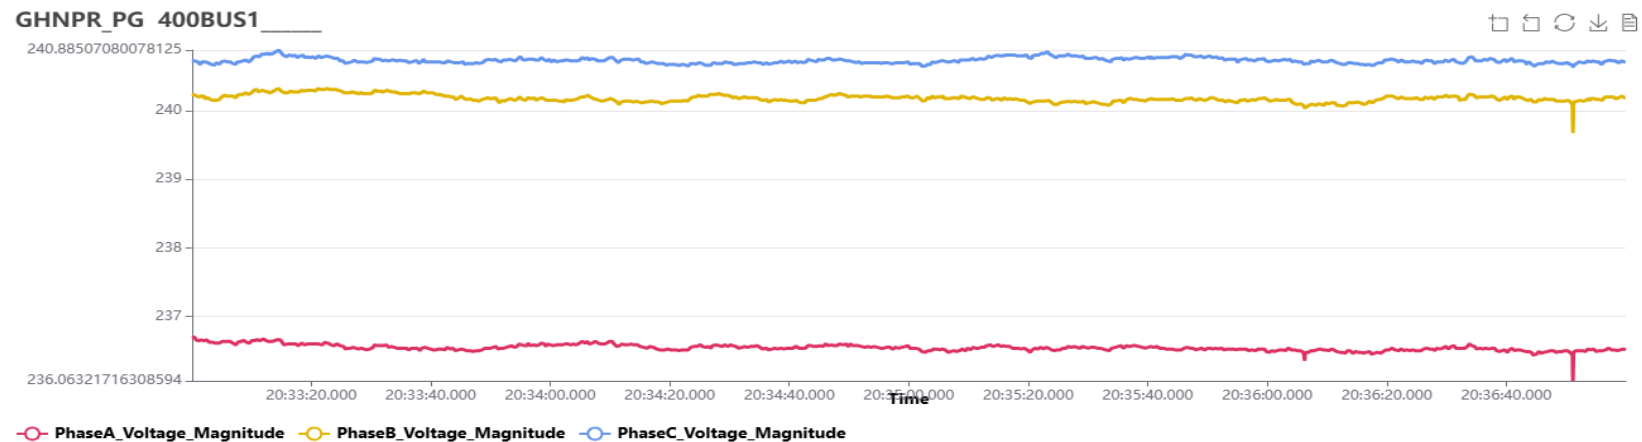
**From the PMU plot, it can be observed that there is no fault**

1. TGTRANSCO informed that the triggering incident was suspected maloperation of the protection relay at Nirmal end, resulting in tripping of 315 MVA ICT-1 on operation of B-phase REF protection. No corresponding fault was observed in the PMU records.
2. TGTRANSCO informed that, during testing carried out on 29.06.2026, the relay again issued an unwarranted trip command to the ICT. Based on the observations during testing, the GE make T60 REF relay was suspected to be malfunctioning.
3. TGTRANSCO informed that the suspected GE make T60 REF relay was replaced with a spare T60 REF relay, following which ICT-1 was successfully charged on 29.06.2026.

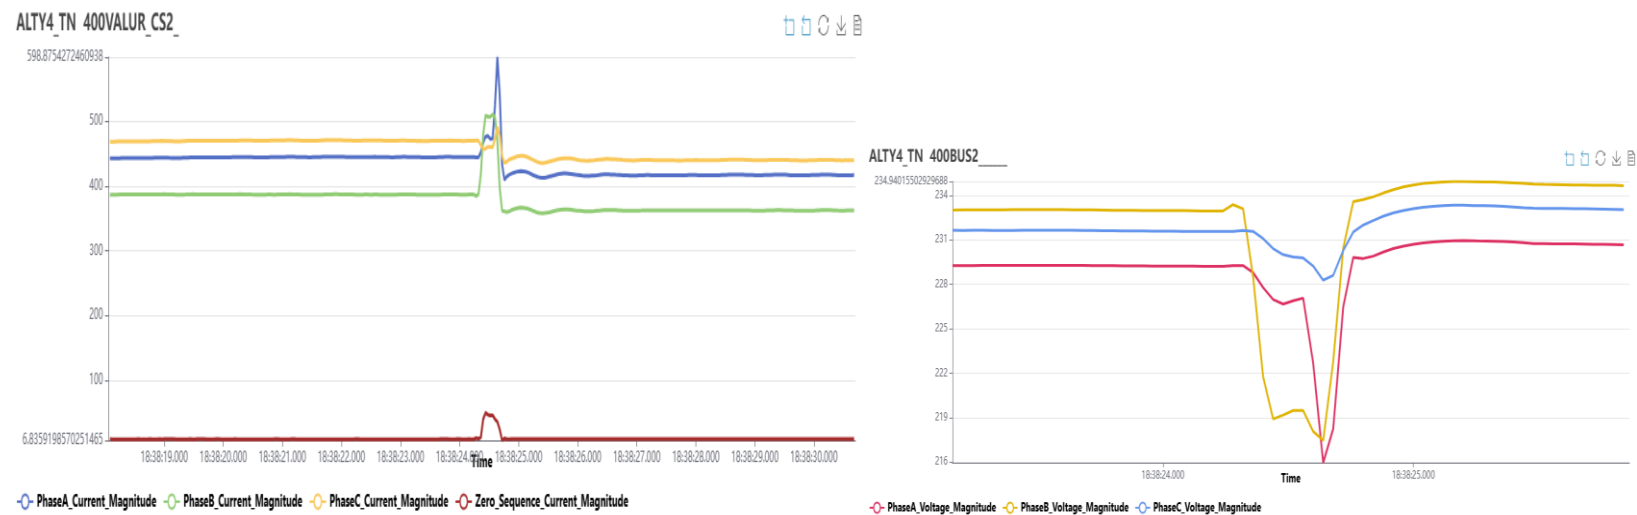
From the PMU plot, Y-G fault can be observed during the event with delayed fault clearing.

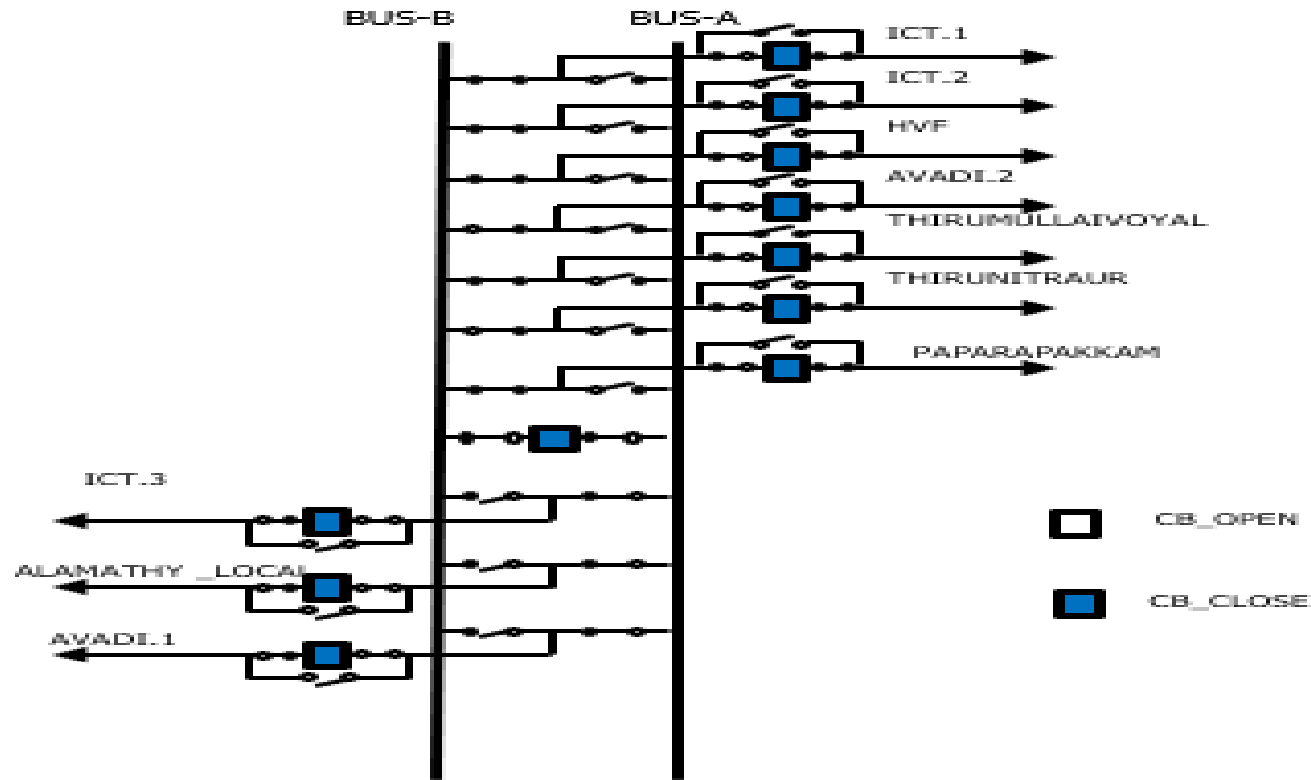
## ANTECEDENT CONDITION

1. Prefault conditions at 400kV Alamthy SS on 26.06.2026 are as follows.
  - Alamathy 400kVSS is having double bus configuration at 110kV Bus
  - Double bus operation was maintained and Bus coupler closed condition.
  - Eight 110kV feeders & 3 ICTs were connected in 110kV Bus.

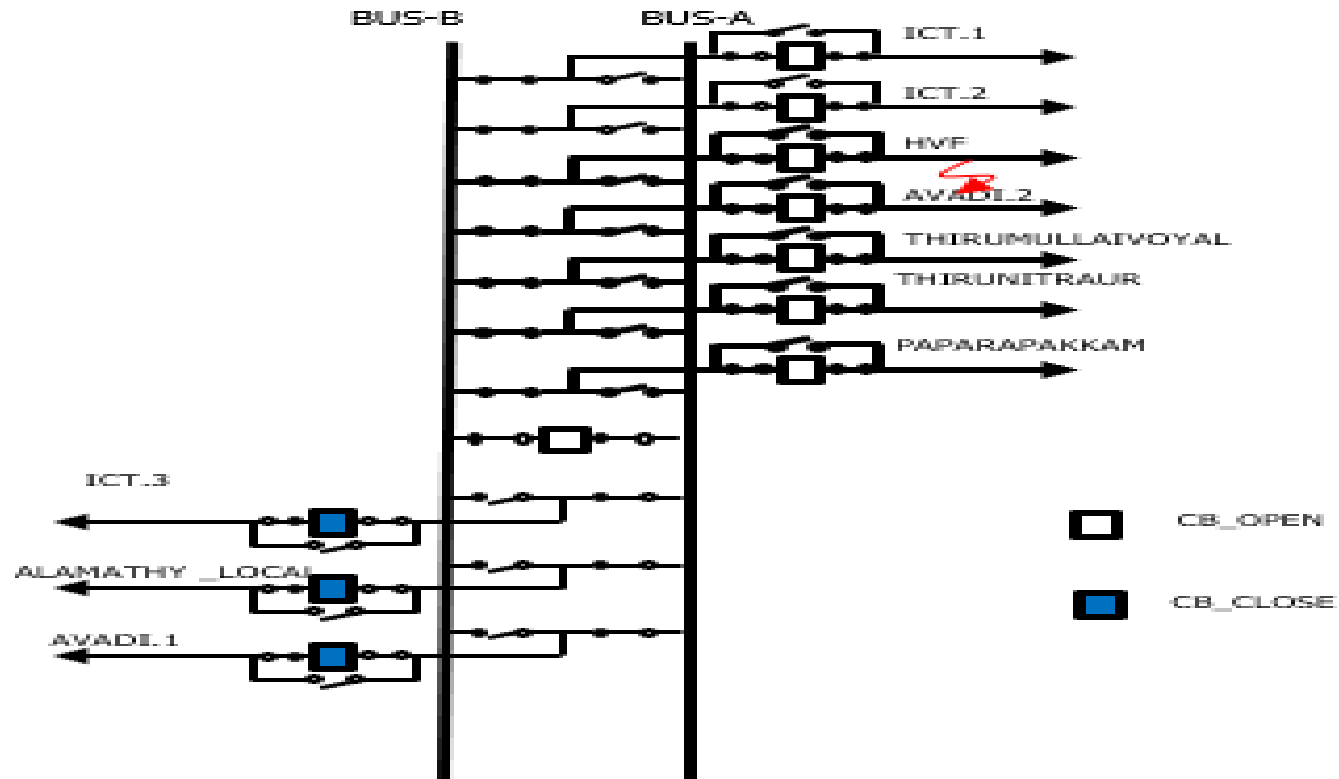
3. For a single line to ground in 110kV HVF feeder (shown below), breaker fails to isolate the fault hence LBB protection operated in 110kV Bus B. 110kV Bus A found stable. Load Loss around 104MW

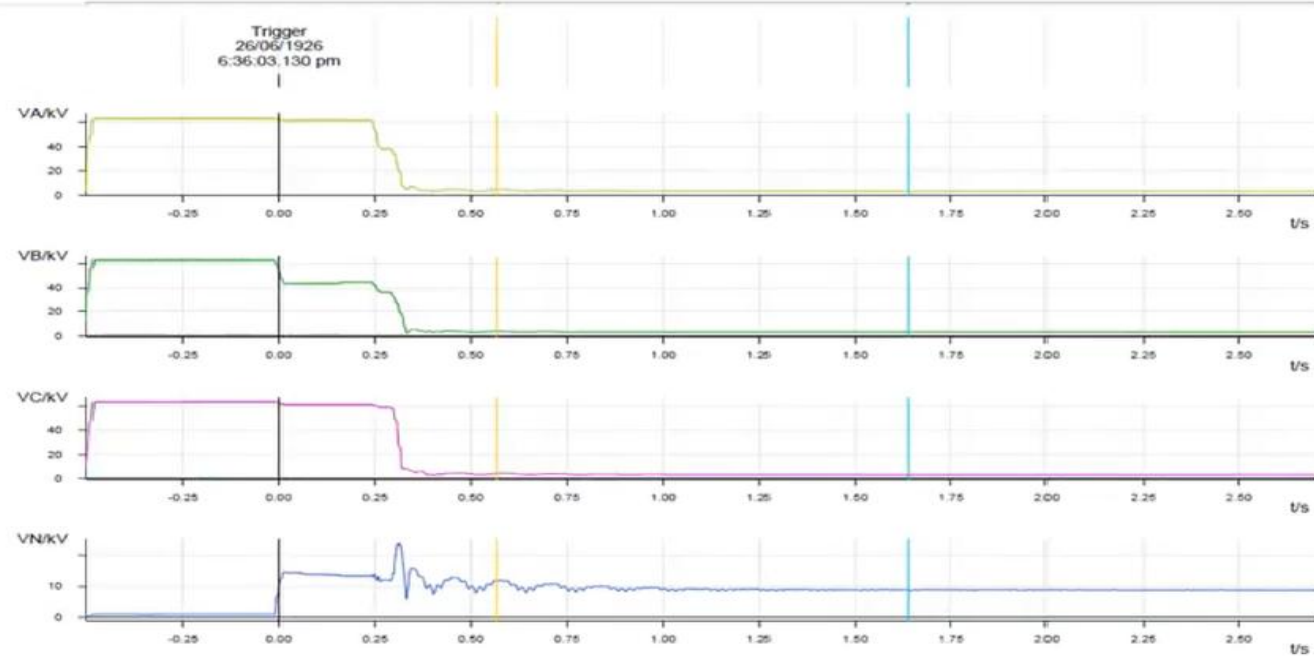
4. TANTRANSCO presented the DR of 110kV HVF feeder as below

- Line patrol done in 110kV HVF feeder & no visible fault Noticed.
- Breaker operation checked & found Normal.
- Line test charged & stood OK.

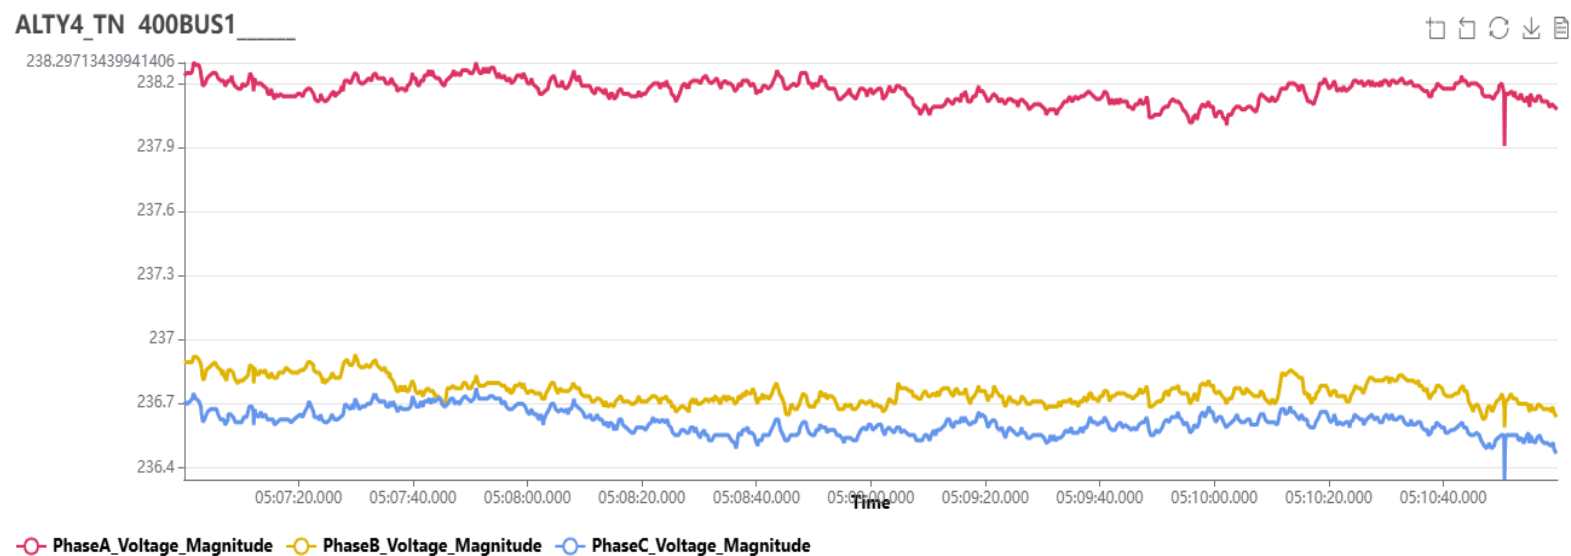
From the PMU plot, it can be observed that there is no fault

1. As per the reports submitted, the Korattur ICT tripped due to operation of the Main-1 relay caused by an unintended contact associated with the Main-2 PRV circuit. The PRV operated for approximately 10 seconds and subsequently reset automatically. After availing Line Clearance (LC), the PRV cover was opened for inspection, during which dust accumulation and traces of moisture ingress were observed on the contact associated with the Main-1 relay.
2. Remedial Action Taken: After availing Line Clearance (LC), the PRV cover was opened and the condition of the contacts was inspected. Dust accumulation and traces of moisture ingress observed on the Main-1 relay contact were identified and addressed.

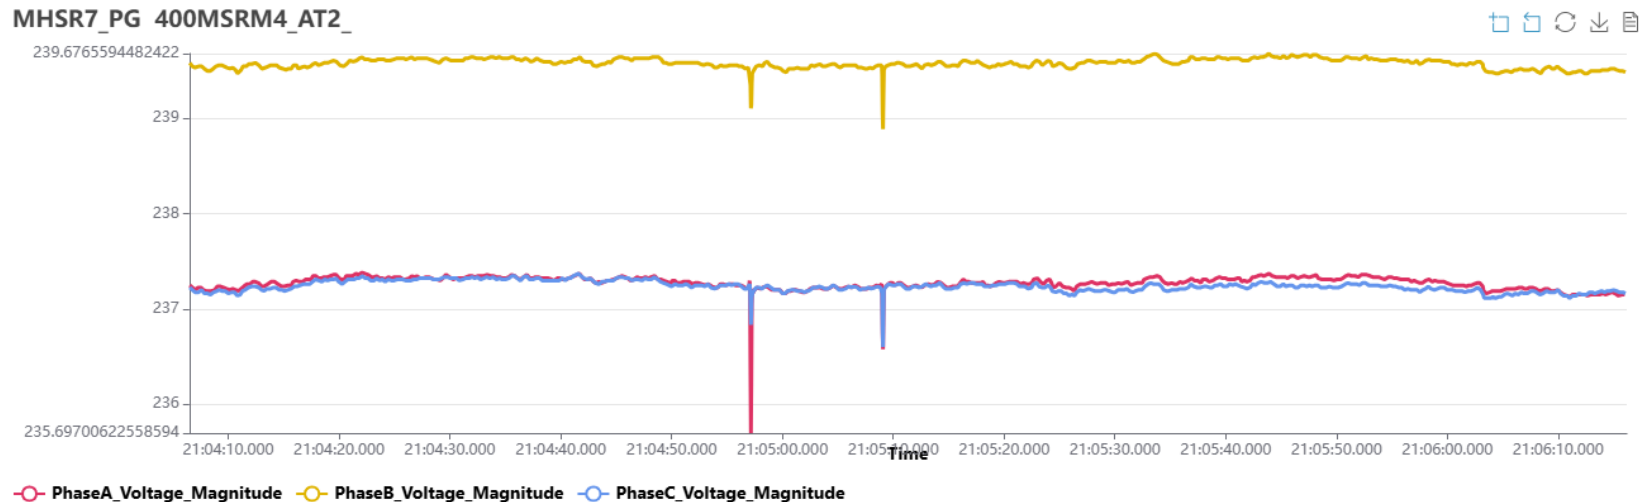
MHSR7\_PG 400MSRM4\_AT2\_

**From PMU analysis, the fault in the line is observed**

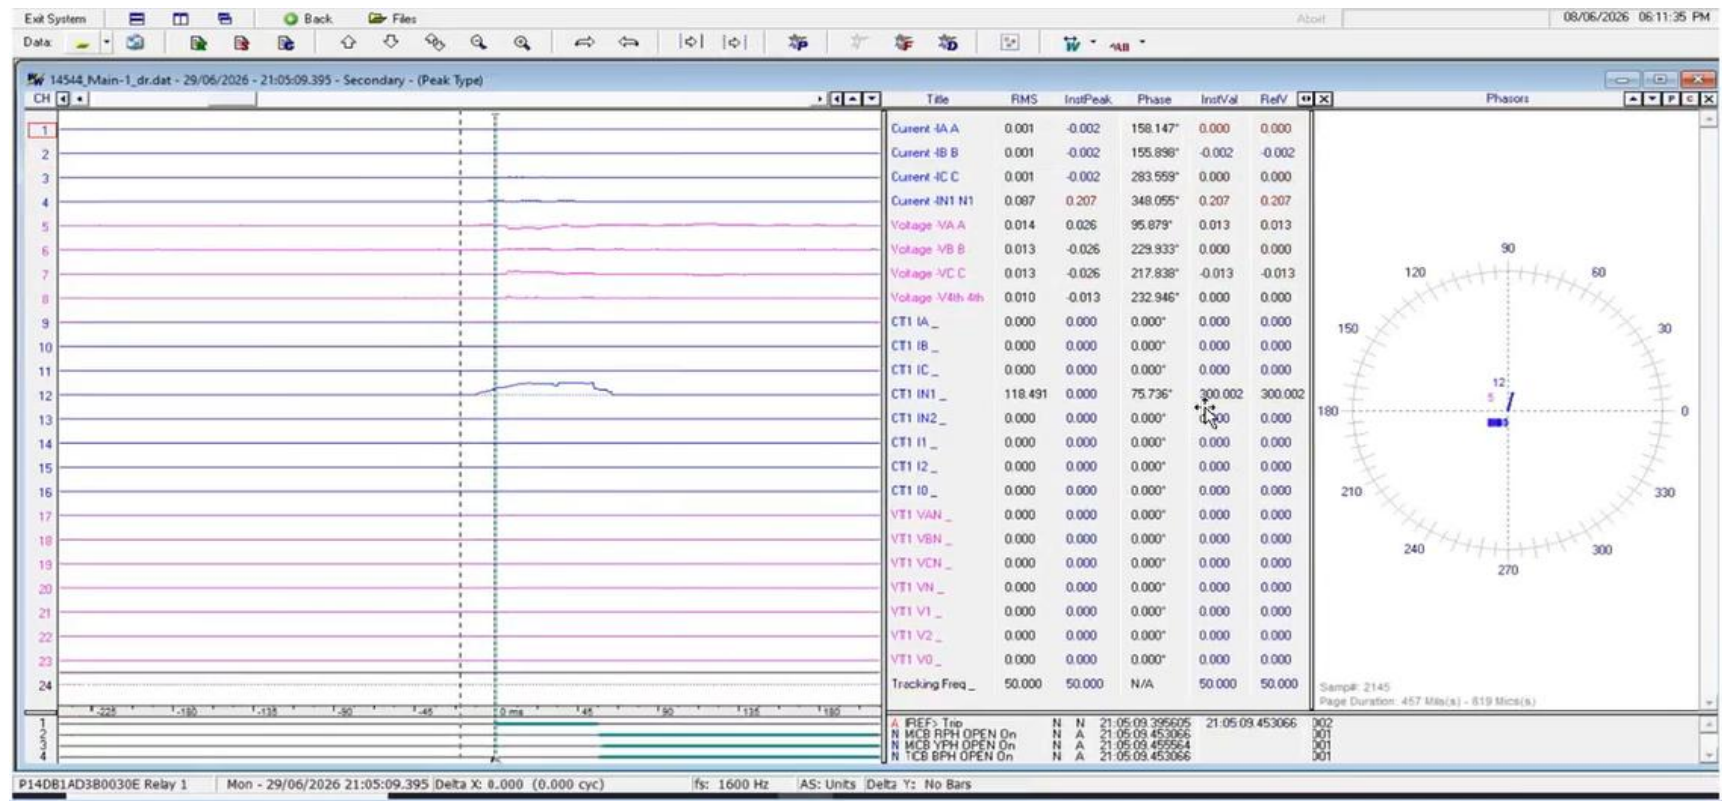
3. TGGENCO suspected that CT saturation during the high through-fault current may have resulted in the maloperation of the Station Transformer REF protection and informed that the matter had been referred to the OEM for detailed analysis.

4. TGGENCO informed that the OEM provided the disturbance recorder (DR) records pertaining to the incident, which indicated that the transformer tripped instantaneously on operation of the REF protection.

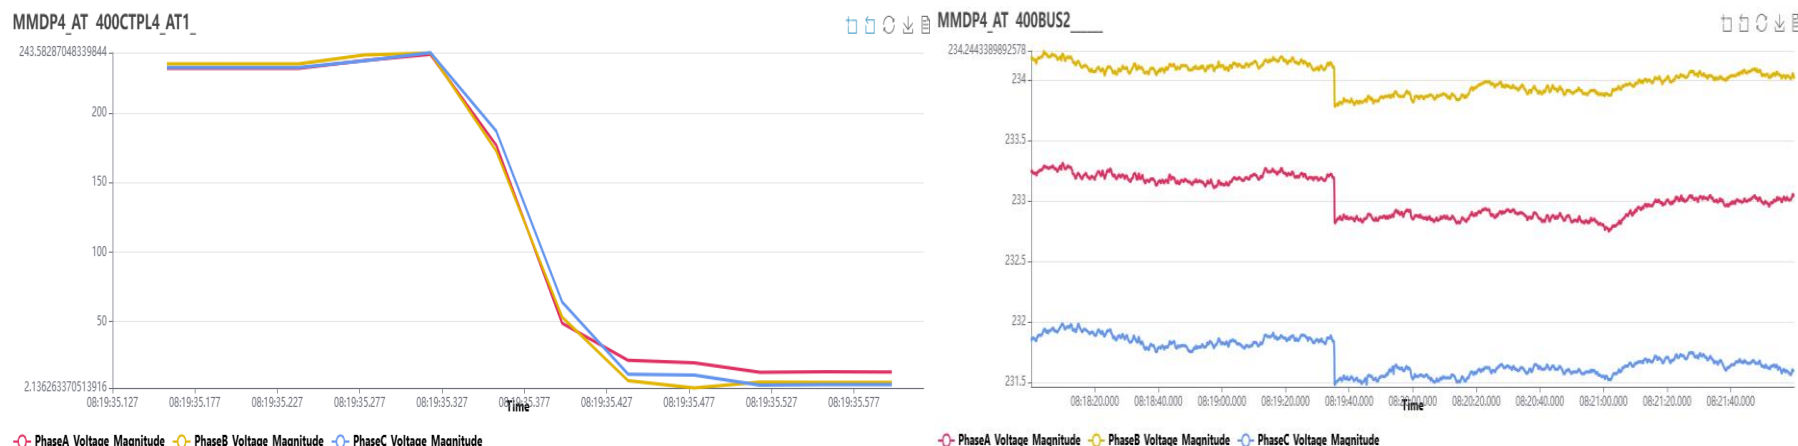
**From the PMU data, 400KV-MAMIDAPALLI-CHOUTUPPAL-1 3phase tripping can be observed and there was no fault during the event.**

1. TGTRANSCO informed that the triggering incident was maloperation of the Pressure Relief Valve (PRV) relay associated with the 63 MVAR line reactor at Mamidipally end of the 400 kV Mamidipally–Choutuppall-1 line. The line reactor was kept in OFF condition due to the reconfiguration of the line.
2. It was suspected that the PRV relay operated due to peacocks climbing on the equipment, resulting in initiation of the Direct Transfer Trip (DT) command to the remote end. At Choutuppall end, the DT command was received and the line tripped three-phase.
3. TGTRANSCO informed that the DC supply to the line reactor, which is kept in OFF condition, was isolated to prevent recurrence of such unwanted tripping.

- ✚ TGTRANSCO to review the operation of PRV in the line reactor

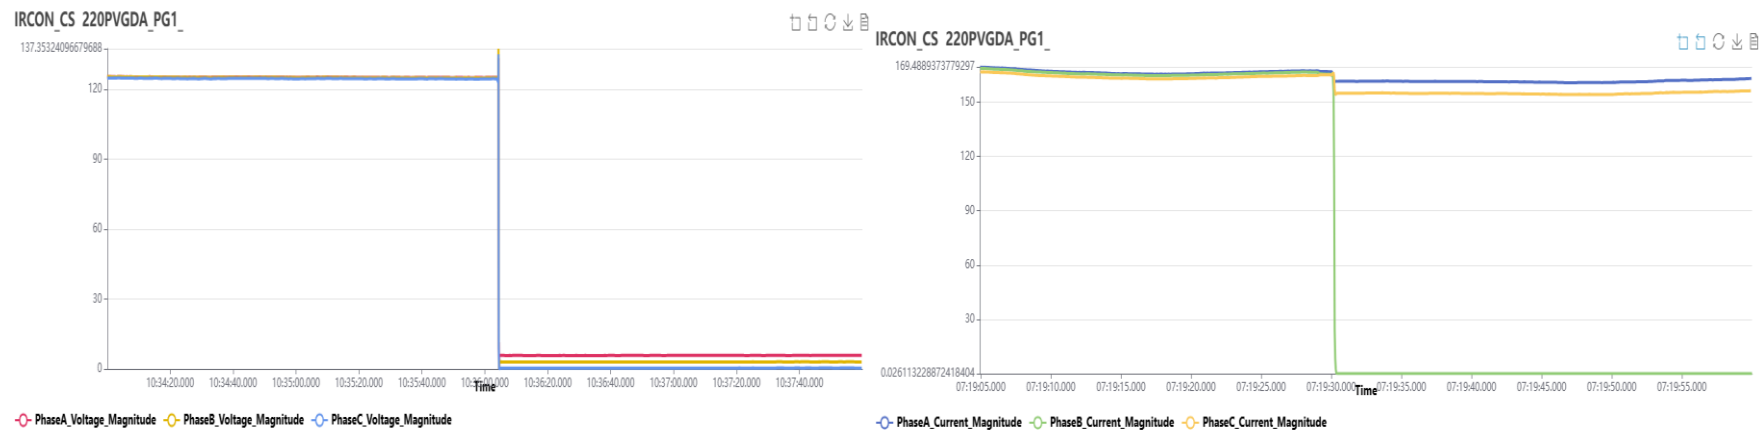
| S. No. | Event | Event Analysis | Outage Date & time | Points for Review | Remedial Actions Furnished |
|---|---|---|---|---|---|
| 10 | 220KV-PAVAGADA_PG-IRCON_PVG_S-1 | As per the reports submitted, the triggering incident is the broken conductor in the line due to Isolator misalignment in Y-phase at 30-06-2026 19:30 Hrs. During the event, tripping of 220 kV PVG-IRCON CKT-1 was observed at both ends where in at IRCON_PVG_S tripped on earth fault protection operation and DT was sent to remote ends. The line at 220 kV Pavagada end tripped on receipt of Direct Trip (DT) signal from the IRCON end. | 03-07-2026<br>10:36 | <b><u>PVG IRCON S</u> : 1.</b><br>Tripping of the line due to Broken Conductor needs review<br>2. Sending of DT to remote end needs review | <b><u>PGCIL SR-2</u>:</b> Line tripped on receipt of DT from IRCON end |

From the PMU data, 220KV-PAVAGADA\_PG-IRCON\_PVG\_S-1 line change in power can be observed.

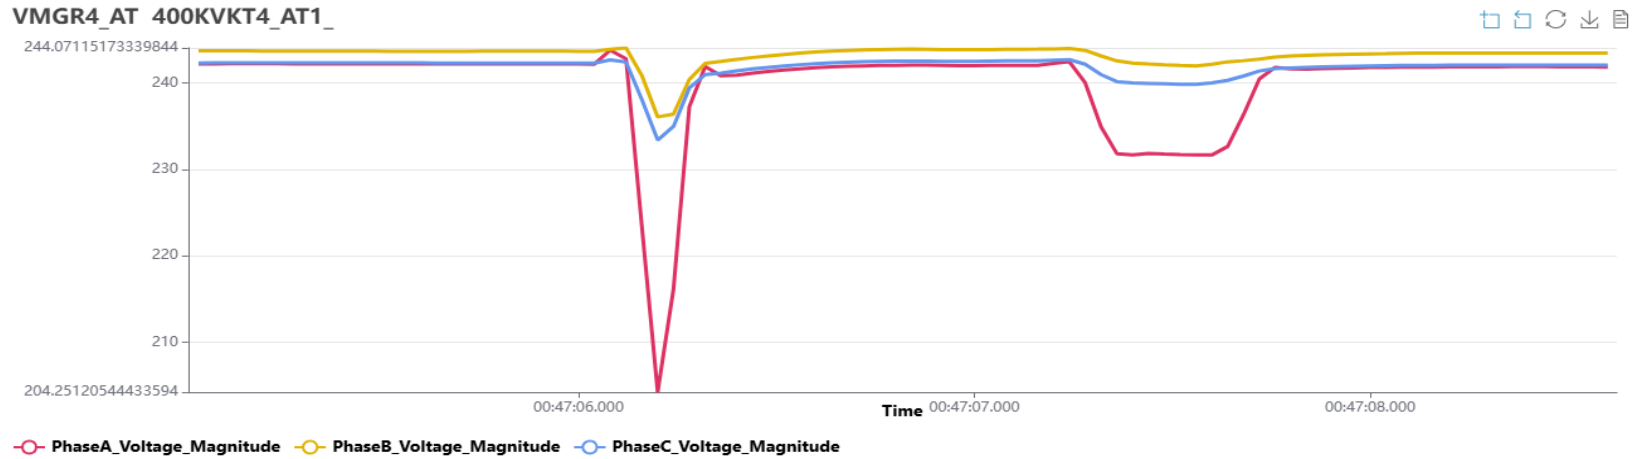
**From the PMU plot, R-G fault can be observed with delayed fault clearance.**

2. At Hinduja end, the fault was detected in Zone-1. Auto Reclosure (AR) did not operate due to the adaptive AR voltage logic, as the grid-end breaker failed to reclose successfully. Subsequently, three-phase tripping operated.

4. As a remedial measure, APTRANSCO informed that the ToR settings were enabled at Guddigudem end on 29.07.2026. The settings were tested and found satisfactory.

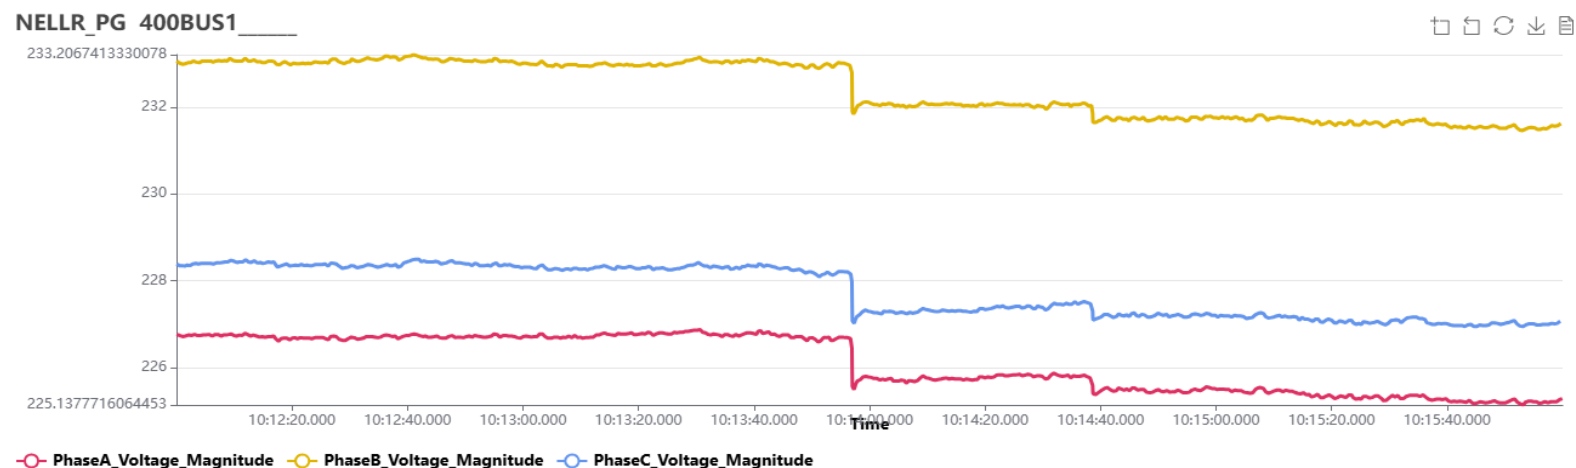
**From PMU, no fault is observed during the event.**

- iii. Subsequently, CBs 6-52 and 9-52 were also manually tripped as part of the process of issuing LC for 400 kV Bus-2.
  - iv. Finally, while manually tripping CB 12-52, *the VTPS line reactor tripped due to the operation of backup impedance protection*, which also resulted in the tripping of Tie CB 2-52. The backup impedance protection operated due to the pickup of 75B (Bus-2 voltage) voltage selection relay instead of 75C (line voltage) voltage selection relay, owing to a loose contact in the voltage selection relay circuit.
2. Consequently, 315 MVA ICT-1 was disconnected from the 400 kV (HV) grid, while its 220 kV (LV) side remained energized and connected to the 220 kV system.
  3. As a remedial measure, the loose contact in the voltage selection relay circuit was rectified.

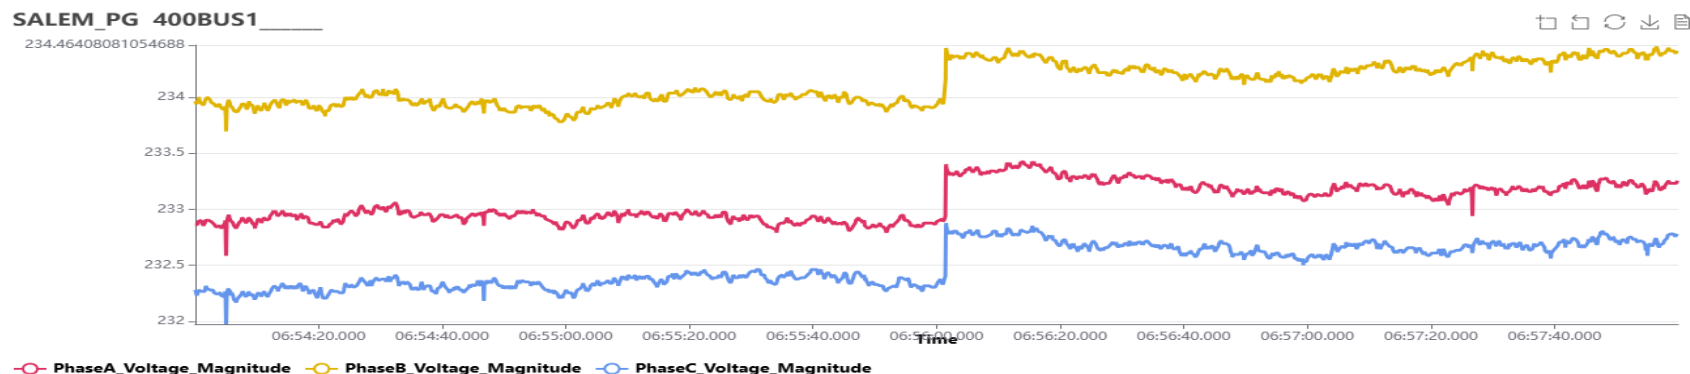
From the PMU plot, no fault is observed

- As per the reports submitted, 400KV/230KV SALEM\_TN-ICT-2 got tripped on Moisture ingress in R phase PRV switch. It is reported that on verification inconsistent performance of contact was observed.
- Remedial action taken by TANTRANSCO
  - Defective contacts of R phase PRV switch was replaced.
  - Sealant applied to arrest moisture ingress.
  - IR value checked & found Normal.

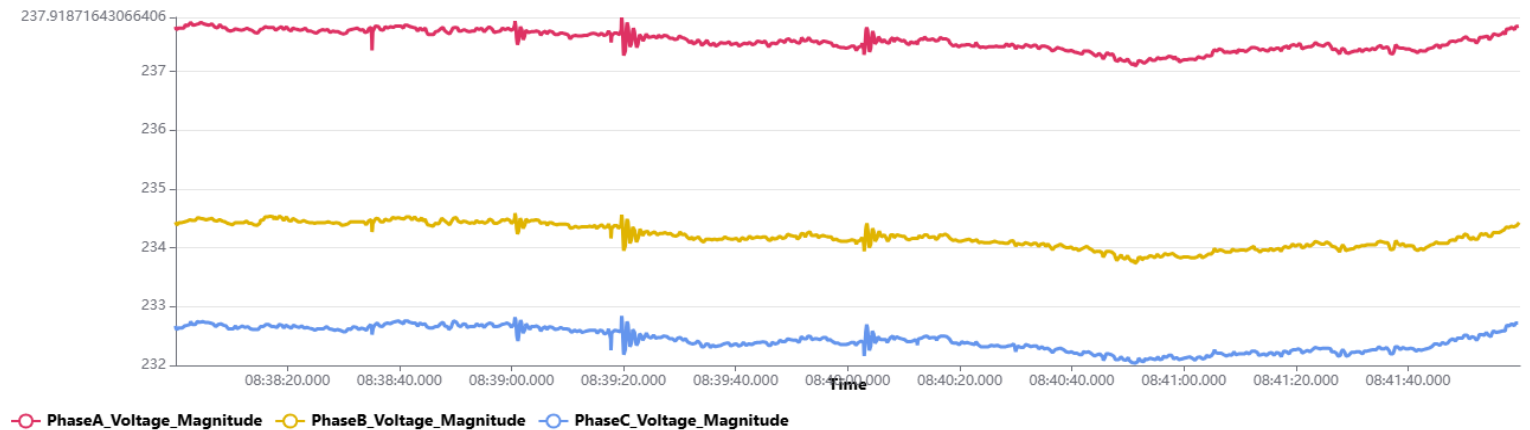
HASAN\_PG 400TLGPA\_KA1\_

From PMU, no fault is observed during the event

3. Momentary fluctuations were observed which resulted in shoot-up of R phase (current more than 0.5Amp) resulted in tripping of ICT-3 on operation of HV side Backup OCR relay (ABB REF 615) .

4. KPTCL further informed that, after charging the ICT, a similar tripping occurred on the same day at 13:12 hrs.
5. KPTCL informed that a detailed investigation was carried out to identify the reason for the R-phase current being recorded at approximately twice the magnitude of the currents in the other two phases by the HV-side backup protection relay. During the investigation, it was found that the 4th core of the 400 kV CT, connected to the backup protection with terminals 4S1 and 4S3 for a 1000/1 A ratio, had a severely arced 4S1 terminal lug. Due to a loose connection at the 409 bays, the R-phase CT secondary 4S1 lead and lug had arced and intermittently open-circuited, resulting in the 4S1 lead making contact with the 4S2 terminal on the CT secondary terminal board.

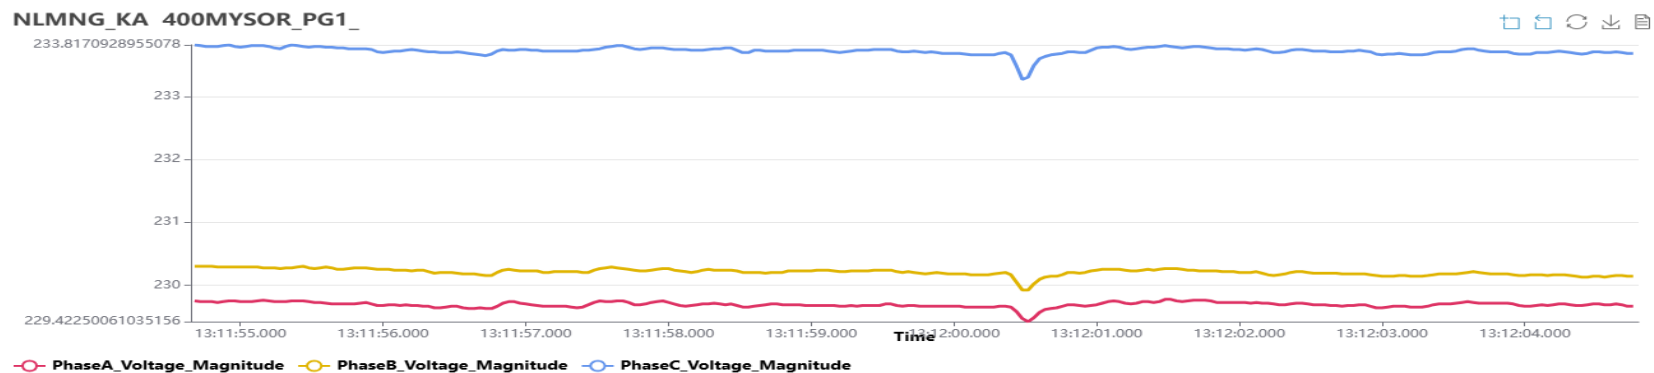
**From PMU, no fault is observed during the event.**

3. Momentary fluctuations were observed which resulted in shoot-up of R phase (current more than 0.5Amp) resulted in tripping of ICT-3 on operation of HV side Backup OCR relay (ABB REF 615) .

4. KPTCL further informed that, after charging the ICT, a similar tripping occurred on the same day at 13:12 hrs.
5. KPTCL informed that a detailed investigation was carried out to identify the reason for the R-phase current being recorded at approximately twice the magnitude of the currents in the other two phases by the HV-side backup protection relay. During the investigation, it was found that the 4th core of the 400 kV CT, connected to the backup protection with terminals 4S1 and 4S3 for a 1000/1 A ratio, had a severely arced 4S1 terminal lug. Due to a loose connection at the 409 bays, the R-phase CT secondary 4S1 lead and lug had arced and intermittently open-circuited, resulting in the 4S1 lead making contact with the 4S2 terminal on the CT secondary terminal board.

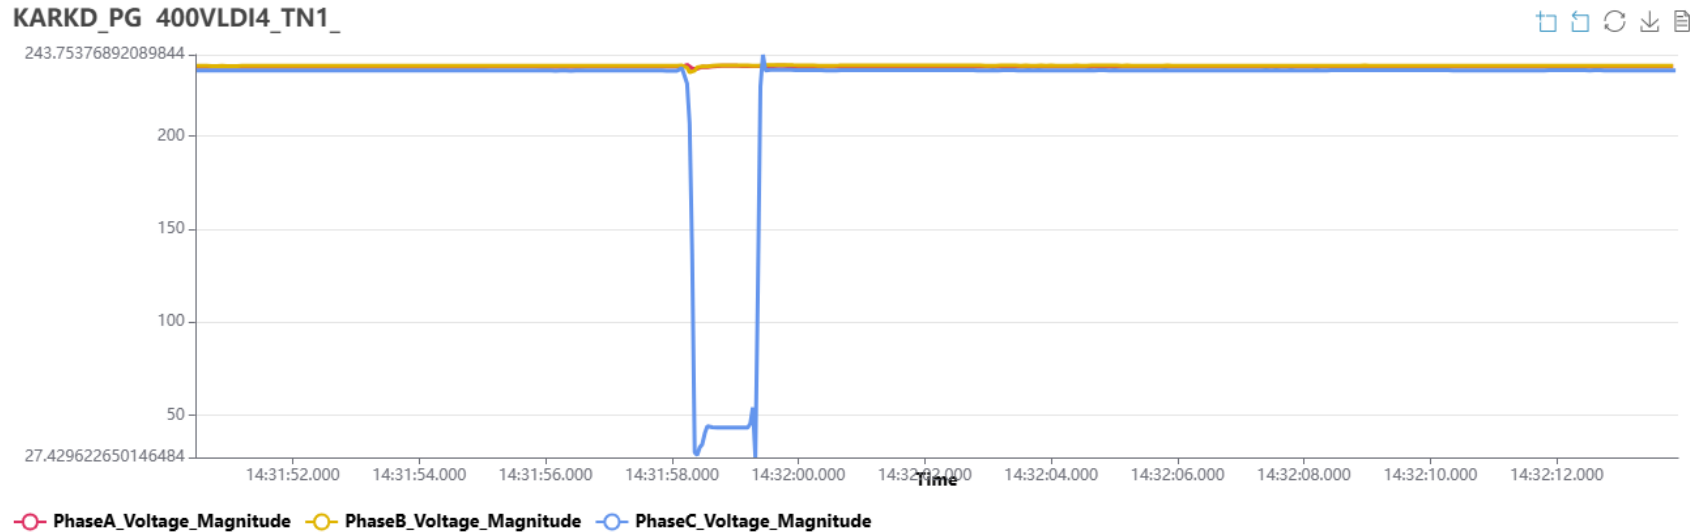
KARKD\_PG 400VLDI4\_TN1\_

**From the PMU Analysis, B-G fault can be observed in 400kV Vellalaviduthi Karaikudi Line-1 with A/R successful during the event.**

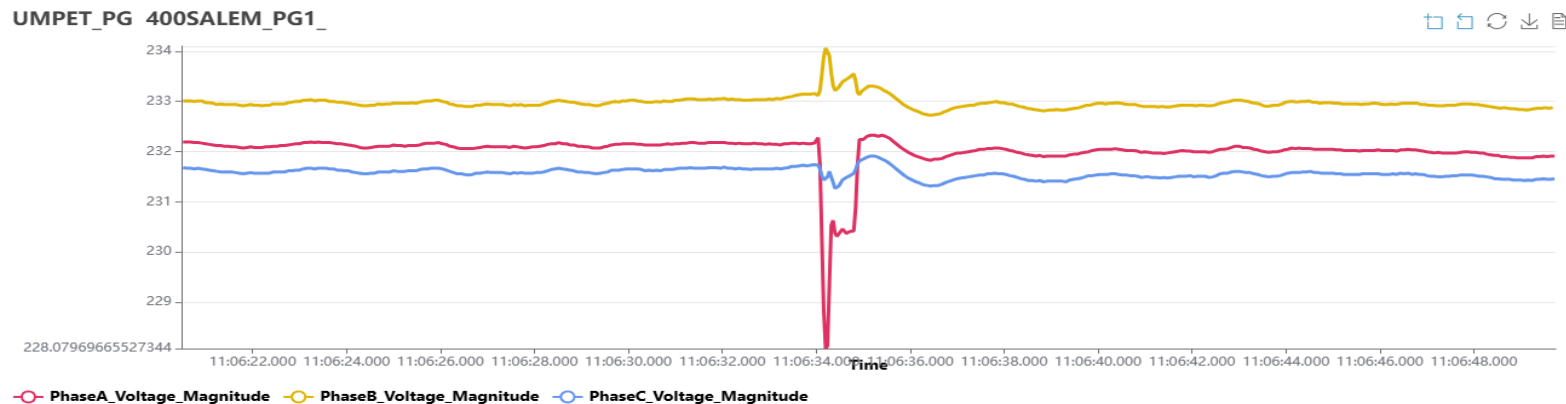
From the PMU Analysis, R-G fault can be observed during the event with a delay of around 760ms.

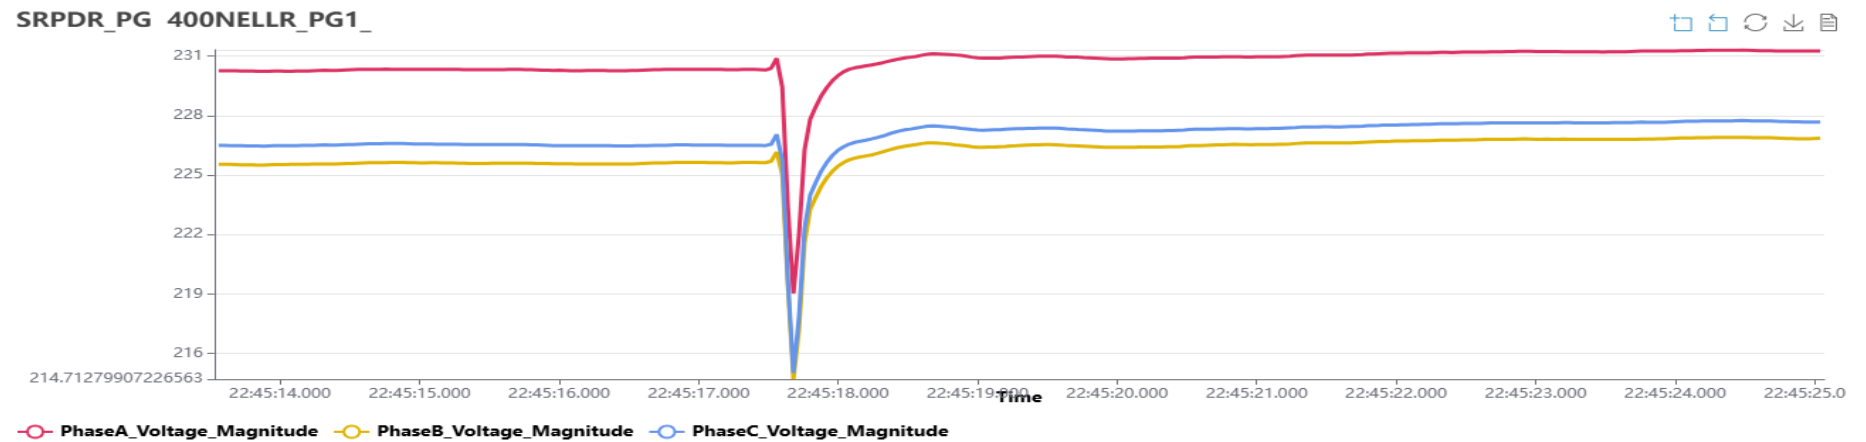
**From the PMU plot, RYB fault can be observed during the event without any delayed fault clearance**

1. As per the reports submitted, 400KV/110KV MANALI-ICT-1 got tripped on REF protection for a through fault in the 110kV Manali-Mathur feeder (RYB fault during test charging of the line).
2. Remedial action: As per the OEM recommendation REF operating time is revised from 0 msec to 30msec.
3. SRLDC advised TANTRANSCO to examine the other relays in the 400kV Manali SS.
