## III. Single/Multiple Element Tripping with Protection Violation

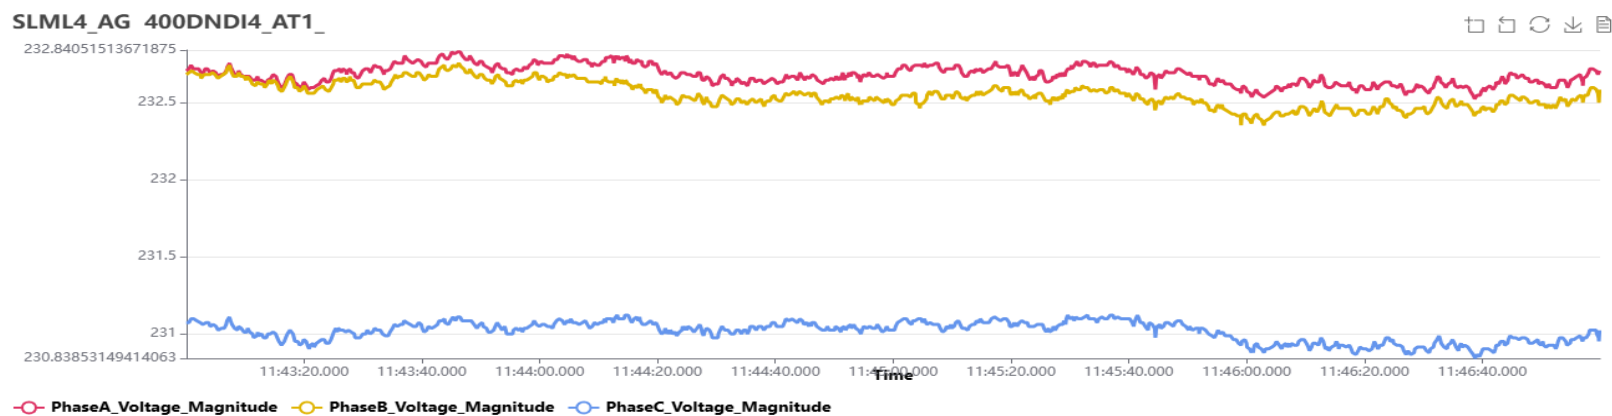
**From the PMU plot, no fault is observed**

1. TGTRANSCO informed that the 220 kV Srisailam Right Bank–Dindi-1 line tripped on Pole Discrepancy (PD) indication at Dindi end only, suspected to be due to DC earth leakage, as indicated in the FIR. The line remained in service from the Srisailam end.
2. TGTRANSCO further informed that during the line clearance (LC) availed on 23.07.2026, a lizard was found inside the Breaker Marshalling Box (MB) and was removed. TGTRANSCO also informed that the O&M staff were instructed to ensure proper sealing of all cable glands to prevent ingress of external objects and recurrence of such incidents.

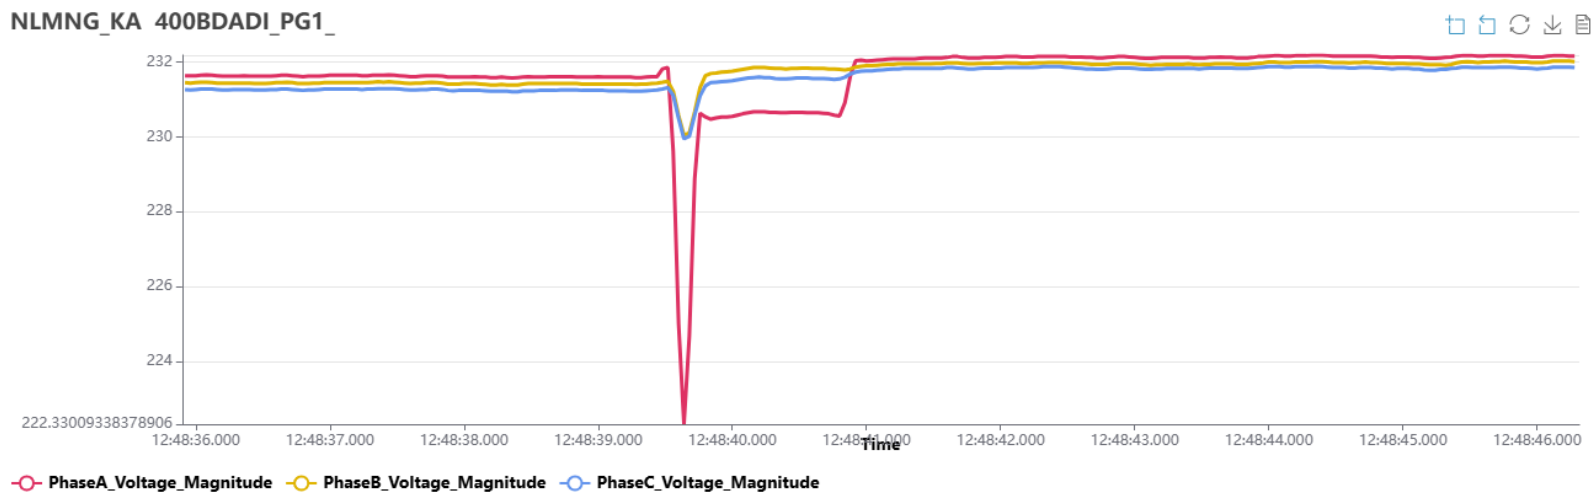
NLMNG\_KA 400BDADI\_PG1\_

From the PMU plot, R-G fault can be observed during the event without any delayed fault clearance

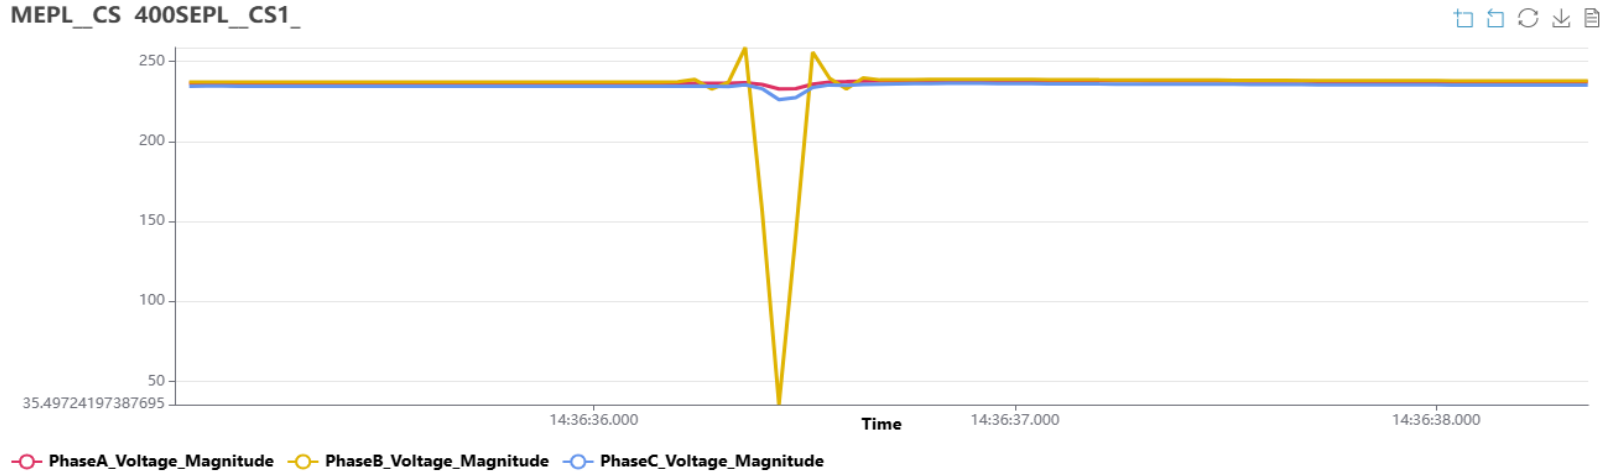
MEPL\_CS 400SEPL\_CS1\_

**From the PMU plot, Y-G fault can be observed during the event without any delayed fault clearance**

1. SEPL informed that, as per the reports submitted, the triggering incident was a Y-G phase fault due to failure of the Y-phase string insulator of GT-4 at SEPL. The fault was detected by the instantaneous overcurrent (50) protection at SEPL end, resulting in tripping of the SEL–MEPL line, while the line remained in service from the MEPL end.

2. SEPL further informed that the Y-phase string insulator failure of GT-4 resulted in a phase-to-ground fault, with a fault current of approximately 25.3 kA. The fault was cleared by the GT-4 feeder protection within 63 ms. During the fault, a reverse fault current of approximately 14.5 kA flowed through the SEL–MEPL line.

3. SEPL informed that the instantaneous overcurrent (50) pickup setting of the SEL–MEPL line was 12.25 kA. Since the reverse fault current of 14.5 kA exceeded the pickup setting, the instantaneous overcurrent protection operated and resulted in tripping of the SEL–MEPL line.

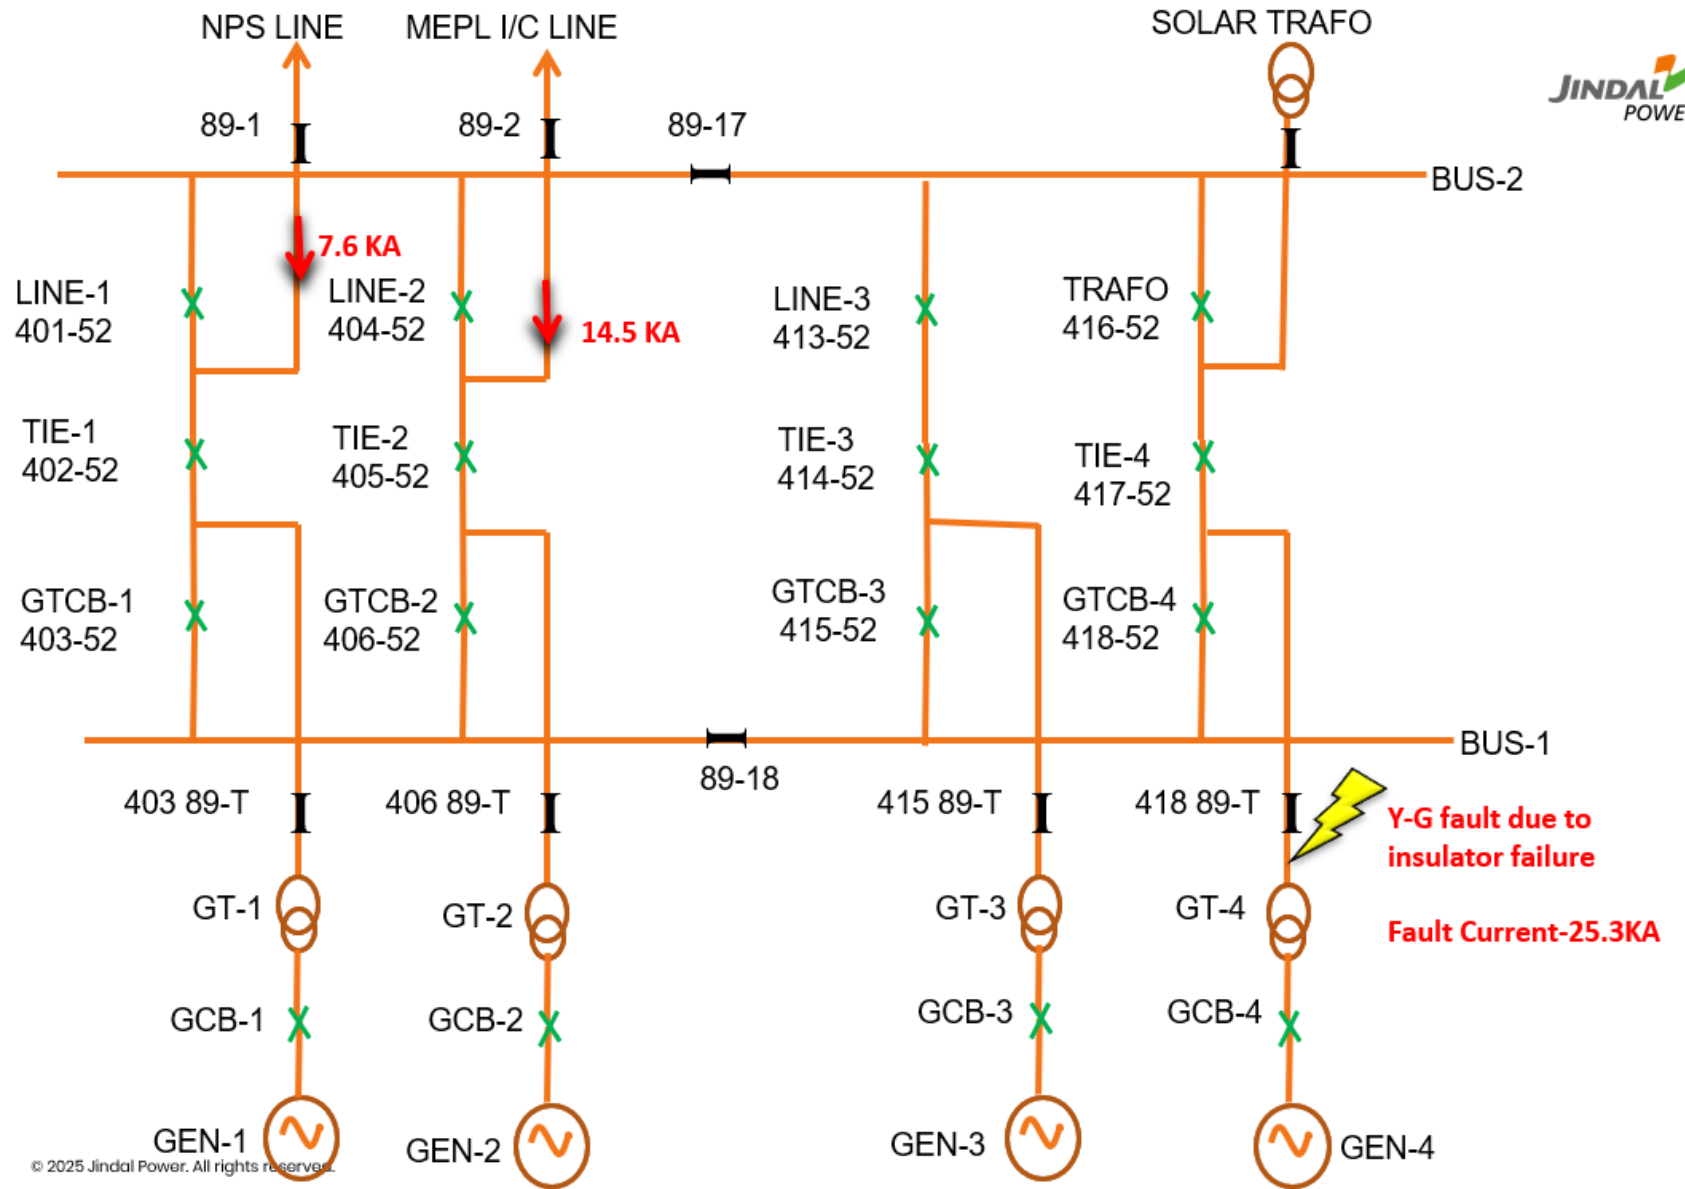
4. SEPL stated that the SEL–MEPL line tripping was due to the operation of the instantaneous overcurrent (50) protection caused by the high reverse fault current associated with the external Y-G fault at GT-4.

5. SEPL informed that all porcelain-type insulators had been replaced with polymer insulators except those installed in the GT-4 row and Line-1 & Line-2. Following the incident, SEPL replaced the porcelain insulators in the GT-4 row and informed that replacement of the insulators in Line-1 & Line-2 is also planned.
