## Grid Occurrences – 144

### I. Details of Grid Disturbances

| S. No. | Event | Event Analysis | Outage Date & time | Generation Loss (MW) | Load Loss (MW) | Category as per CEA Grid Standards | Date of receipt of Draft Report/ Updated draft report from SRLDC | Date of receipt of User Detailed report | SRLDC furnished revised Report after considering the User Report |
|---|---|---|---|---|---|---|---|---|---|
| 1 | Complete Outage of 220kV Renigunta SS of APTRANSCO | As per the reports submitted, the triggering incident was R-Phase CT failure in 220kV Nagari Renigunta line at Renigunta SS which eventually became a 220kV Bus fault. 220kV BBP did not operate and all lines connected to 220kV Renigunta SS tripped from remote ends. This led to complete outage of 220kV Renigunta SS. | 21-05-2026<br>22:49 | 0 | 250 | GD - 1 | 13-06-2026 | 07-06-2026 | Considered |

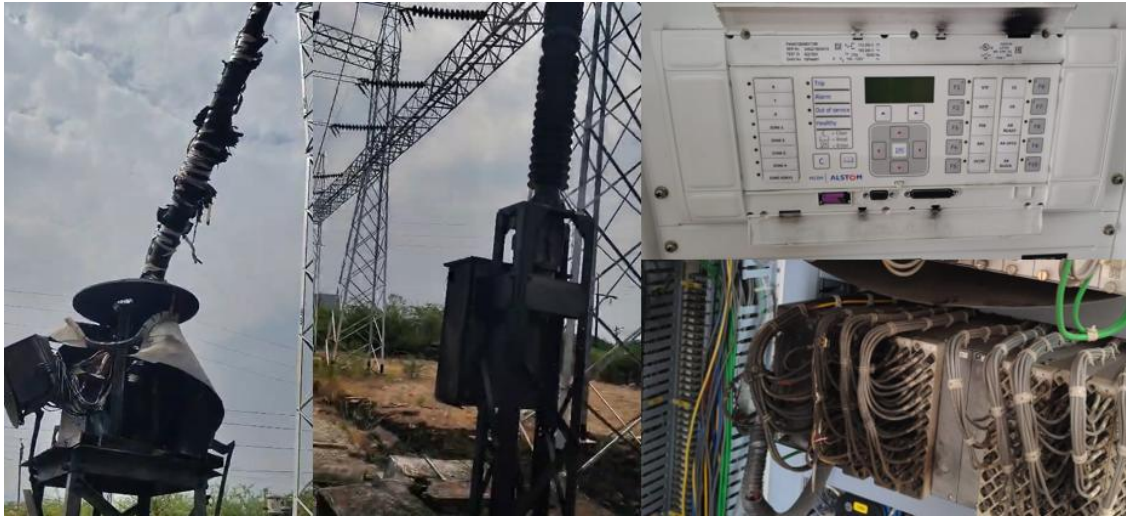
As per the reports submitted, the triggering incident was R-Phase CT failure in 220kV 220kV Nagari Renigunta line at Renigunta SS leading to a 220kV Bus fault. Further as the failure R-ph CT fire has come into vicinity and the CB connected to Nagiri also failed (as per FIR) as shown below. This has led to a R-G fault at 22:49:10.960 Hrs which cleared in time and later developed into R-Y-B fault at 22:49:11.600 Hrs.

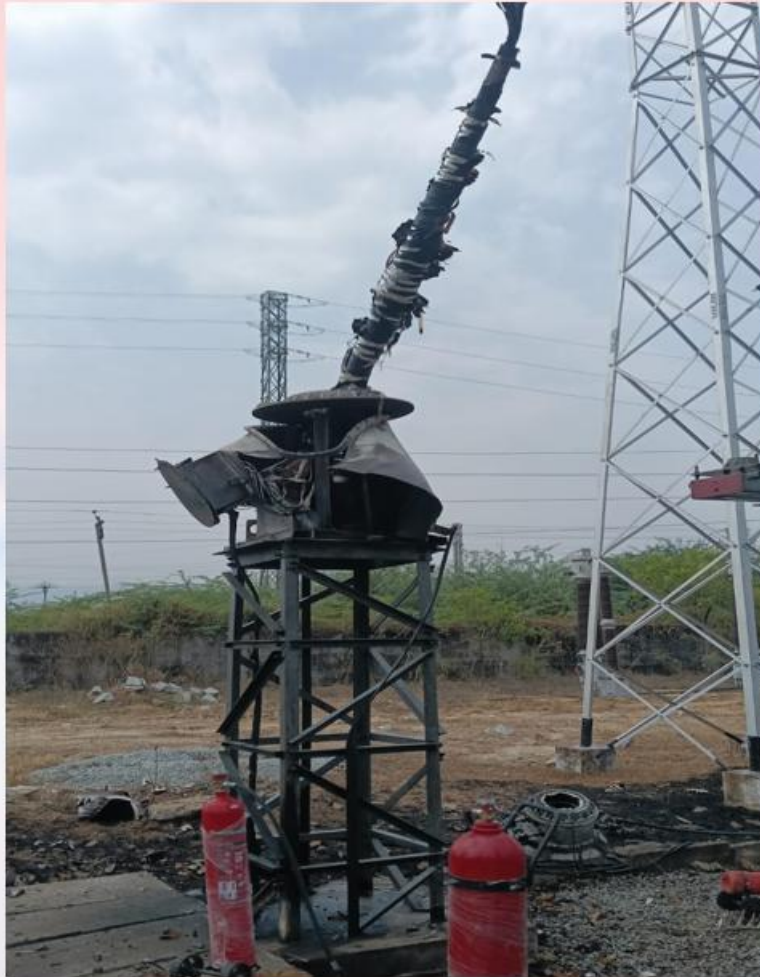
## **Picture of failed CT**

2. APTRANSCO stated that on 22.05.2026 at 22:49 hrs, at 220/132/33 kV Renigunta Substation, the R-phase Current Transformer (Make: WS Industries, Year of Manufacture: 2000) of the 220 kV Nagari feeder exploded. Consequently, the 220 kV Nagari feeder tripped at both ends within 100 ms.

4. APTRANSCO further stated that although the 220 kV Nagari feeder circuit breaker had tripped, the fire caused by the CT explosion spread to the R-phase and Y-phase breaker limbs and the circuit breaker cubicle, resulting in flashover of the R and Y phase breaker limbs to ground, which subsequently developed into a bus fault.

- Bus Coupler restored after power card replacement with spare card on 23-05-2026
- Failed 220KV Nagari bay CTs , Circuit Breaker and C&R Panels replaced with New Equipment and feeder charged on 09-06-2026
- Failed NR make Bus Bar Panel is to be replaced with New HITACHI make Bus Bar Panel

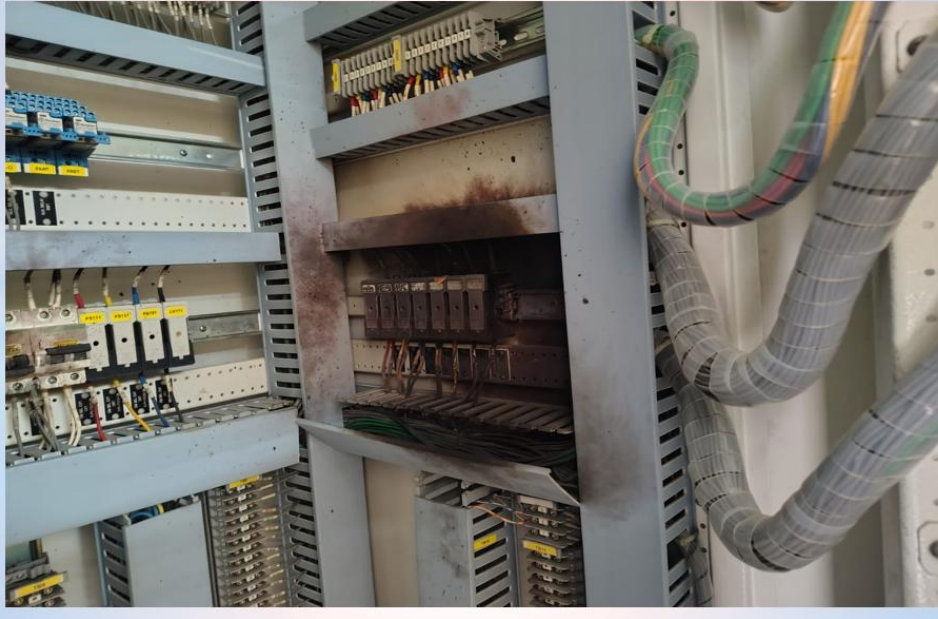
## Failed Equipment (220KV Nagari line C&R Panel)

3. APTRANSCO informed that the fault current discharged through the Control and Relay (C&R) panel, resulting in extensive damage to the 220 kV Nagari feeder C&R panel, including the relays and associated wiring. The incident also caused failure of the Busbar Protection (BBP) relay and the Bus Coupler Bay Control Unit (BCU), as these panels were installed adjacent to the Nagari feeder C&R panel within the same kiosk.

5. APTRANSCO stated that the power cards of the Busbar Protection relays and the Bus Coupler relay were also damaged due to the high voltages induced from the adjacent failed 220 kV Nagari feeder C&R panel, leading to the failure of the Busbar Protection scheme. As the Busbar Protection was unavailable, the bus fault was ultimately cleared by tripping all connected source elements from the remote ends.

6. SRPC enquired about the reason for the fault current reaching the Busbar Protection relay. APTRANSCO stated that, due to an earthing issue, the fault current propagated to the **Busbar Protection panel**, resulting in damage to the panel

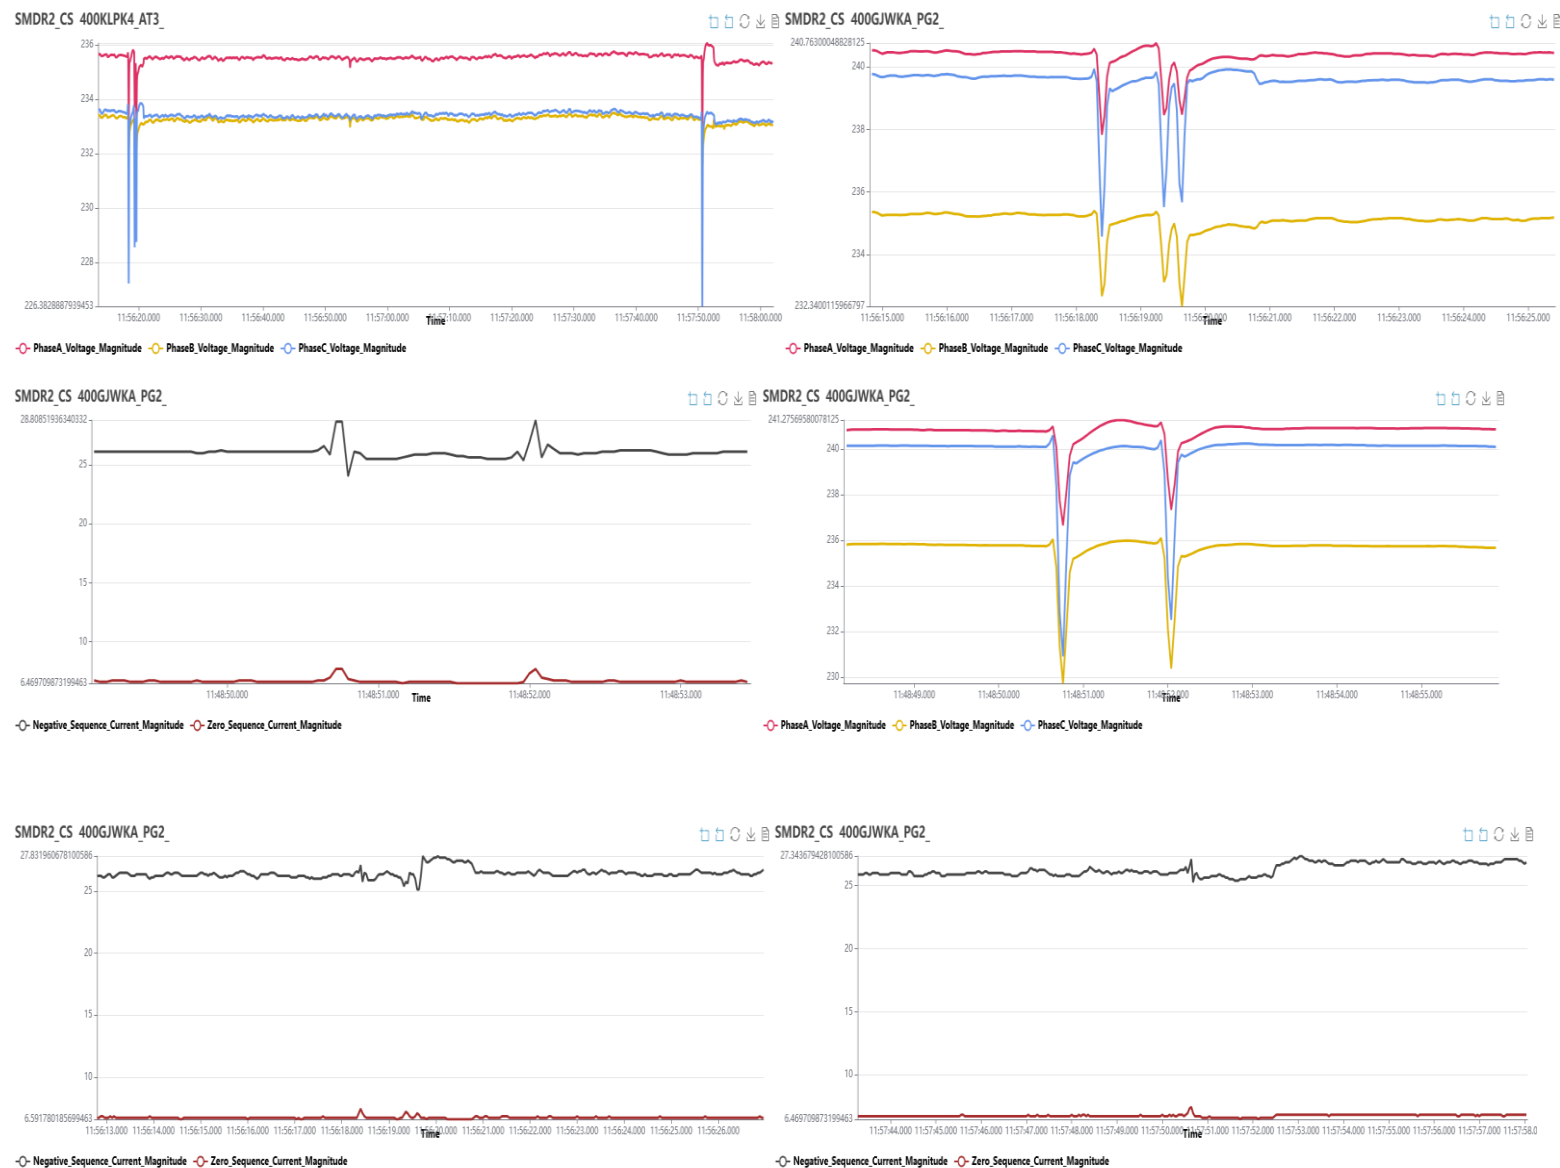
## 12. A) PMU Analysis:

From PMU dip in B-phase voltage is observed at 11:48hrs, 11:56hrs and 11:57hrs with no delayed fault clearance during the event.

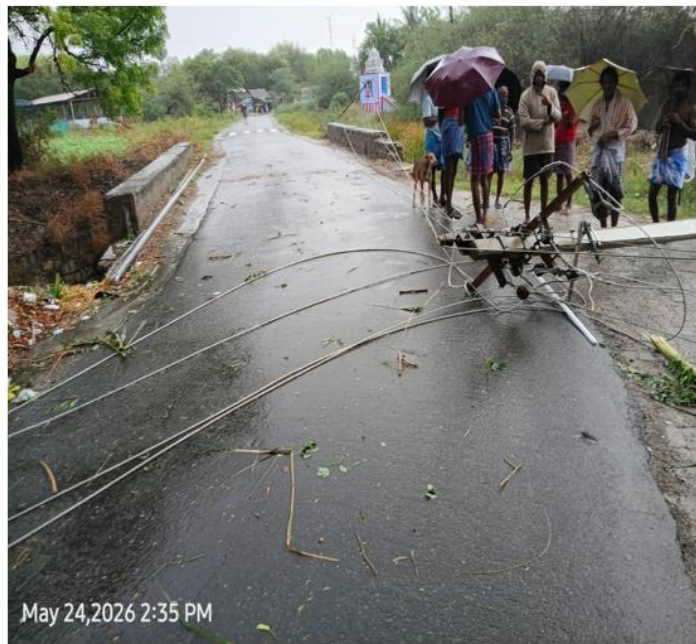
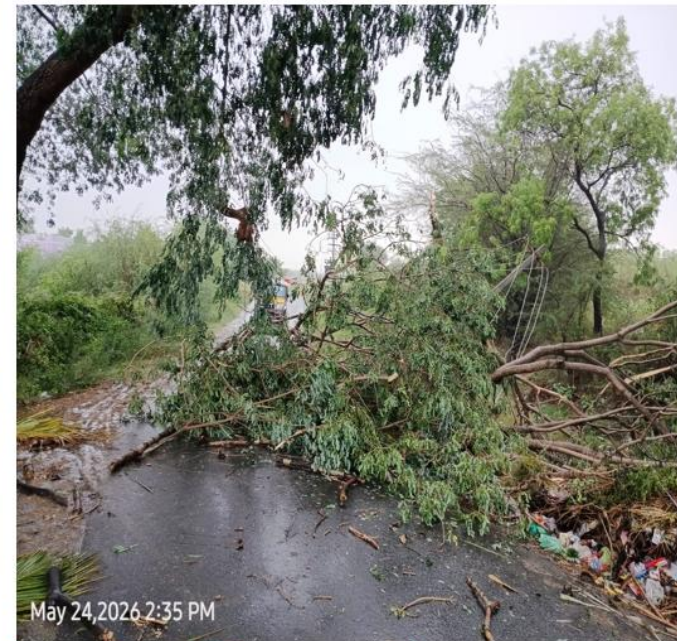
### **Rain & whirlwind at the time of fault- nearby area**

1. NTPC Ettayapuram stated that on 24.05.2026 at 13:22 hrs, a B-phase to ground fault occurred on the 230 kV Single Circuit transmission line. During post-fault inspection, it was observed that the Y-phase jumper support insulator at Tower No. 30 had detached and was hanging towards the B-phase conductor. The relay recorded the fault at a distance of 8.89 km from the plant end, with a fault current of 11.1 kA.
2. NTPC stated that the fault occurred due to heavy winds and rainfall prevailing at the time of the incident, which resulted in the detachment of the Y-phase jumper support insulator from Tower No. 30.

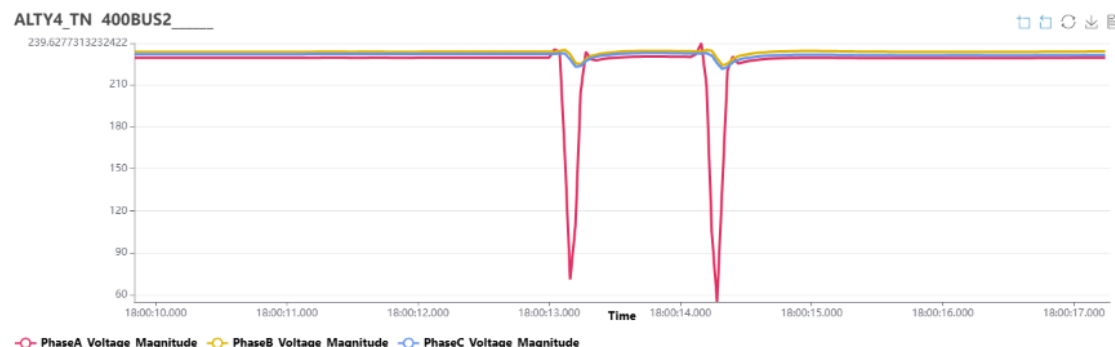
#### At 18:00hrs:

Due to heavy wind and rain, At 400kV Alamathy SS at 18.00 hrs, the triggering incident was R-G fault in 400kV Alamathy-Manali line due to failure of R phase supporting insulator . At both ends, the fault was sensed in zone-1. At Alamathy end, A/R operated and the line tripped on persistent fault. During the second fault after A/R dead time the fault developed into R-G fault in 400kV Alamathy 400kV Bus-2. Immediately, 400kV Bus-2 BBP operated and all main breakers connected to 400kV Bus-2 tripped. This led to loss of power supply to 400kV Alamathy Bus-2. At Manali end, the fault was sensed in zone-1. After A/R dead time A/R did not operate and the line tripped.

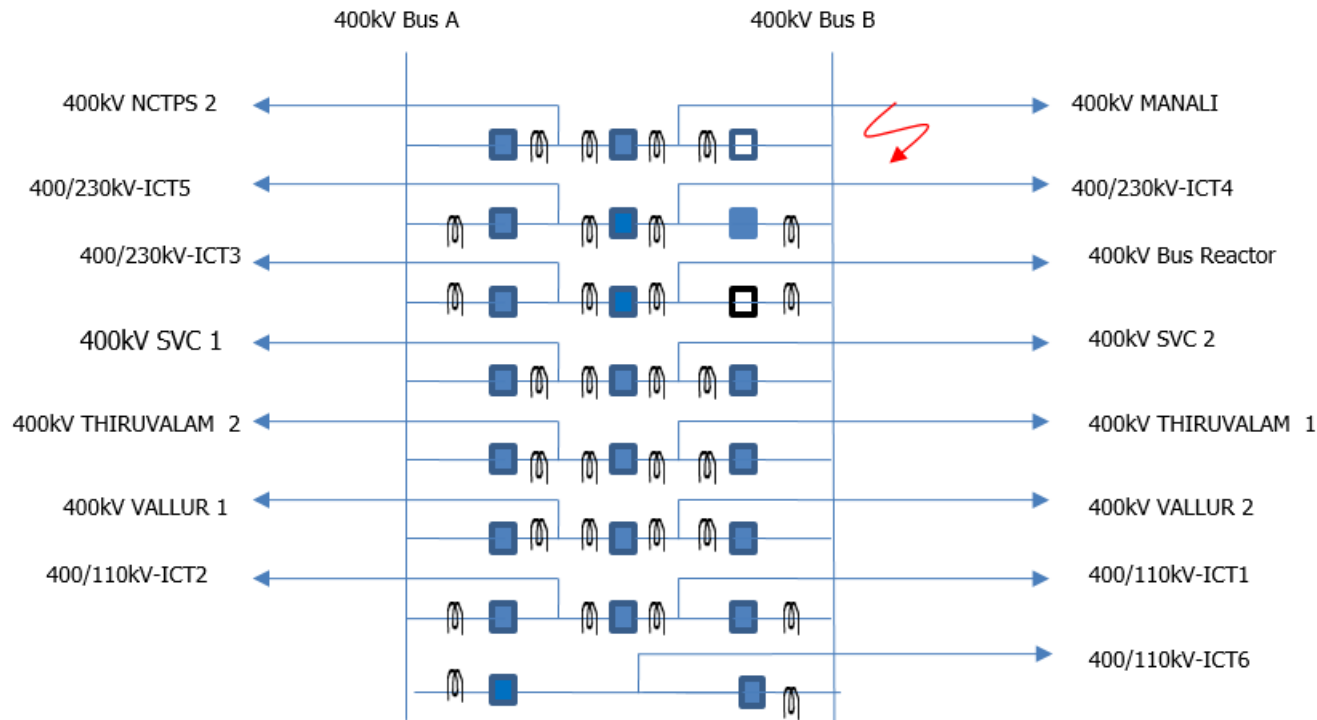
2. TANTRANSCO stated that on 03-06-2026 at 18:00 hrs 400kV Manali- Alamathy line fault tripped with Zone.1, R-N indication & TOR operated.

3. TANTRANSCO informed that on 03-06-2026 at 18:01 hrs Subsequent fault trip 400kV Manali\_Alamathy line high Impedance BBP-2 operated. Heavy rain & lightning was reported. During inspection of yard , no visible fault noticed. 400 kV Bus Bar protection operated may be due to transient fault.. All elements were in service through Tie breaker. ICT 6 was in service through main breaker of Bus.A.
