Grid Occurrences – 142

I. Details of Grid Disturbances

Detailed Draft Report of grid event submitted by SRLDC:

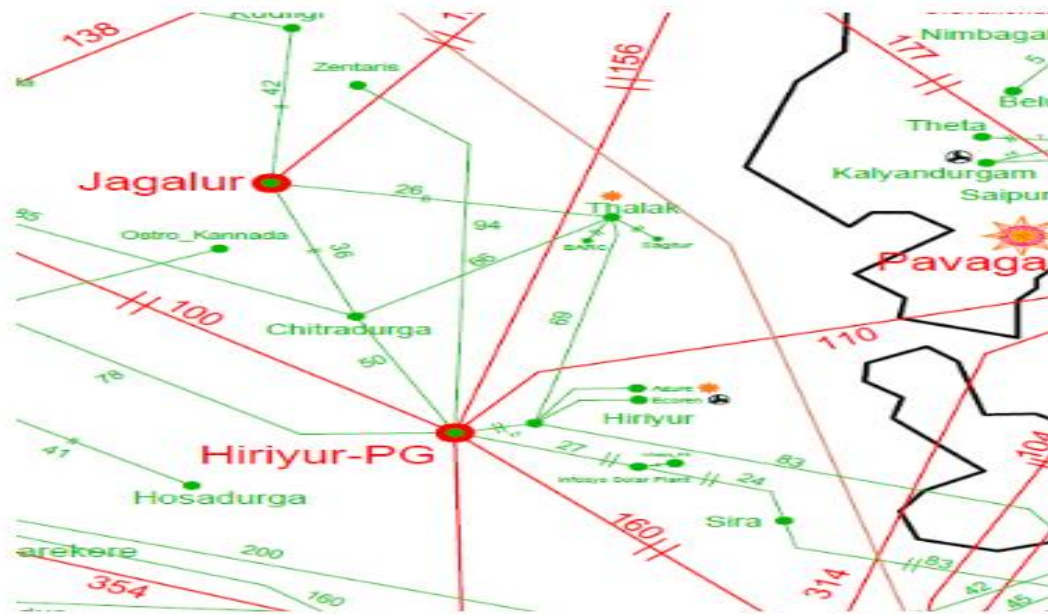
As per the reports submitted, at Zenataris SS, Phase-2 commissioning internal testing is presently underway, and the DC supply was accidentally switched off due to human error, which led to the tripping of the circuit breaker of the 220 kV Hiriyur–Zenataris Line-1 at the Zenataris end only. The line was holding at the Hiriyur end. The tripping of the only connected line resulted in a complete outage of the 220 kV Hiriyur–Zenataris Line-1.

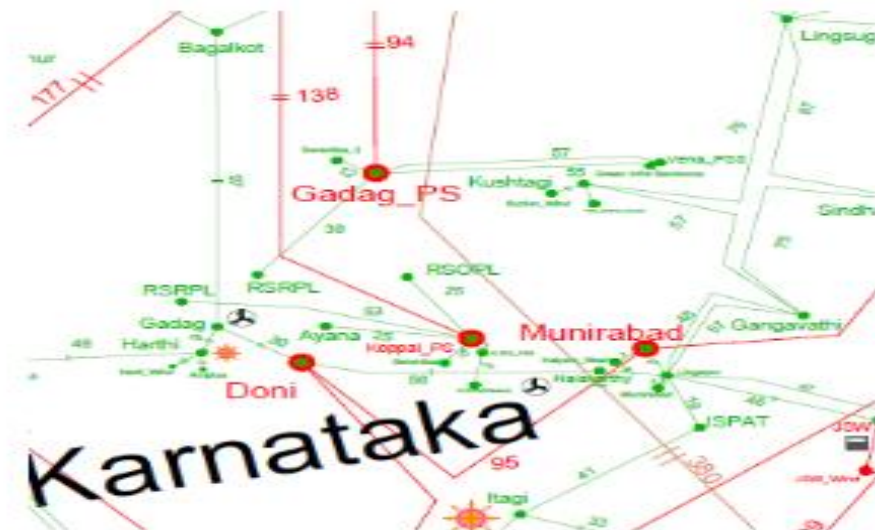
220kV Renew_Surya_Koppal is connected radially to KOPPAL through 220KV-KOPPAL-Renew_Surya_Koppal-1. The triggering incident is the R-G fault in the 220KV-KOPPAL-Renew_Surya_Koppal-1 line during heavy rain and lightening. At both ends, the fault was sensed in differential protection. At Koppal end, A/R operated and the line was holding. At RSRPL end, A/R did not trip and the line tripped. Tripping of the only line connected to 220kV Renew_Surya_Koppal led to the Complete Outage 220kV Renew_Surya_Koppal of RENEW.

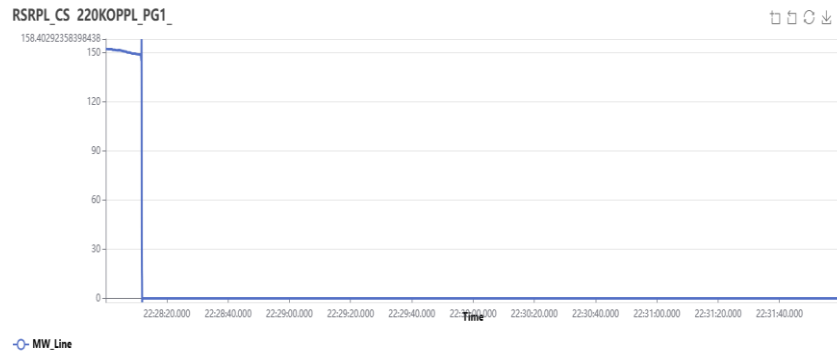
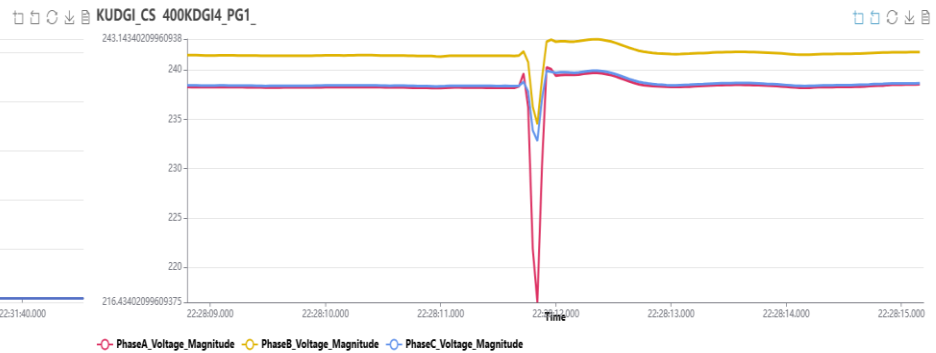
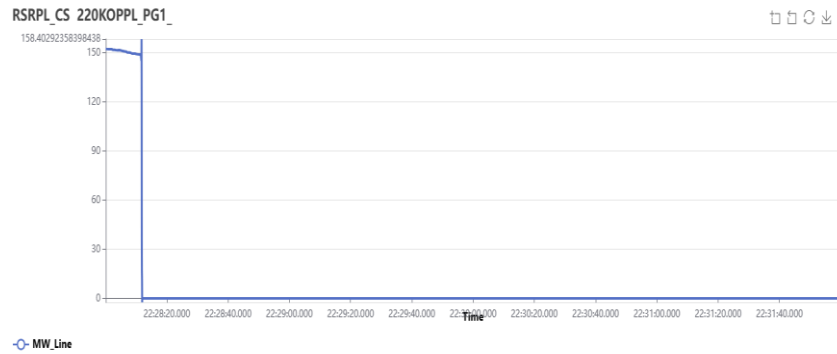
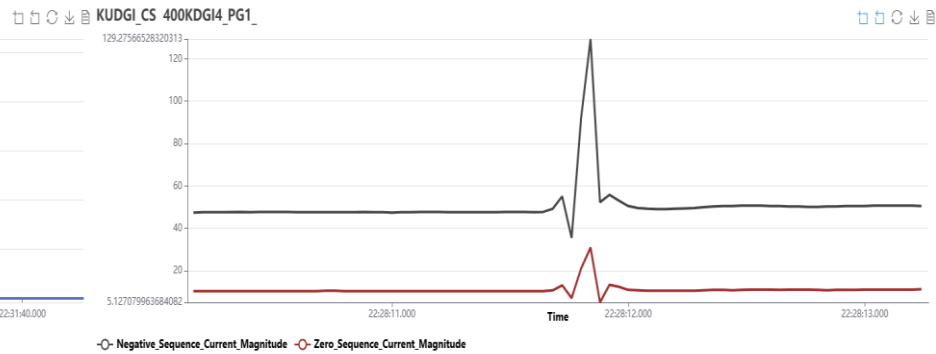
From PMU, dip in R-phase is observed indicating R-G fault during the event.

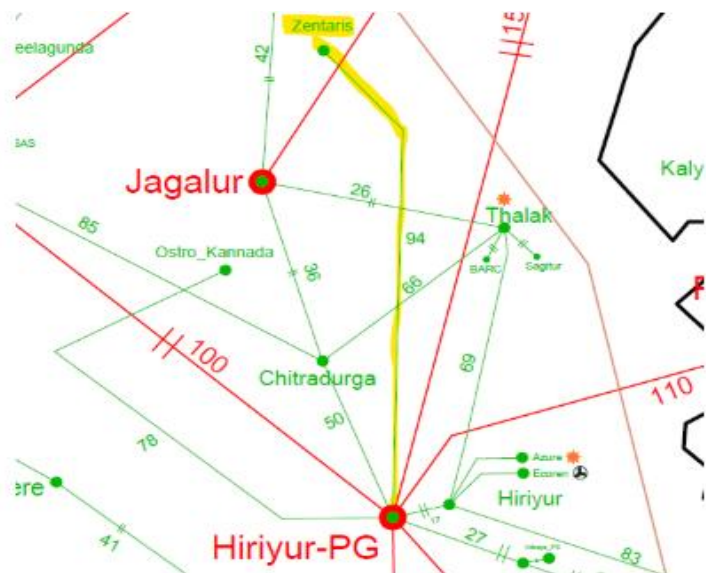
220kV Zenataris_PSS is connected to Hiriyur through 220KV-HIRIYUR-ZENATARIS_PSS-1. 220 kV Hiriyur is connected to 220 kV Zenataris. The triggering incident was Y-B fault in the line which was located from 42.3 km away from Hiriyur end. At Hiriyur end fault was sensed in Zone 1 and 3ph tripped. At Zenataris end fault was not sensed. Tripping of the only connected line led to complete outage of ZENATARIS_PSS - 220KV

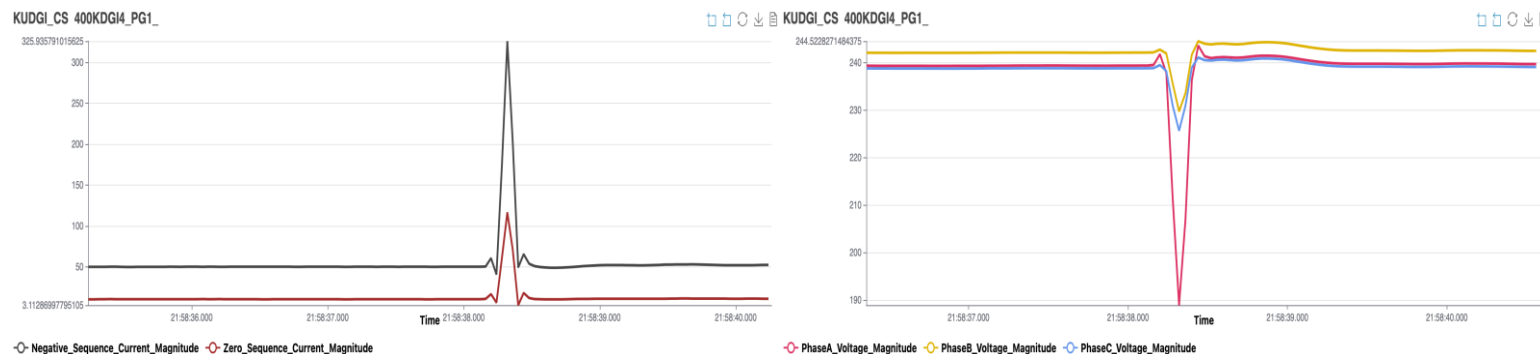
From the PMU, dip in R-phase is observed indicating R-G fault during the event.

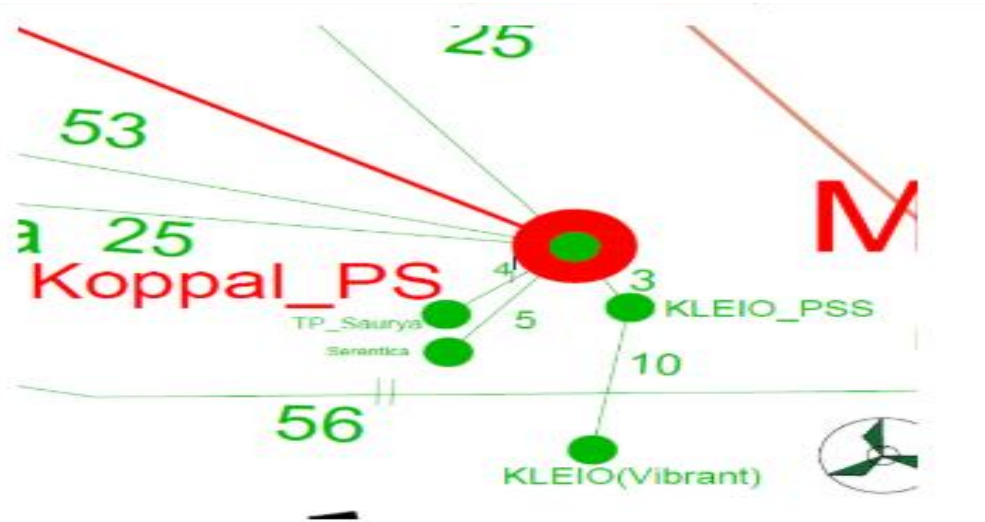
As per the reports submitted, the triggering incident was B-G fault in 220kV Koppal TP Sourya line. At TP Sourya end, the fault was sensed in line differential protection and the line tripped. However, the same could not be verified at Koppal end due to non submission of FIR, DR, EL and TR. Tripping of the only

connected line led to complete outage of TP SAURYA LIMITED - 220kV.

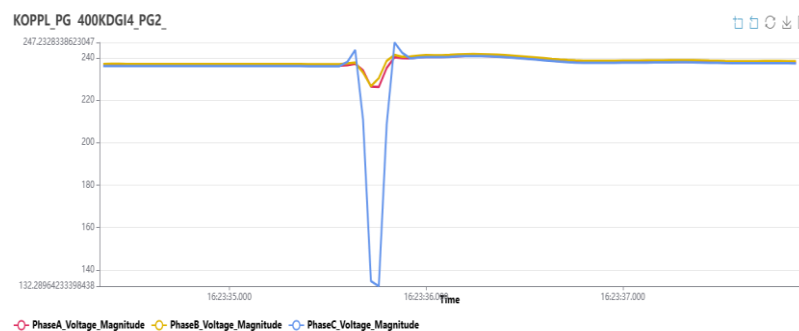
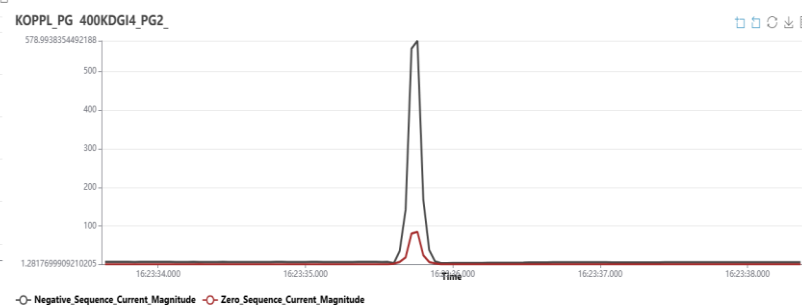
From the PMU, dip in B-phase is observed indicating B-G fault during the event.

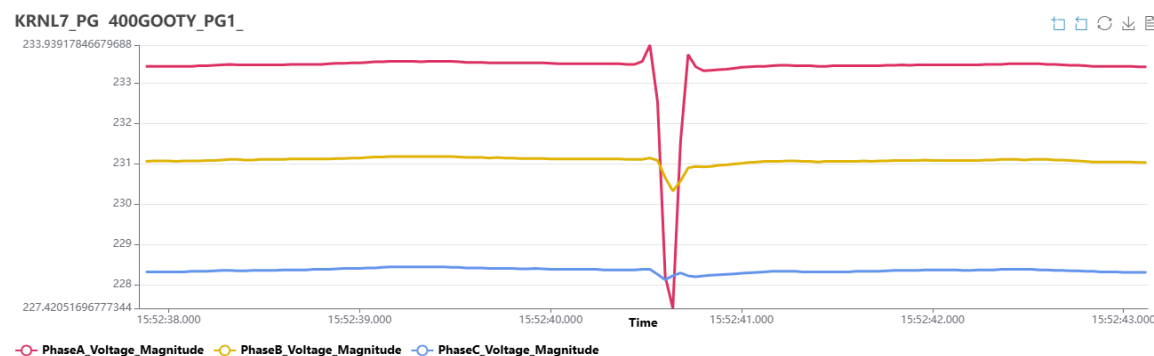
From PMU dip in R-phase voltage is observed indicating R-G fault during the event.

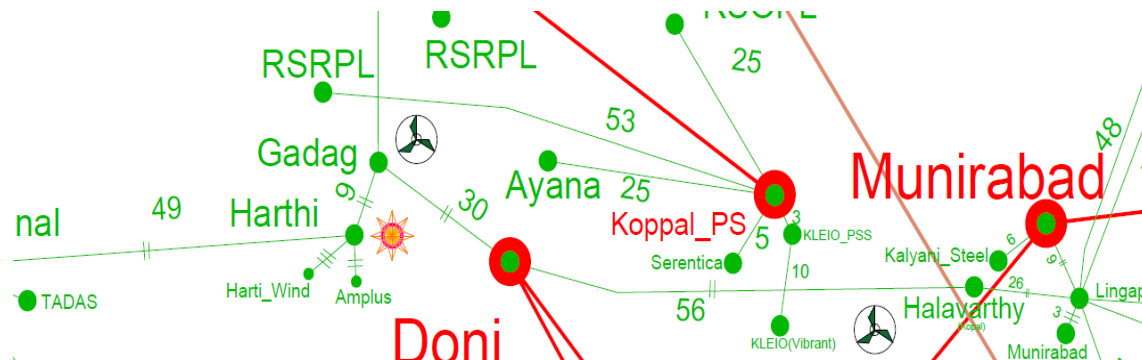
220kV Renew_Surya_Koppal (RSRPL) is radially connected to Koppal through 220kV Koppal-RSRPL. As per the reports submitted, the triggering incident was tripping of 220kV Koppal-RSRPL line while charging 220KV/33KV Renew_Surya_Koppal-ICT-2 at 220kV Renew_Surya_Koppal on suspected DEF protection. However, the same could not be verified from DR and EL. At the same time DT was sent to Koppal end and the line tripped at both ends. Tripping of the only connected line led to complete outage of 220kV Renew_Surya_Koppal.

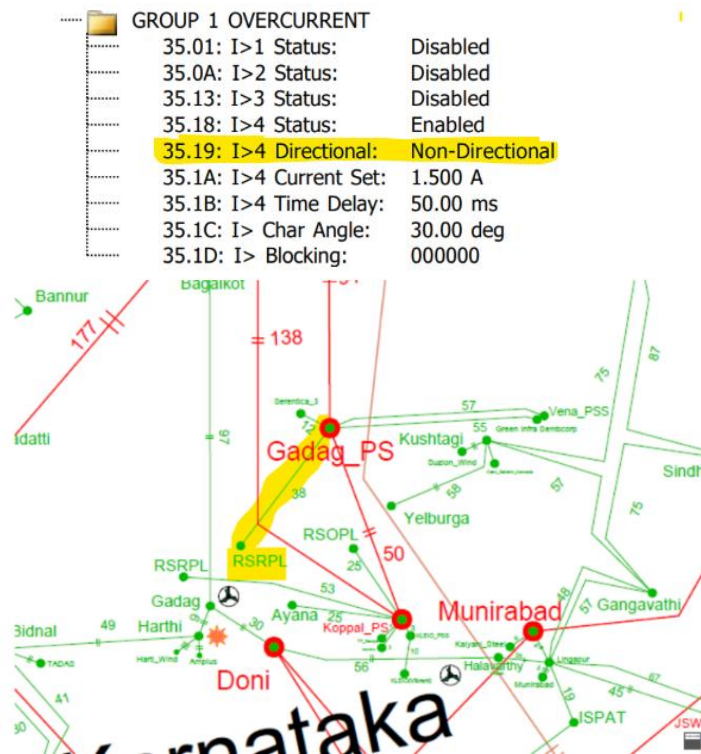
220kV RSRPL_GadagPS was radially connected to Gadag through 220KV-GADAG_PSS-RSRPL_GadagPS-1. As per the reports submitted, the triggering incident was YB-G fault in 220kV Gadag RSRPL_Gadag_PS line at 205 line bay at RSRPL end (as per FIR) due to foreign object (monkey). At RSRPL end, the fault was sensed in I>4 non directional over current protection in only one Main (Main-1 as shown below) and DT was sent to Gadag end (as per DR).

However, the DT was not received at Gadag end as the line tripped only at RSRPL end and the line was holding at Gadag end. At Gadag end, the fault was not sensed and the line was holding. Tripping of the only connected line to RSRPL_GadagPS led to complete outage of 220kV RSRPL_GadagPS.

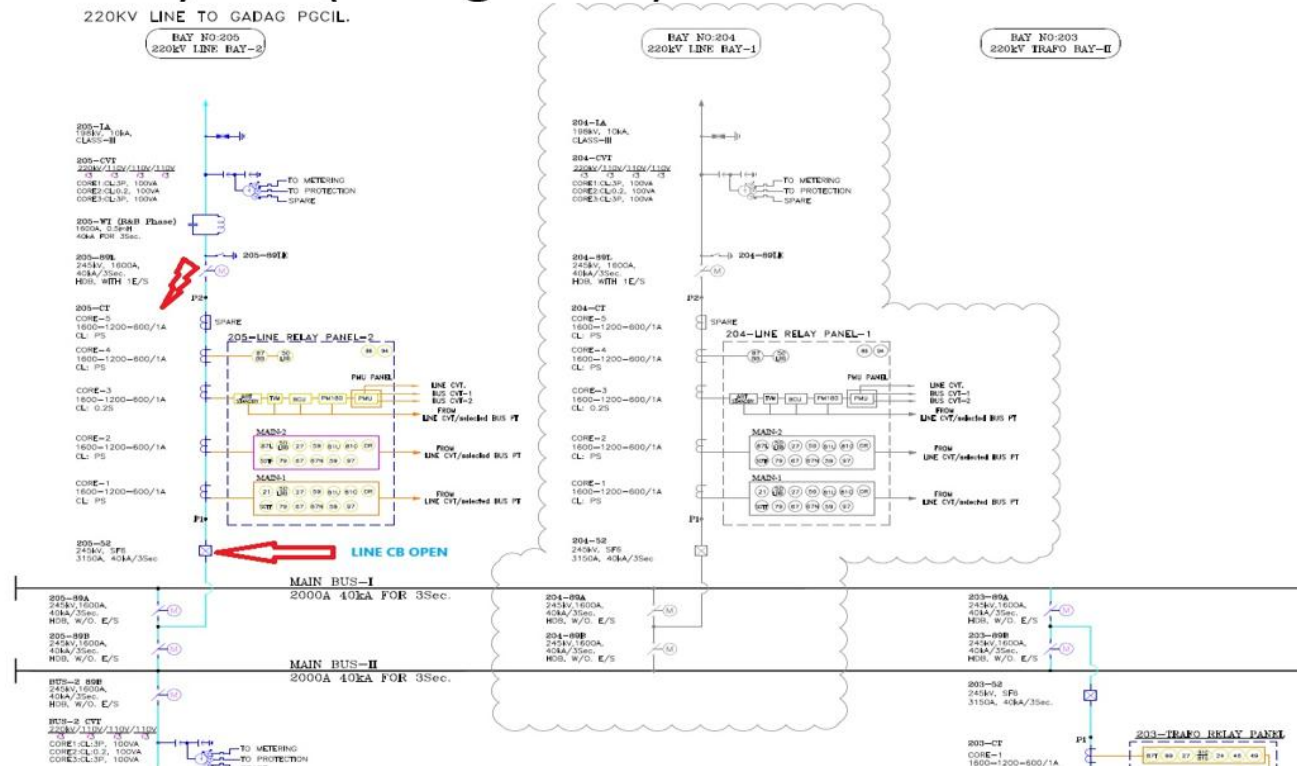
SLD Bay-205 (Gadag RSRPL)

1. M/s Renew stated that 220 kV Gadag–RSRPL line bay tripped on 05.04.2026 at 08:55:08 hrs. It was informed that Differential Relay (backup protection) had operated with fault currents of IA – 0.30 kA, IB – 2.76 kA and IC – 2.11 kA.
2. M/s Renew further informed that at 08:55:08 hrs, 220 kV EHV Bay-205 had tripped on OCR operation in Y and B phases. During yard inspection, a foreign object was observed electrocuted between the line circuit breaker and Bay-205 line isolator. The foreign object was subsequently removed and the line was charged back at 10:13 hrs.

3. Regarding remedial measures taken, M/s Renew informed that complete yard inspection had been carried out and red flags had been installed throughout the switchyard area of the PSS.
4. SRPC enquired regarding the reason for non-operation of distance protection during the event. M/s Renew stated that the matter had been referred to the OEM and the response was awaited.
5. M/s Renew to submit the OEM report on the incident to SRPC & SRLDC

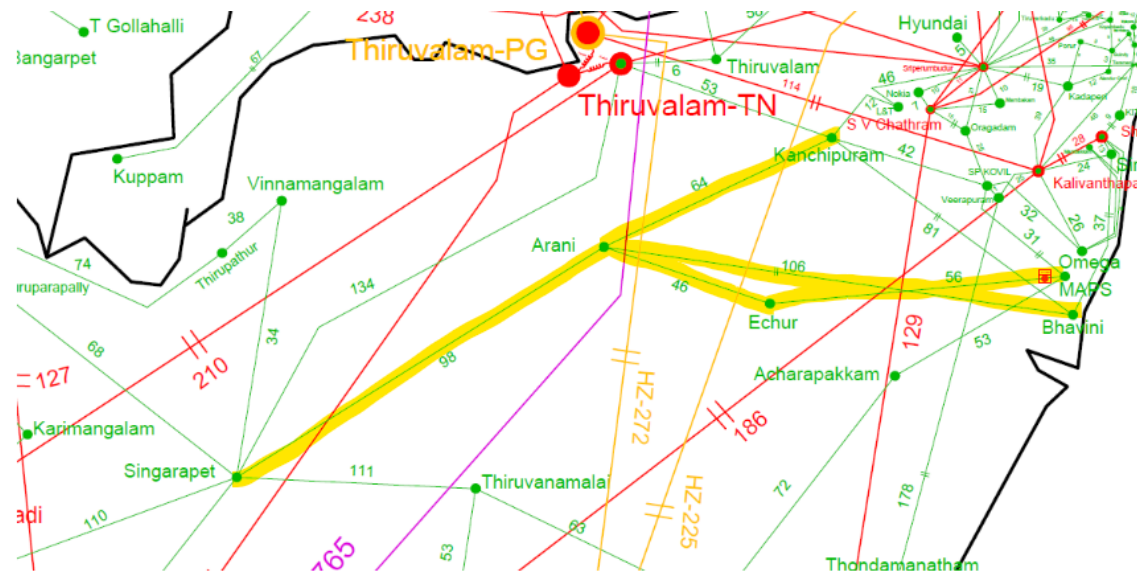
230kV Echur is connected to 230kV Arani and MAPS. 230kV Arani is connected to Singarpet, Kanchipuram and Bhavini as shown below.

The triggering incident is the 110kV Y-ph bus PT failure at Arani (as per FIR) causing 110 kV Bus Fault. As the BBP protection is not available at 110kV level, the fault was not isolated instantaneously. It can be observed that initially the fault was sensed in R-ph and further developed into R-Y ph fault after around 350ms.

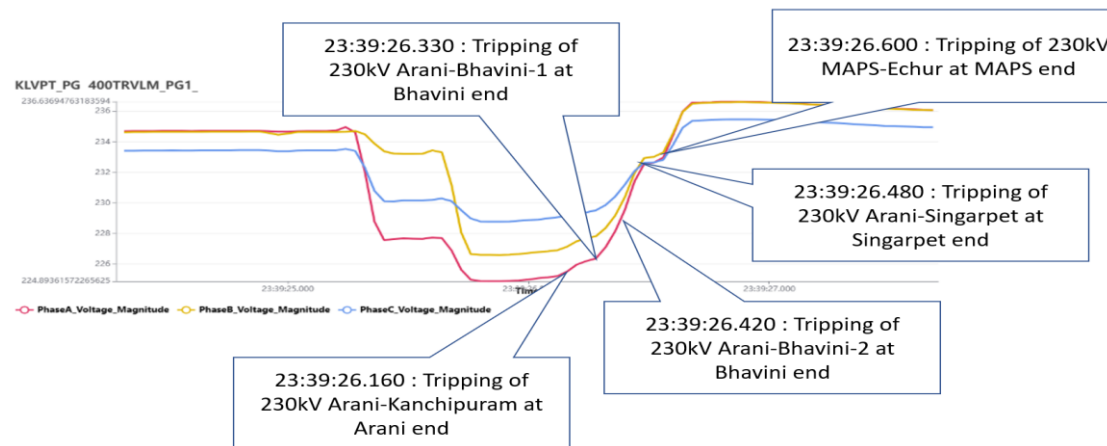
Thereafter, the only connection to Arani was through 230kV Arani-Echur-MAPS, subsequently 230kV MAPS-Echur line tripped at 23:39:26.600 on DEF protection operation, which was set for 100mA Time delay- 1.2 sec CTR-600/1A, isolating the fault. This led to the complete outage of 230 kV Arani and Echur of TANTRANSCO. The complete tripping sequence is as below:

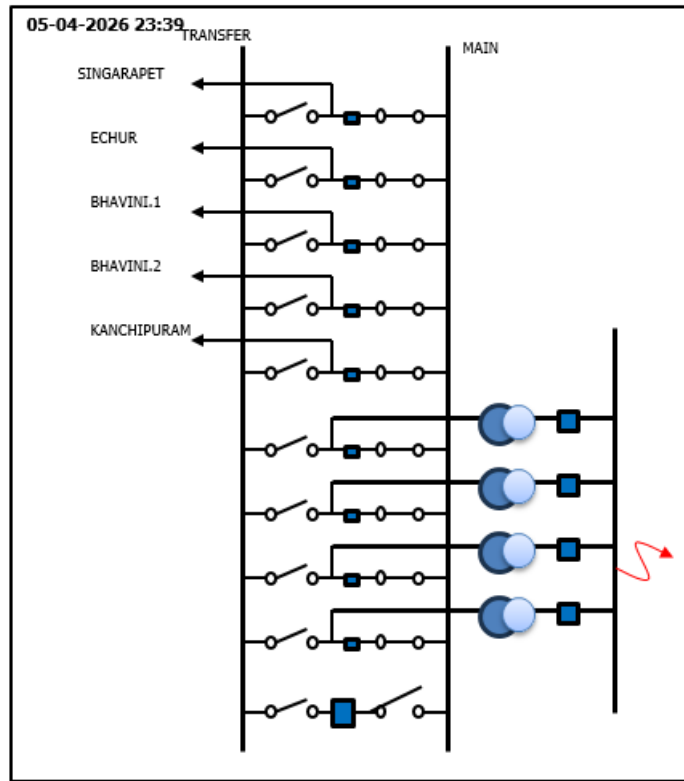
2. TANTRANSCO informed that on 05.04.2026 at 23:39 hrs, Y-phase 110 kV Bus PT had failed, which subsequently damaged the R and B phase Bus PTs also.

3. TANTRANSCO confirmed non-availability of 110 kV busbar protection at Arani Substation and consequently the fault was cleared by the 230 kV source feeders under Zone-3 protection operation.

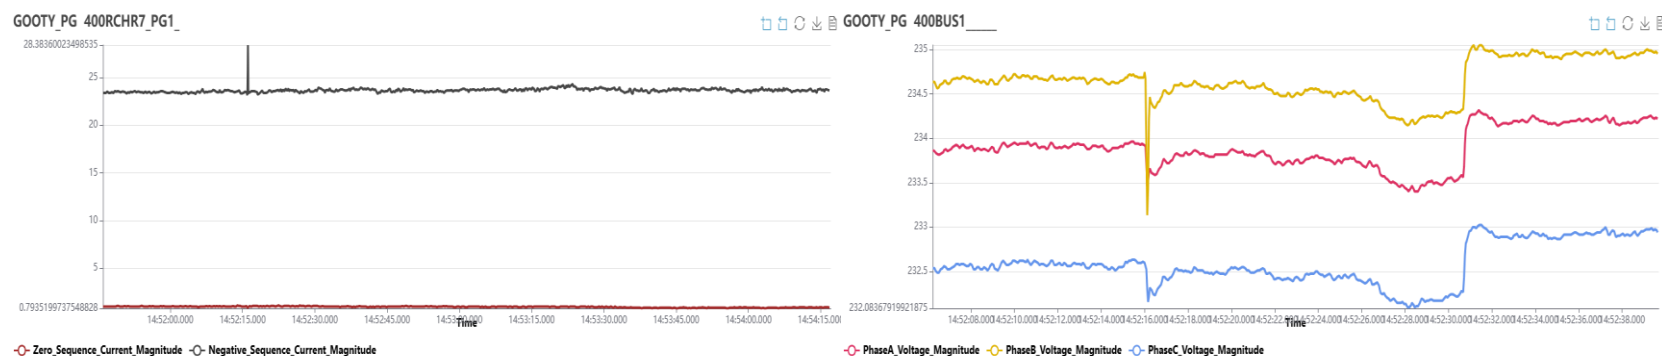
12. A) PMU Analysis:

From PMU, dip in Y-phase is observed indicating Y-G fault during the event.

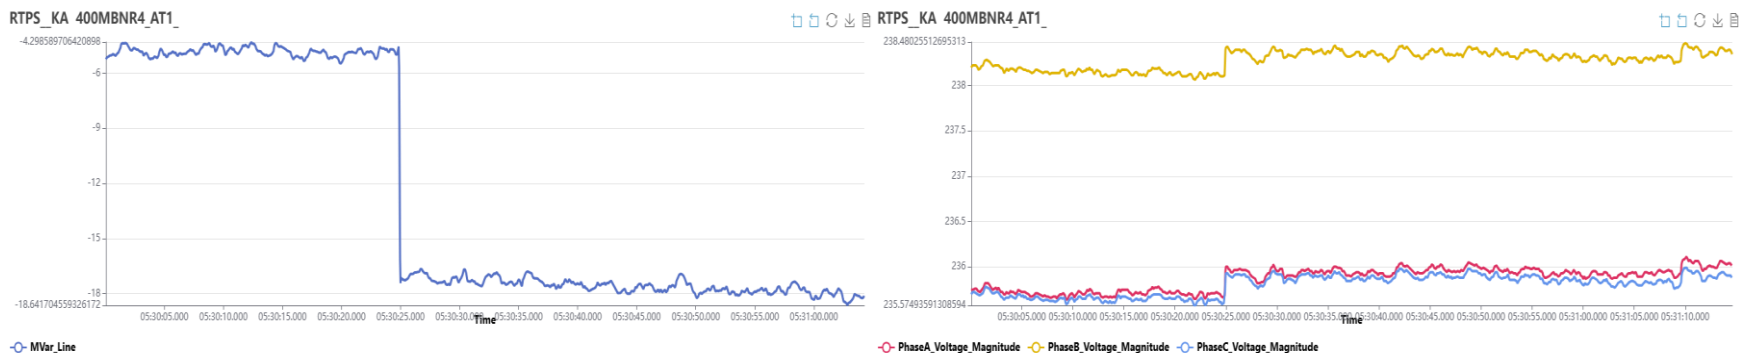
12. A) PMU Analysis:

As per the PMU data, fault was not observed.

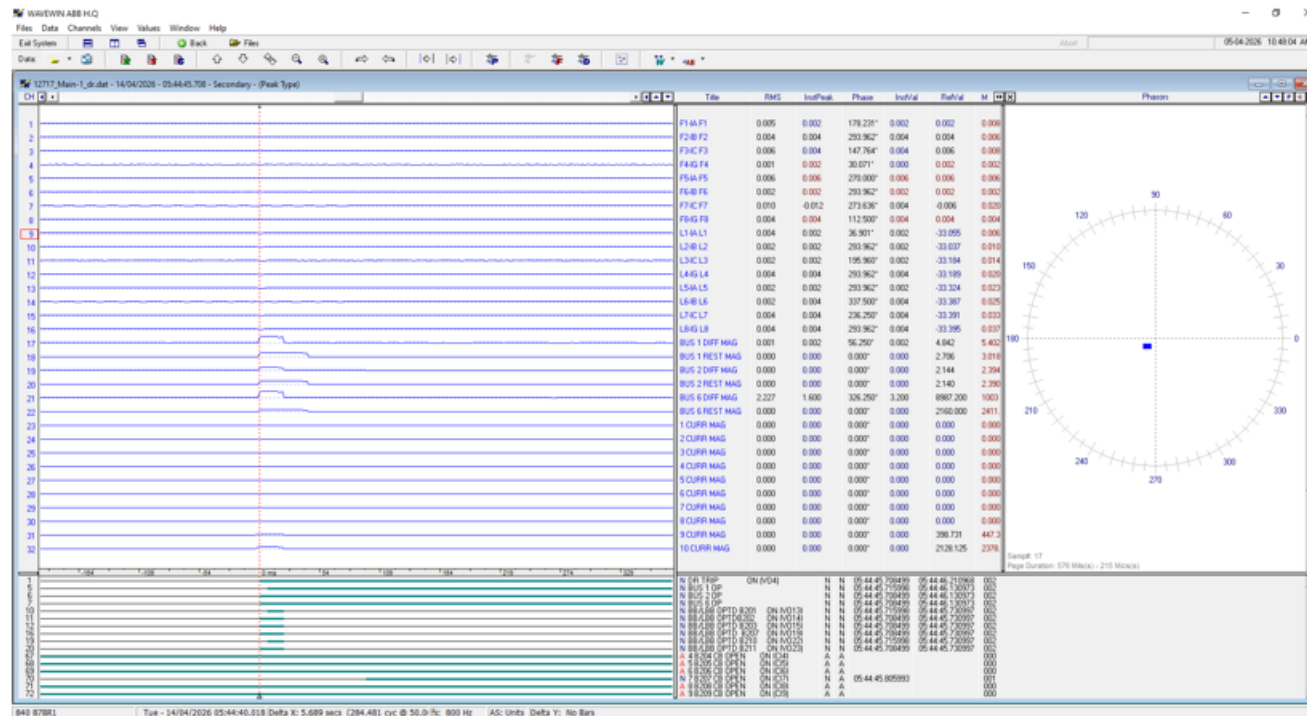
Disturbance Record (DR)

1. TGGENCO stated that on 14.04.2026 at 05:32 hrs, 220 kV Jurala–Raichur Line-1 & 2 feeders, Unit-4 and Bus Coupler circuit breakers tripped due to operation of Main-1 Busbar Differential Protection on R-phase. The event resulted in tripping of multiple 220 kV circuit breakers leading to complete outage of Upper Jurala generating station of TGGENCO.

2. TGGENCO informed that post-event inspection of the entire switchyard had been carried out and no abnormalities were observed. It was further stated that no operation was detected in Main-2 relay. TGGENCO informed that line clearance on the busbar had been sought from 02.05.2026 to 05.05.2026 for detailed relay testing and verification of relay healthiness.

3. TANTRANSCO suggested TGGENCO to verify the CT secondary circuits, carry out IR testing of CTs and also check whether any double earthing existed in the CT secondary circuits. SRLDC further suggested TGGENCO to examine the relay cards in detail.
4. SRLDC highlighted that fault current had been observed for nearly half a cycle and opined that the issue might be related to the secondary circuit. Accordingly, TGGENCO was requested to thoroughly review the CT secondary circuits and associated wiring.

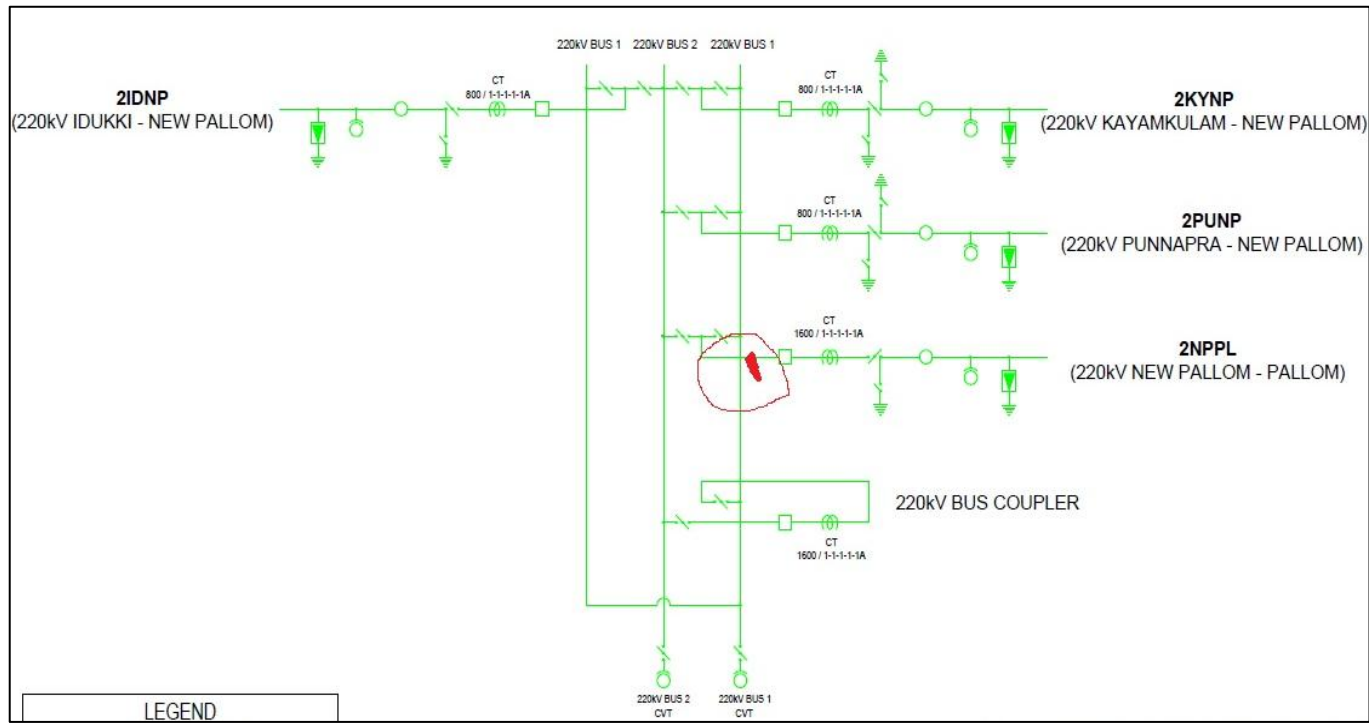
As per the reports submitted, the triggering incident was B-G bus fault on 220kV Bus-2 of 220kV New Pallom station within the bus protection zone of 220kV Pallom - New Pallom line due to flashover in the suspension insulator as shown in the SLD below:

Other Information (Antecedent Conditions) : On 14.04.2026 at 16:40 hrs, a bus fault occurred at the 220 kV Switching Station, New Pallom. The fault was identified at the suspension insulator in the cross bus of 2NPPL, connected to the junction of Bus-1 and Bus-2 isolator.

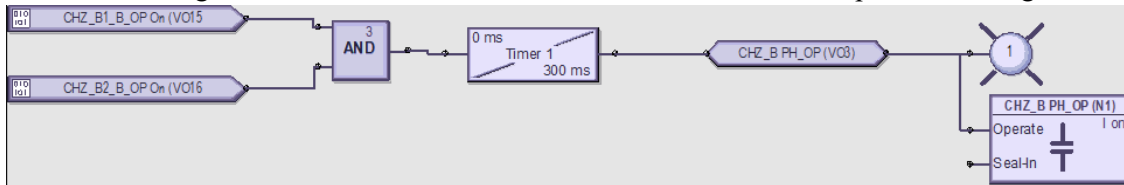
During this instance, the main zone busbar protection for both Bus 1 and Bus 2 was sensed at the New Pallom end due to the isolator high status of the 220 kV Pallom–New Pallom line in Bus-1 as well, whereas the isolator status is supposed to be set high only for Bus-2. However, as busbar checkzone protection was not sensed due to logic issue which was as follows and hence BBP did not operate isolating the fault.

During the event, the busbar protection did not operate as the check zone was found in a 'non-operate' condition. However, Main Zone-1 and Zone-2 protections operated. Upon analysis of the logic unit, it was observed that both Bus-1 and Bus-2 isolator status were indicated as 'high'. Further investigation revealed that the Bus-1 isolator auxiliary contact was faulty and remained in the 'high' position, which resulted in incorrect zone selection and caused both zones to operate simultaneously.

DR Time synchronization issues observed (सुरक्षा/प्रचालन समस्या)	:	False
Remedial Measures Taken (सुधारात्मक सुझाव)	:	Relay settings are verified. Corrective action in progress.
Relay/PLCC Operation Details	:	
Control Panel Anunciation	:	
Main I Relay Indications	:	
Main II Relay Indications	:	
Other Relay Indications	:	
PLCC Counter Increment I/T	:	
PLCC Counter Increment D/T	:	
Fault Current Value (kAmp)	:	None
LA Counter	:	
Remarks	:	
Attachments	:

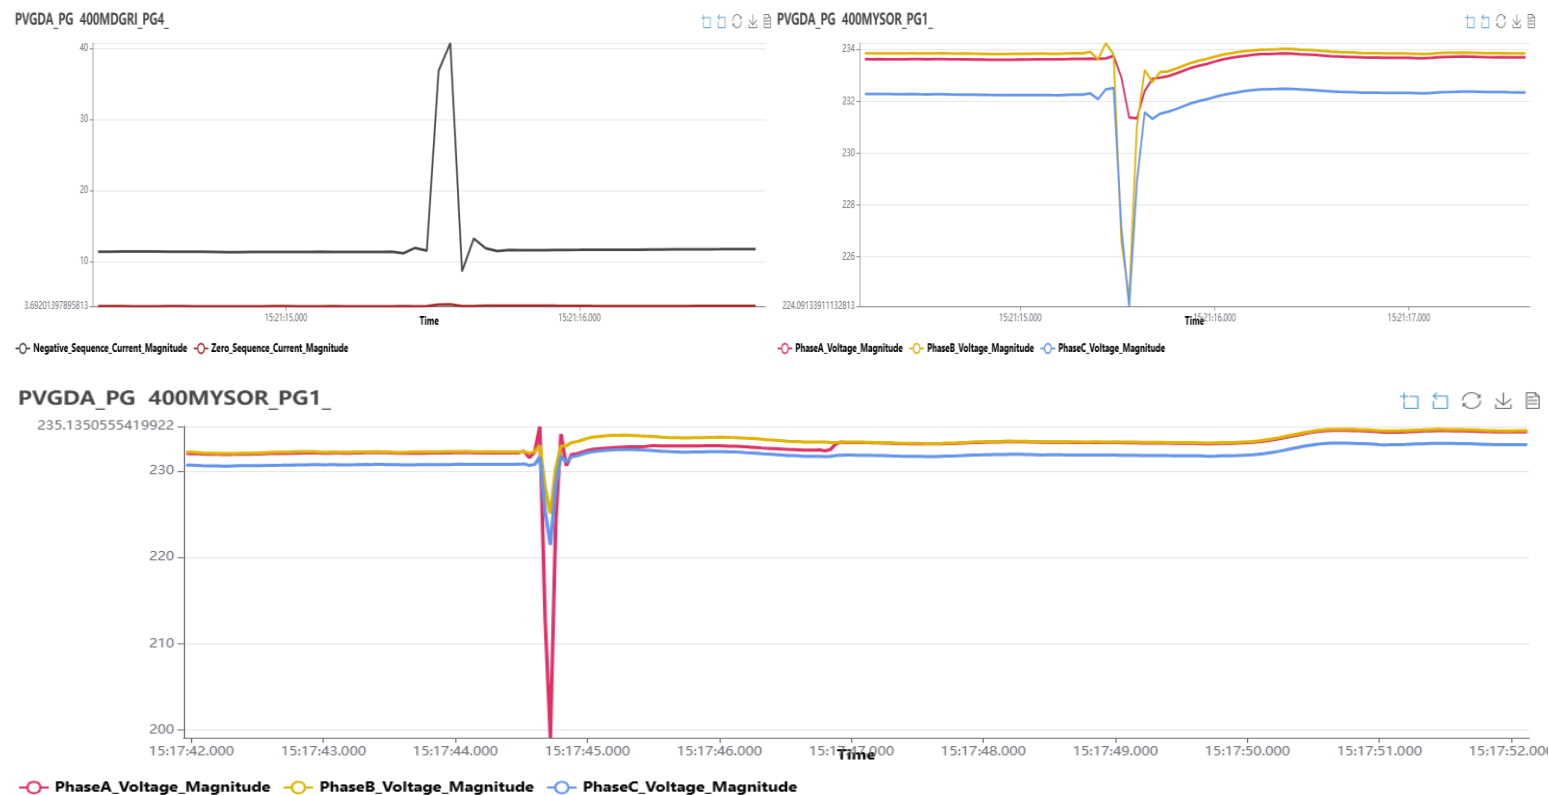
12. A) PMU Analysis:

From the PMU plot, R-G fault can be observed without any delayed clearance.

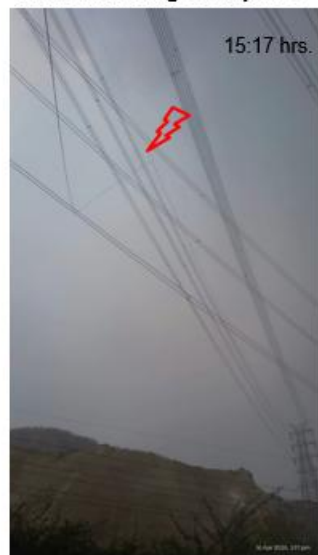
Post Securing of ropes :

10. It was further informed that subsequently the guide rope used for manual roller installation snapped due to the impact, recoiled and came into contact with JSW RE Line-2, resulting in phase-to-phase fault and tripping of the RE Line at 15:22:44 hrs. Since BPS Line-3 remained energised from BPS end and a wet rope was in contact with live conductors, the line was isolated from BPS end as a precautionary measure to avoid possible electrocution of personnel working under the tower.

11. Regarding remedial measures taken, JSWEL informed that SOP for OPGW installation activities had been revised with provision of additional pulley arrangements. It was further informed that a separate team had been constituted for monitoring weather and wind conditions. JSWEL stated that tripping of BPS-JSW Line-3 was being analysed separately under GPR-related issues and detailed investigation report from M/s Manav was awaited.
12. SRLDC highlighted non-receipt of information and reports from RE generators. SRPC requested JSWEL to coordinate with JSW-RE and ensure submission of reports within the timelines specified under IEGC Regulations. JSWEL agreed to the same.

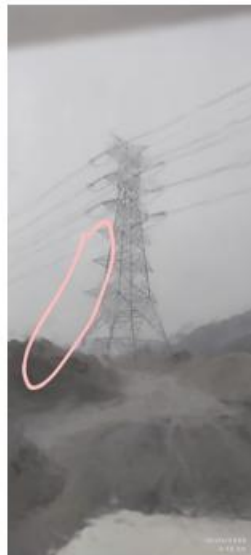
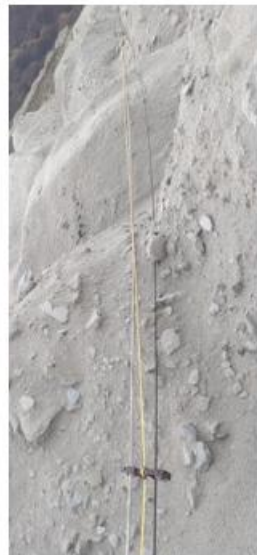
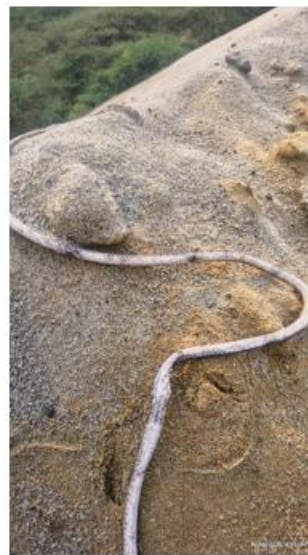
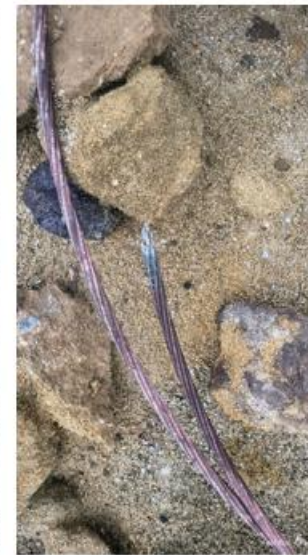
BPS Ckt 2 Earth Wire snap :

9. JSWEL further informed that at 15:05 hrs light drizzle commenced. Since all ropes had already been secured and necessary clearances maintained, demobilisation of personnel from the towers was initiated at 15:15 hrs to avoid possible electrocution hazards. Subsequently, at 15:17 hrs, the drizzle intensified into heavy rainfall accompanied by gusty winds and thunderstorms. Due to wet conditions, the pilot rope became conductive and at 15:17:44 hrs arcing occurred between the R-phase conductor and the pulling rope (Platina rope), which in turn came into contact with the earth wire of JSWEL–BPS Transmission Line Circuit-2. This resulted in snapping of the earth wire and caused a phase-to-ground fault, leading to tripping of 400 kV JSWEL–BPS Line-4.

P444 : Distance trip Z1 , Fault duration:73.28 , Fault location: 6.368km
IA : 14.08KA, IB: 1.917, IC: 2.028 , Van: 47.27 , Vbn: 216.9, Vcn:
209.2

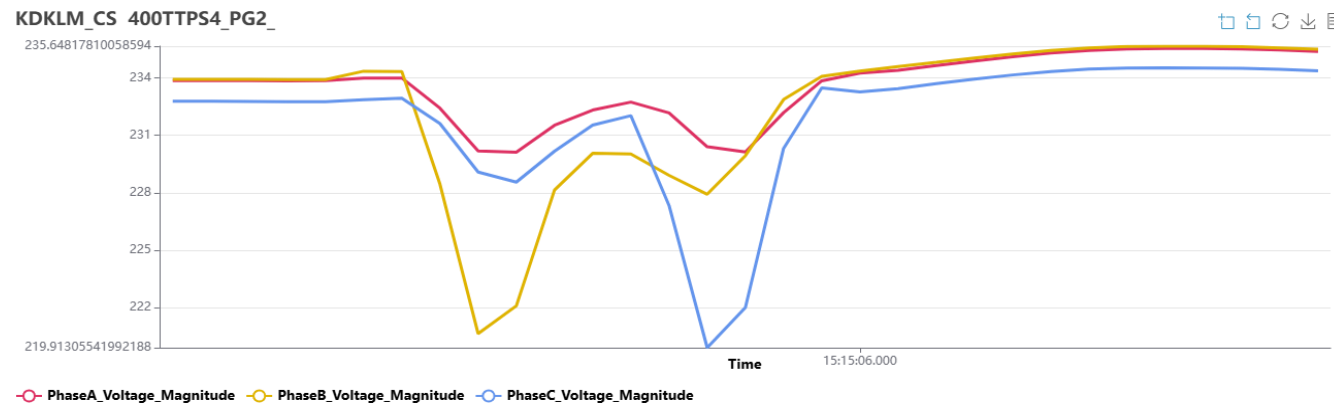
12. A) PMU Analysis:

From the PMU plot Y-G fault can be observed with delayed clearance.

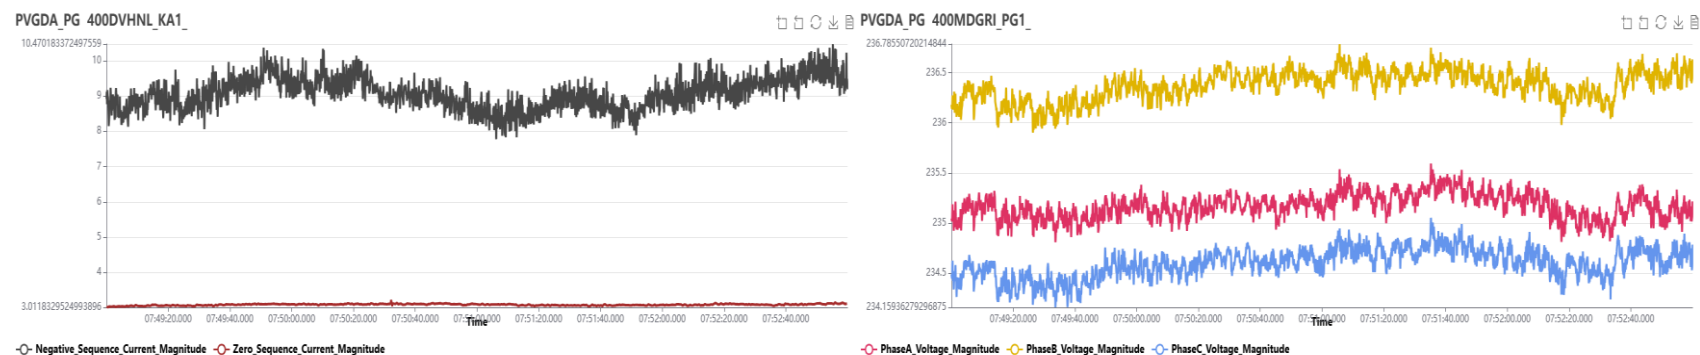
12. A) PMU Analysis:

From PMU, no fault is observed during the event.

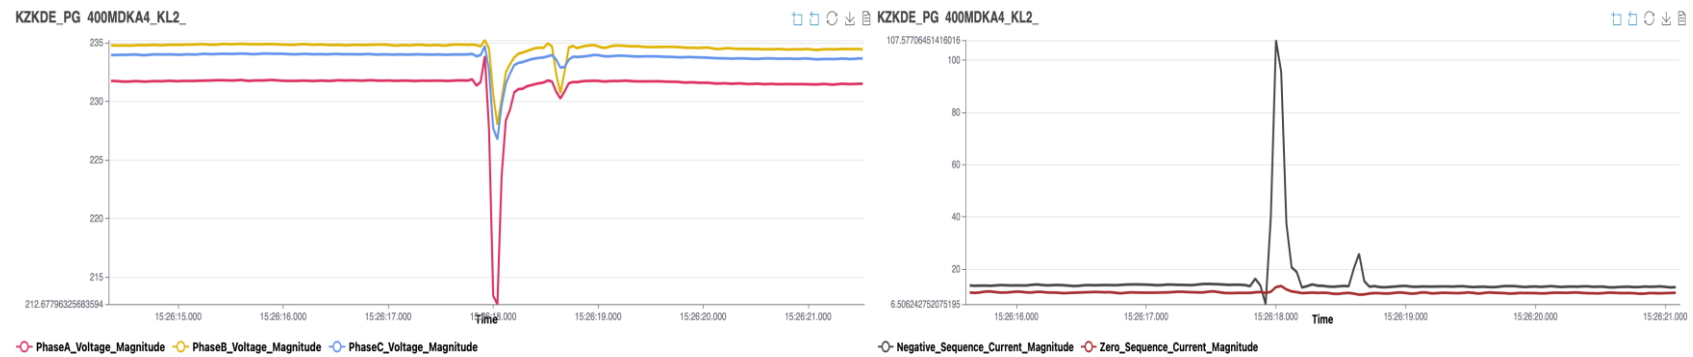
From PMU, dip in R-phase is observed indicating R-G fault during the event

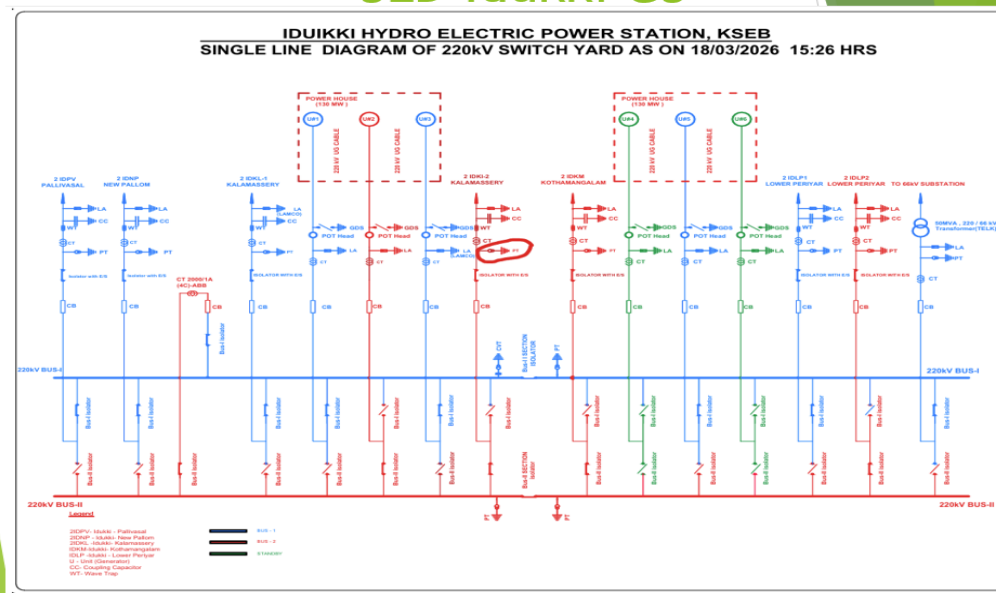
SLD Idukki GS

2. KSEBL stated that Bus Bar Zone-2 protection operation occurred at the 220 kV switchyard of Idukki HEP, resulting in tripping of multiple feeders along with one generating unit. It was informed that the disturbance was initiated due to flashover in the R-phase Line Potential Transformer (PT) of 220 kV Idukki–Kalamassery-2 feeder on 18.03.2026 at 15:26 hrs.

3. KSEBL further informed that the Line Potential Transformer of feeder 2IDKL-2 was physically located within the Bus Bar Protection zone at Idukki 220 kV switchyard. Hence, flashover of the R-phase PT had been correctly detected as an internal fault by the Bus Bar Protection scheme, resulting in operation of Bus Bar Zone-2 protection and tripping of all elements connected to Bus No. 2. It was further informed that Direct Transfer Trip (DTT) signals had also been transmitted to the remote ends.

4. KSEBL submitted that Idukki HEP is an old generating station; the existing switchyard layout has PTs installed ahead of the CTs, thereby inherently placing them within the protected zone of the Bus Bar Protection scheme. It was further informed that due to space constraints, existing layout limitations and operational constraints, relocation or modification of PT placement was presently not feasible without major switchyard reconfiguration.

- All stations normalised. 2IDKL-2 PT Replaced on 20.03.2026, @ 01:57 feeder charged
- Subsequent to the above incident, two Potential Transformers (PTs) in the R phase and Y phase of the 220 kV Idukki–Kalamassery Feeder No. 2 were replaced.

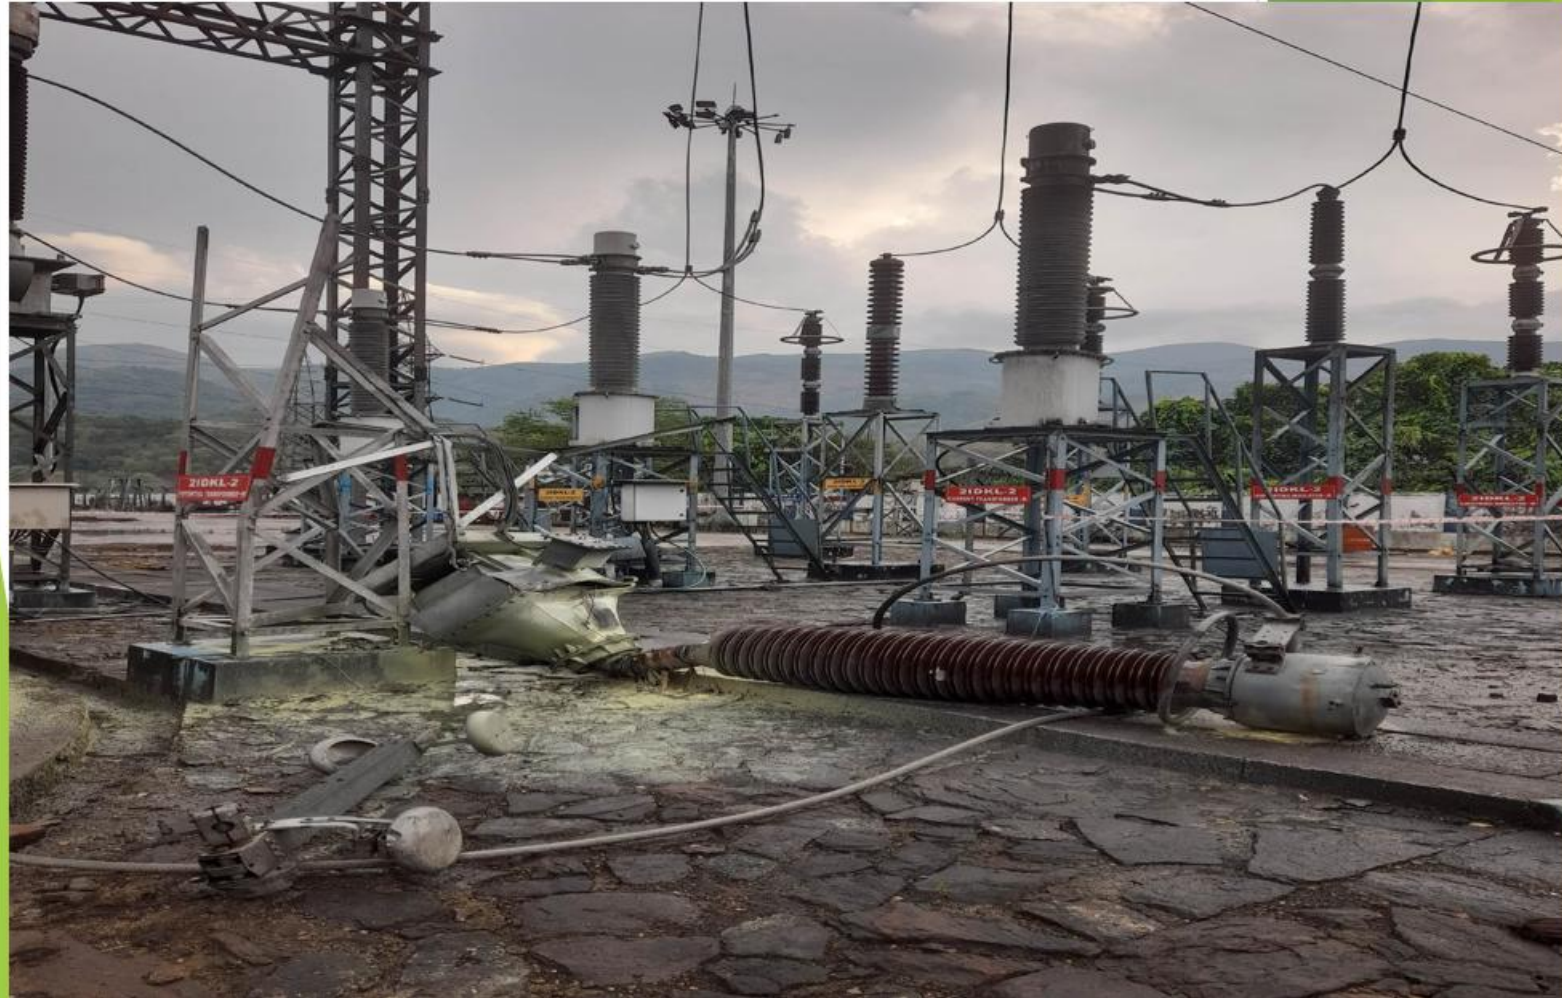
SCT Make PT Sl No. 2015/1706

The disturbance was primarily caused by the failure of the Line PT, and the subsequent Bus Bar protection operation was correct and as per design philosophy, considering the PT lies within the protection zone.

6. SRPC requested KSEBL to report equipment failure to CEA.

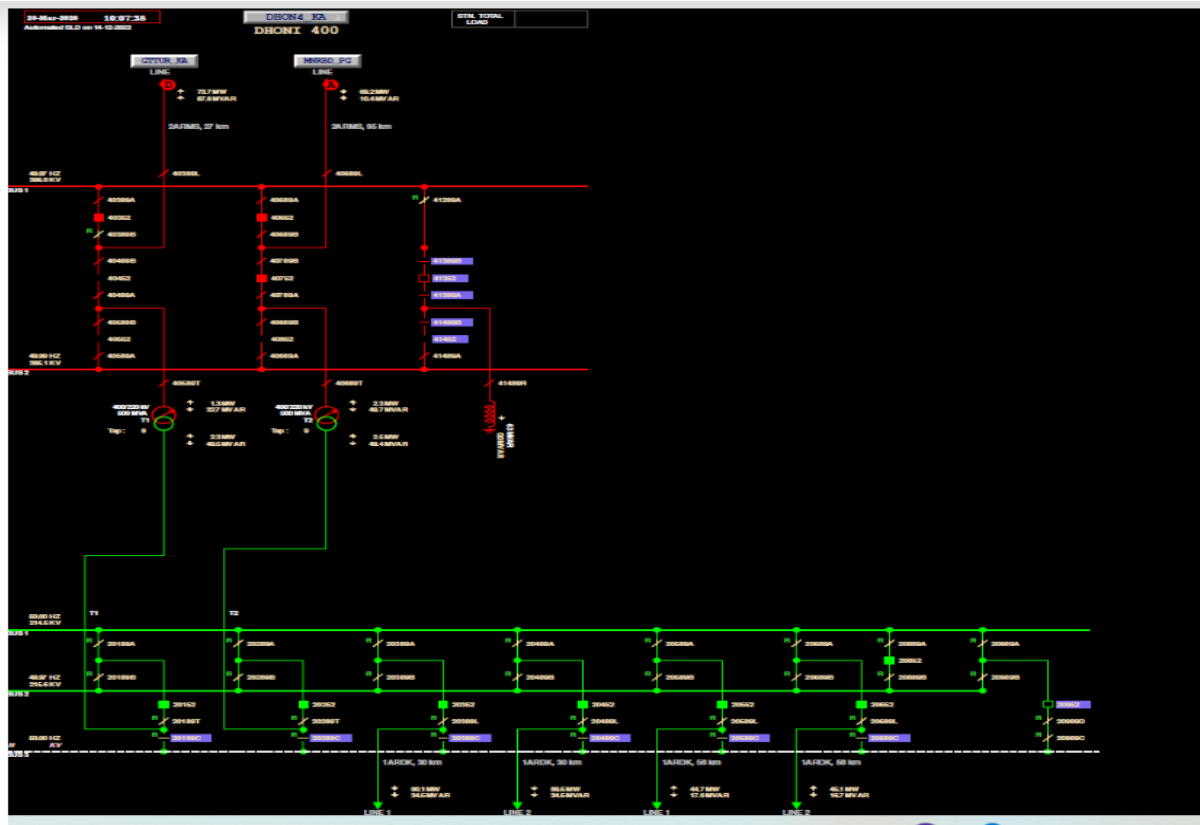
As per the reports submitted, the triggering incident was B-G fault in 400kV Bus-2 due to B-phase limb flashover during Bus reactor CB operation. Immediately, 400kV Bus-2 BBP operated and all main breakers connected to 400kV Bus-2 tripped resulting in loss of power supply to 400kV Dhoni Bus-2.

It is reported that the Tie breaker of 400kV/220kV Dhoni ICT-1 was hand tripped by the shift engineer during fault. This led to the loss of power supply to tripping of 400kV/220kV Dhoni ICT-1.

Constituent	Remedial Actions
KPTCL	Isolated the faulty section of Bus Reactor Bay and charged the 400kV bus-2 and ICT-1. Need to replace the faulty breaker.
