Grid Occurrences – 142

I. Details of Grid Disturbances

Detailed Draft Report of grid event submitted by SRLDC:

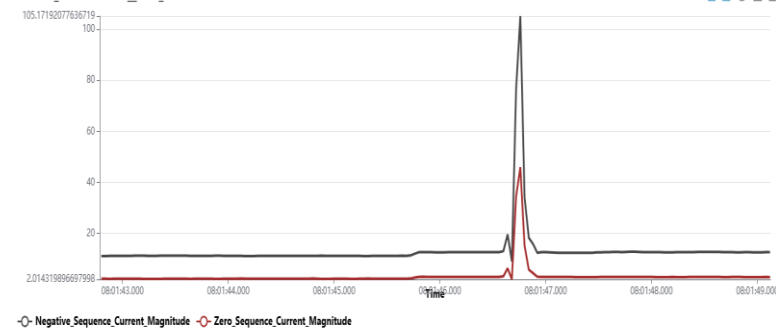
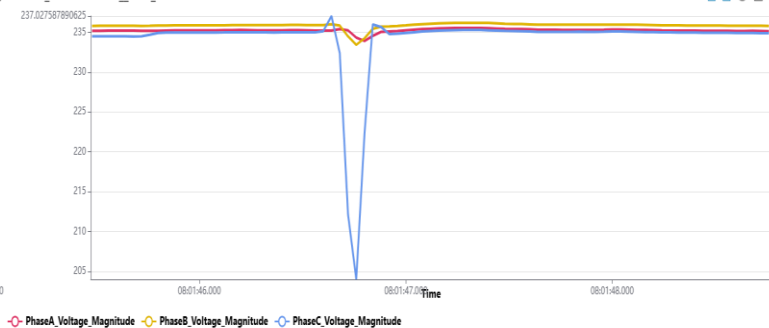
GTTUR_KA_400BTPS_KA1_

From PMU voltage at 400kV Guttur, dip in B-pole is observed indicating B-G fault during the event with no delayed fault clearance.

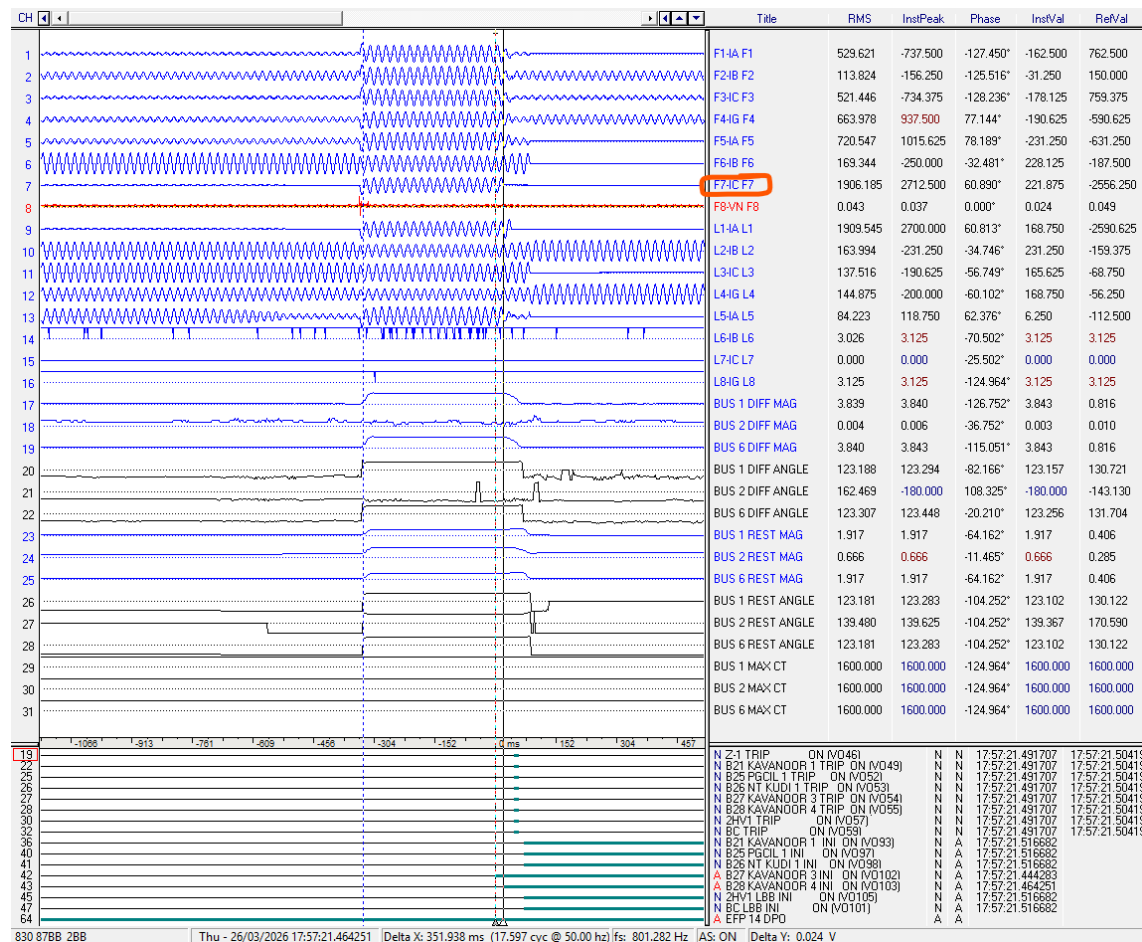
As per the reports submitted, the triggering incident is the B-ph jumper cut in Bus-1 in 230kV NT Kudy Bay and Kavanur-3 line (as per FIR) which led to the Bus-1 fault. However, from the DR data, it can be observed that the BBP did not operate immediately and operated almost after around 350ms.

It can also be observed that after tripping of F7 (exact line to be confirmed by TANTRANSCO), where in after around 2 cycles BBP operated in Z1 and all the elements connected to Bus-1 tripped. This led to the Tripping of 230kV Bus-1 of Karaikudi SS. 230kV Bus-2 and 110kV side was in service during the event.

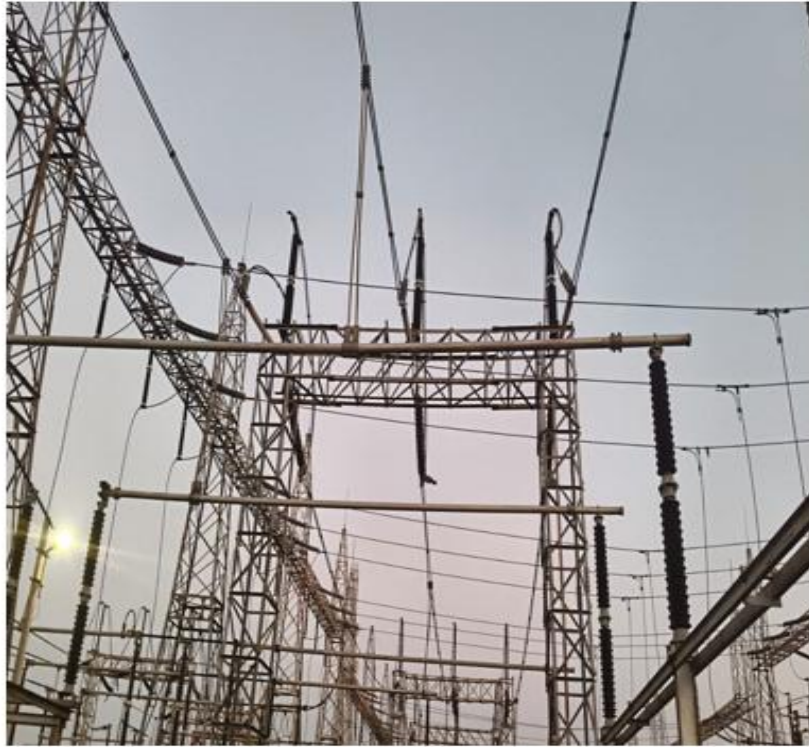
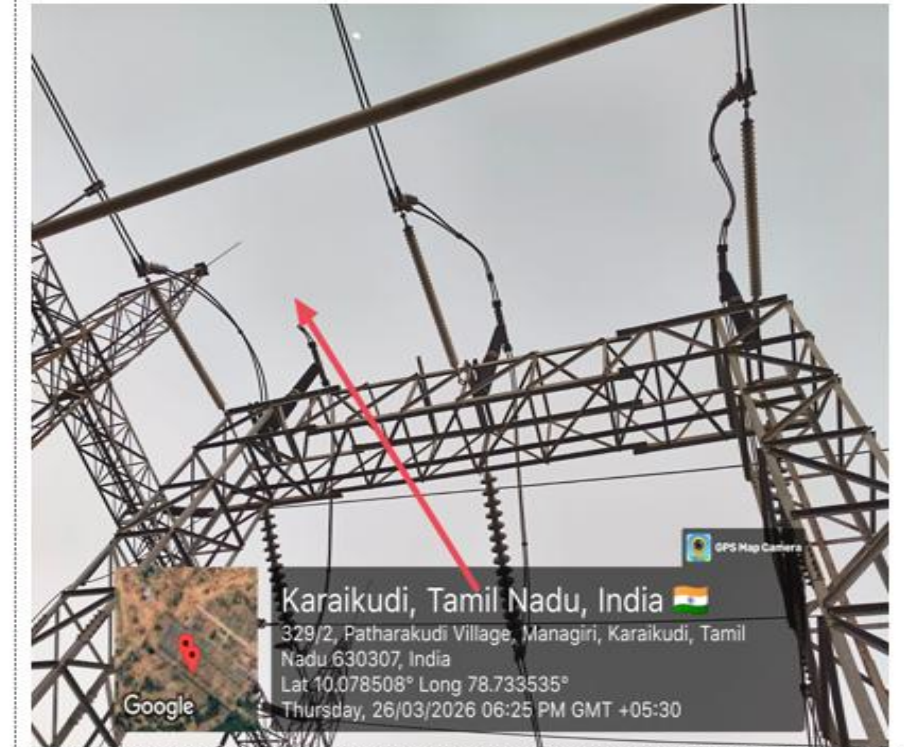
2. TANTRANSCO stated that the fault was in between Kavanur-3(L1) & Karambayam Line-1 (F6). From the DR following were inferred:
 - a. No current was observed in Kavanur-3 & Kavanur-4 feeder (17:57:20:942 to 17:57:21:102 hrs).
 - b. Jumper towards Kavanur-3 had opened & not earthed for 160 msec.

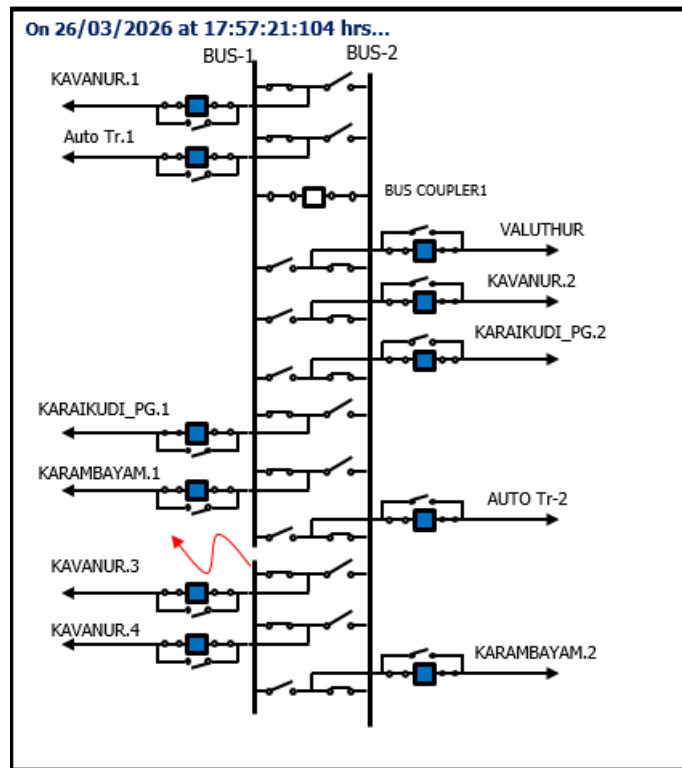
3. TANTRANSCO informed that fault current raised from 17:57:21:104 hrs in Kavanur-3 & Kavanur-4 only, rest of the bays connected in Bus-1 was having normal load current since Jumper had earthed towards Kavanur 3 & kavanur 4 direction. During the incident, all the elements connected in Bus-1 currents were not converged due to nature of fault.

4. Fault current raised from **17:57:21:465 hrs** in Kavanur-3 & 4 feeder tripped on reverse zone. The Busbar protection did not operate for 350 ms, due to the blocking of directional feature in the Busbar relay even though the Differential and Restraining current were 3.85kA and 1.85kA respectively.

5. The Busbar relay had initiated trip only during decay of current in Kavanur-4 feeder at **17:57:21:494**. From the analysis it was concluded that, as per the Relay principle the protection operated in order, since the nature of fault was such that, Bus-1 itself had sectionalized during the fault. This was addressed to OEM for further analyzing.

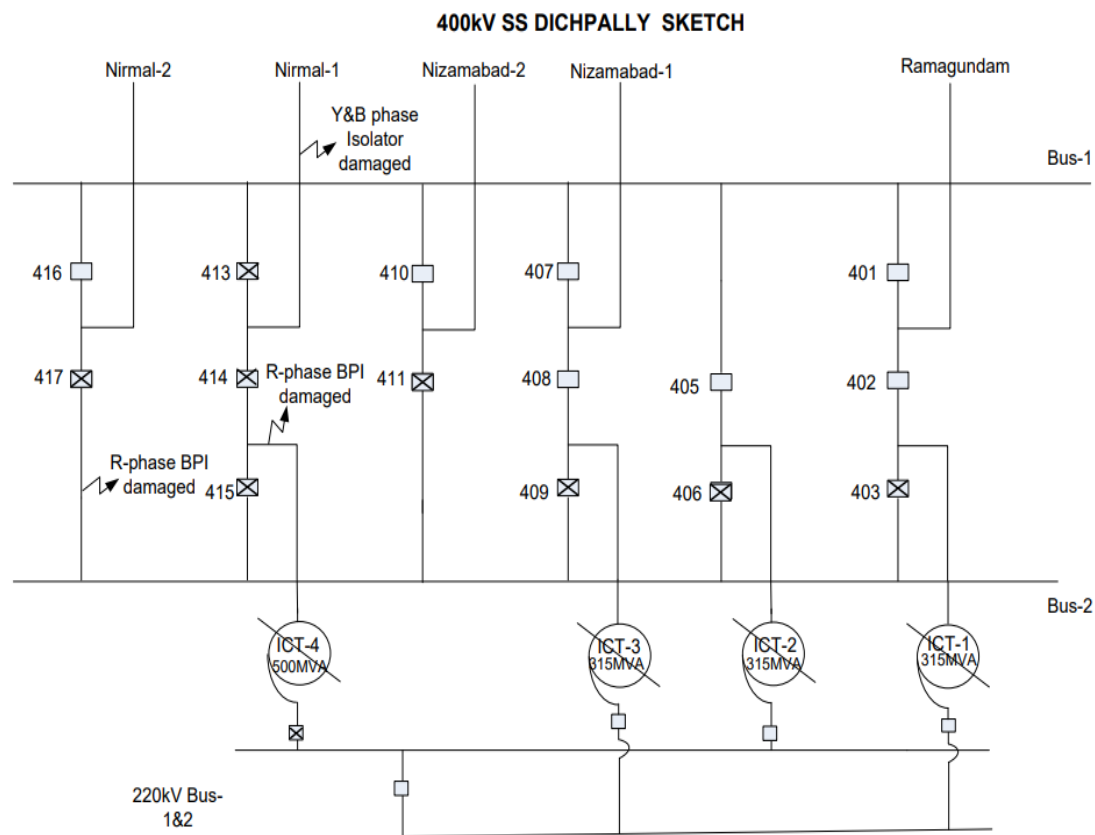
The location of fault with the SLD is as shown below:

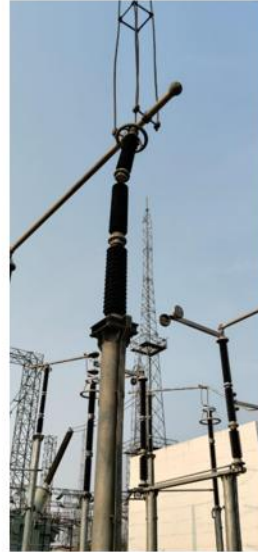
Fault in 400kV Nirmal-Dichipally-1

As per the reports submitted, the first fault which was triggered in 400kV Dichpally-Nirmal line was B-G fault within the substation and subsequent Y-G fault during the AR dead time due to isolator damage. At Nirmal end the first B-G fault was sensed in Zone 1 and B pole opened and during the subsequent Y-G fault was sensed in Z2 carrier aided protection and Y-pole opened, but the R-pole was in service until it tripped on suspected PD operation after around 3.1s from the initial fault (as per EL). At Dichipally end the first B-G fault was sensed in Zone 1 and B pole opened and during the subsequent Y-G fault was sensed in Z1 and 3 ph tripped.

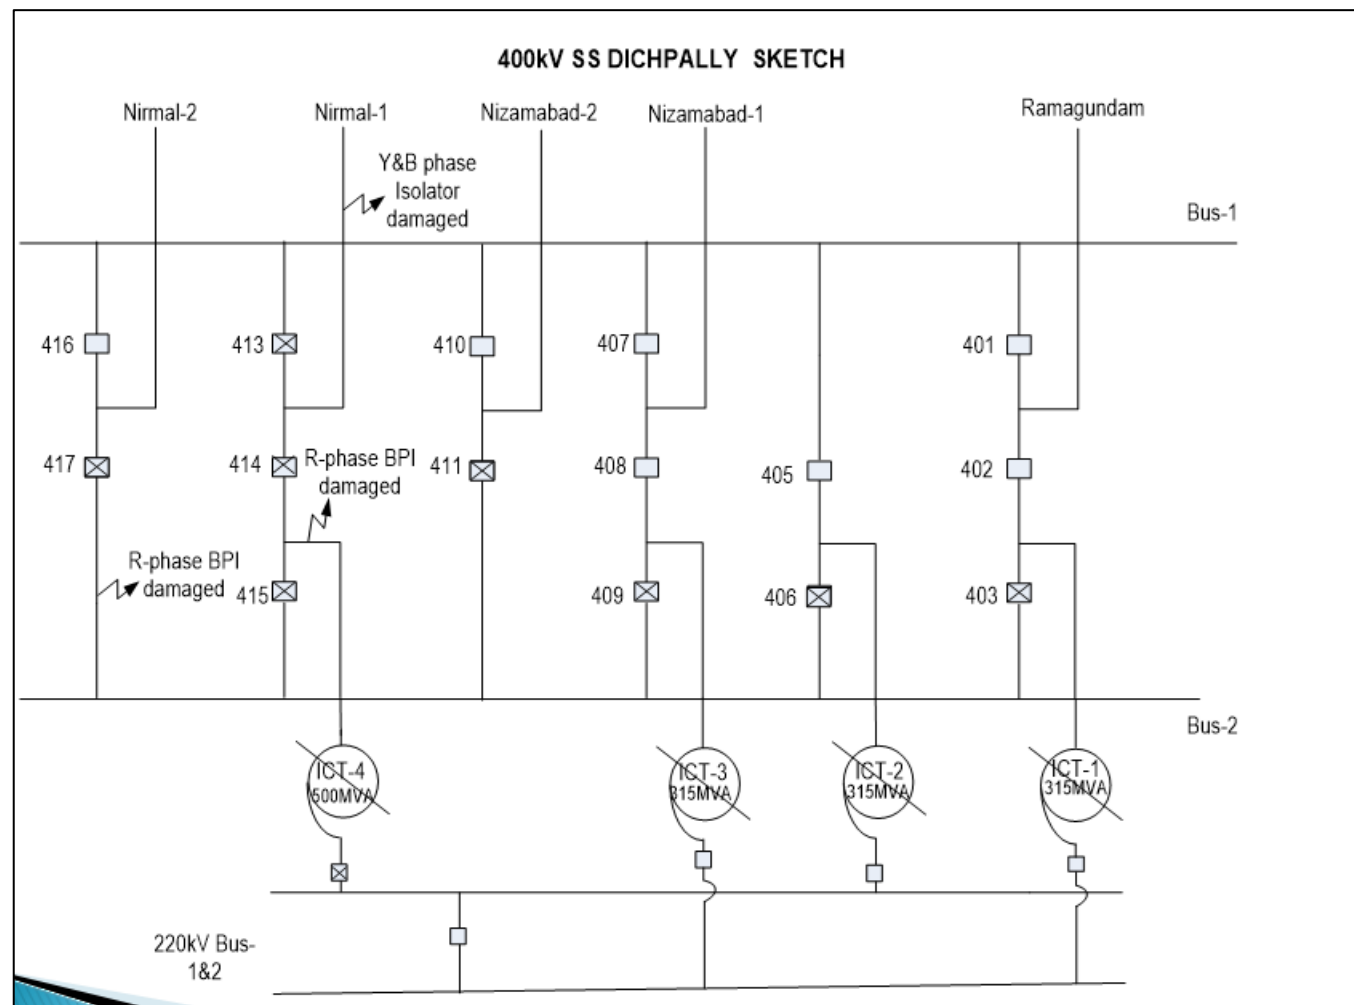
1. TGTRANSCO stated that on 04.04.2026 at 22:26 hrs, a grid incident had occurred at 400/220 kV Dichpally substation due to severe gale and storm, resulting in tripping of multiple 400 kV and 220 kV elements along with equipment damage.

2. TGTRANSCO informed that 400 kV Busbar Zone-2 protection operated and tripped all breakers connected to Bus-2, due to damage of R-phase Bus Post Insulator (BPI) connecting Nirmal-2 Tie Circuit Breaker-417 to Bus-2. It was further informed that 500 MVA ICT-IV tripped on Differential Protection and HV Overcurrent Highest Protection, due to damage of ICT-IV HV side R-phase Bus Post Insulator. Further, 400 kV Dichpally–Nirmal-1 feeder had tripped on B-phase to ground fault, due to damage of Y and B phase line isolators. TGTRANSCO also informed that GPS time synchronisation was not available during the incident.
