## III. Single/Multiple Element Tripping with Protection Violation

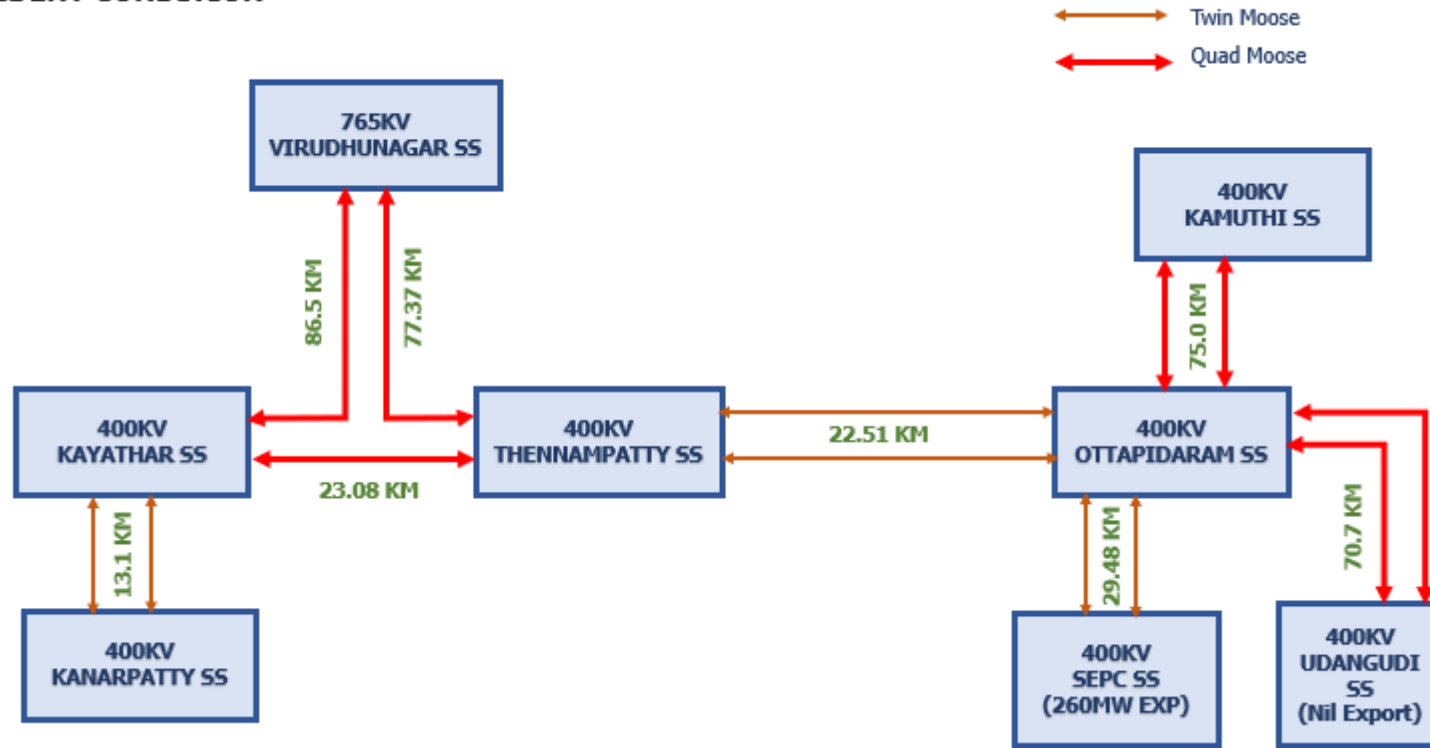
## ANTECEDENT CONDITION

1. TANTRANSCO stated that as per the reports submitted, the triggering incident is a Y-G fault in the 400 kV Ottapidaram – Thennampatti-2 line. At Thenampatty end, the fault did not clear immediately and the fault was being fed through remote lines where 400 kV Kayathar – Thennampatti-1 tripped at Kayathar end and 400 kV Kayathar – Kanarpatti-1, and 400 kV Kayathar – Kanarpatti-2 lines tripped at Kanarpatti end on zone-3 protection. At the same time, SEPC GT-1 tripped on Earth Fault Protection at SEPC generating station.
2. TANTRANSCO presented the Prefault system connectivity as follows.

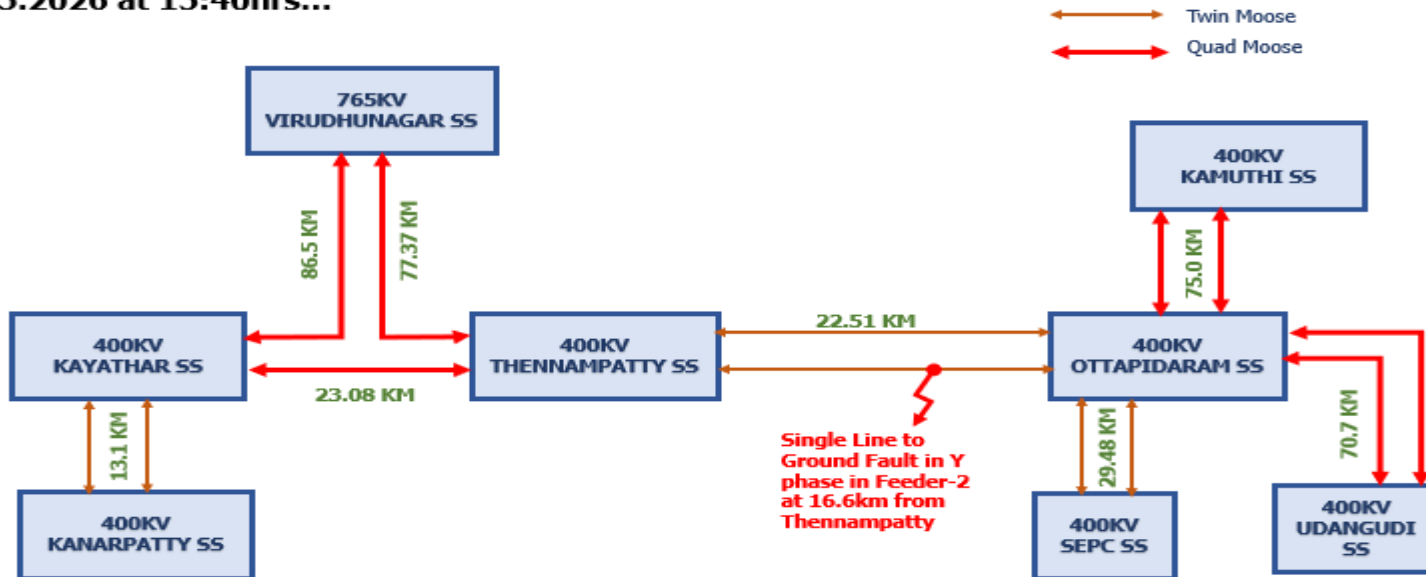
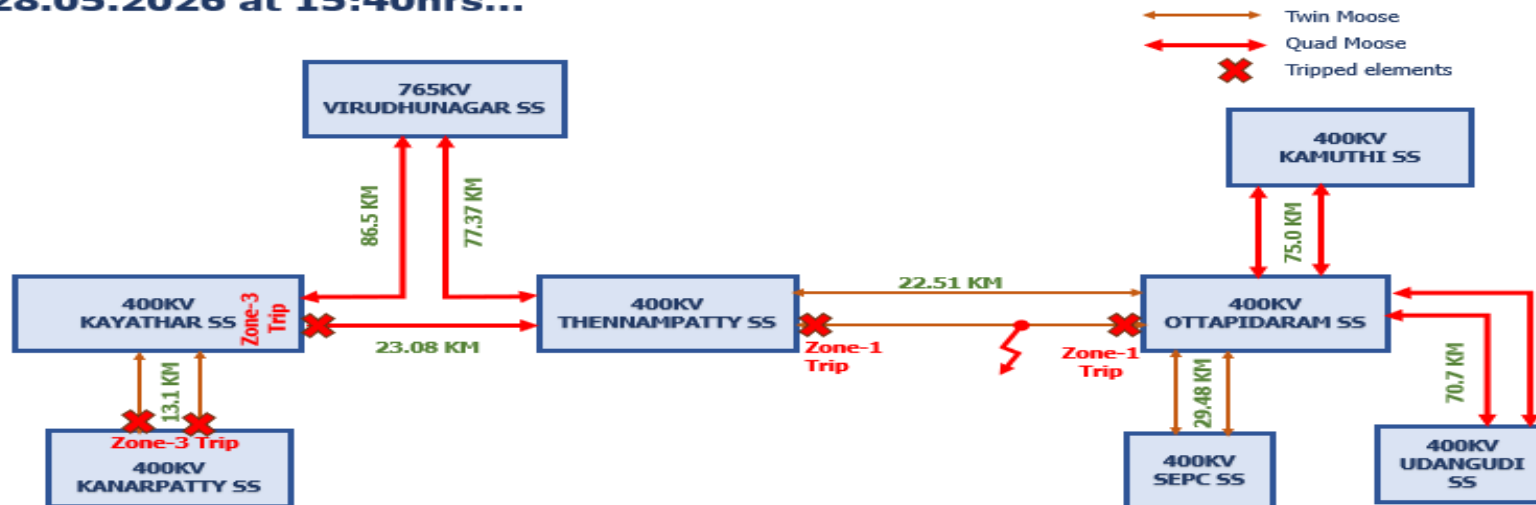
On 28.05.2026 at 15:40hrs...

4. TANTRANSCO informed that Single Line to Ground fault in Y phase (Location – 16km from Thenampatty) on 28.05.2026 at 15.40 hrs.
5. At 400KV Thenampatty end:

- TANTRANSCO informed that, on analysis of the disturbance recorder (DR), both Main-1 and Main-2 relays detected the fault within Zone-1 in the Y-phase and issued a single-pole trip command to the Y-phase breaker.

- TANTRANSCO further informed that the DR recorded a fault current of 8.1 kA in the Y-phase along with a significant dip in the Y-phase-to-neutral voltage to 75 kV (33%). However, despite the Y-phase trip command being issued by the relays, the R-phase breaker pole was found to have opened, as indicated by the reduction of the R-phase-to-neutral voltage to zero, while the fault current in the Y-phase continued to persist.

- At THENNAMPATTY SS, the breaker & relays in 400kV Ottapidaram-2 were tested on 29.05.2026.
- It was observed that in the 400kV Breaker Marshalling box, the R & Y phase cables (both tripping & status wires) were

- The wiring was set right, the breaker single pole trip from both Main-1 & Main-2 relays were checked and operation of the correct breaker pole for each trip was ensured.
- The operation of Auto-reclosure & LBB functions was also tested and found to be in order.

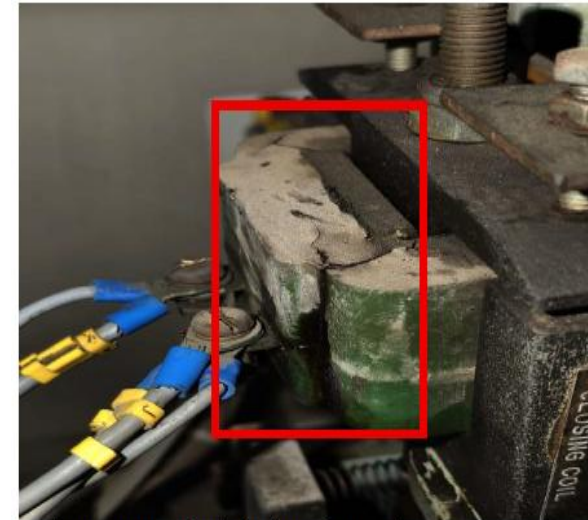
TC1 & TC2 Continuity

Inadvertent Opening/ Closing of CB poles:

- Trip coil-1 & trip coil-2 in R-Ph also got failed due to which DC mixing has happened.
- Cracks Observed on R Phase Close coil. The coil is found to be earthed.

5. In the present incident, fluctuations in the DC voltage were observed due to an issue with the Trip Coil (TC) and Close Coil (CC) circuits. Subsequently, the root cause was identified and rectified in the 252 kV Circuit Breaker (CB). Following rectification, the DC system stabilized and the issue was resolved.

- After Isolation of DC of 252 CB, the Main & TIE CB's verified for Close and open operation. Thereafter, Simhadri-I was taken into service.
- Further Individual Bay SD were availed and verified the IR of all the cables in 1152 & 1252 and no issue noticed.

- However, in 1152 CB, suspected close contactor in control room is replaced as precautionary measure and 1252 CB all wiring were tightened.
- The issue in 252 CB was rectified and CB taken into service and there was no issue observed since then.

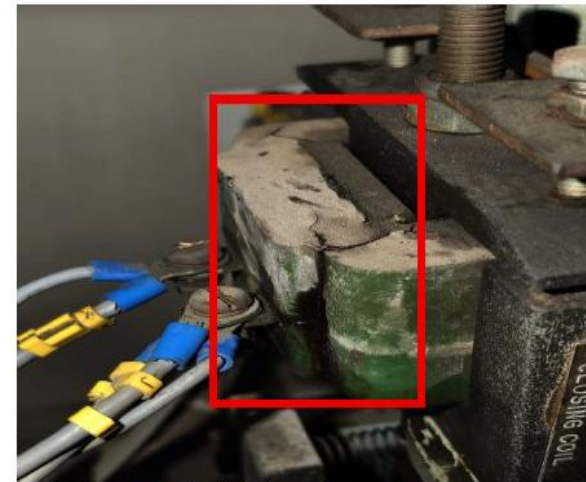
TC1 & TC2 Continuity

Inadvertent Opening/ Closing of CB poles:

- Trip coil-1 & trip coil-2 in R-Ph also got failed due to which DC mixing has happened.
- Cracks Observed on R Phase Close coil. The coil is found to be earthed.
