## Grid Occurrences – 145

### I. Details of Grid Disturbances

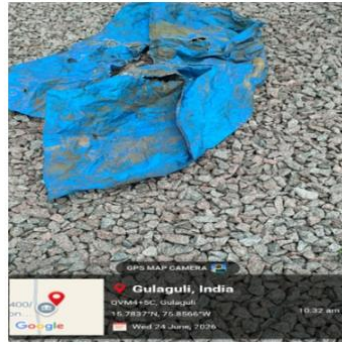
Hence, RSRPL was radially connected through 220kV Bus-2 of Gadag. As per the reports submitted, the triggering incident is R-G fault on 220kV Bus-2 of GADAG PSS possibly due to movement of the tarpaulin which may have resulted in interference with live equipment and resulted in R-G fault in 220kV Bus-2.

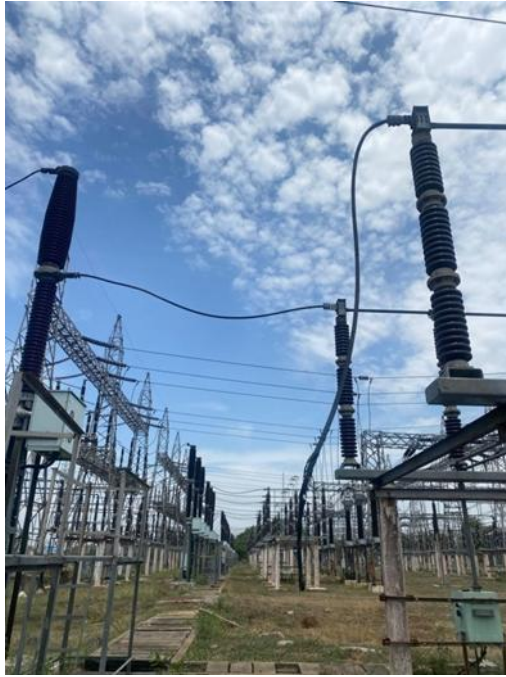
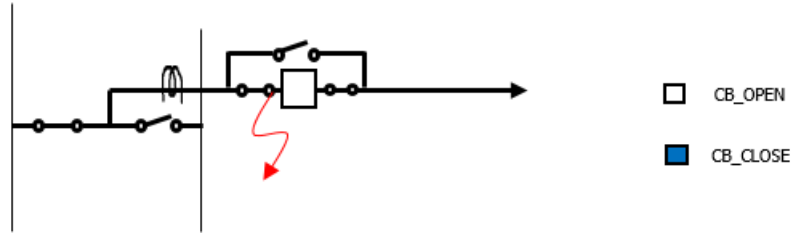
6. TANTRANSCO stated that on detailed analysis they found that Jumper cut & hanged in between feeder 211-89C isolator and feeder breaker Then hanging jumper fell on the structure caused sensing of continuous fault current by the feeder CT until fault is cleared by the feeder LBB protection. All elements connected in Bus A got tripped

#### 7. Remedial Actions Taken:

- Feeder breaker timing test carried out
  - Feeder CB IR value checked when CB is in open condition as well as in closed condition.
  - Defective Y polymer insulator at take off tower attended.
  - Jumper cut in between breaker & 89C isolator attended.
  - Feeder CB LOCAL/REMOTE operation checked and found in order.
8. SRPC enquired about the bus configuration at Hyundai SS. TANTRANSCO stated that Hyundai SS is having 2 sources one is from Sriperumpudhur Bus A as radial feeder (since load). Alternate source is tapped off from 230kV Sriperumpudhur-Koyembedu feeder Which is always open condition

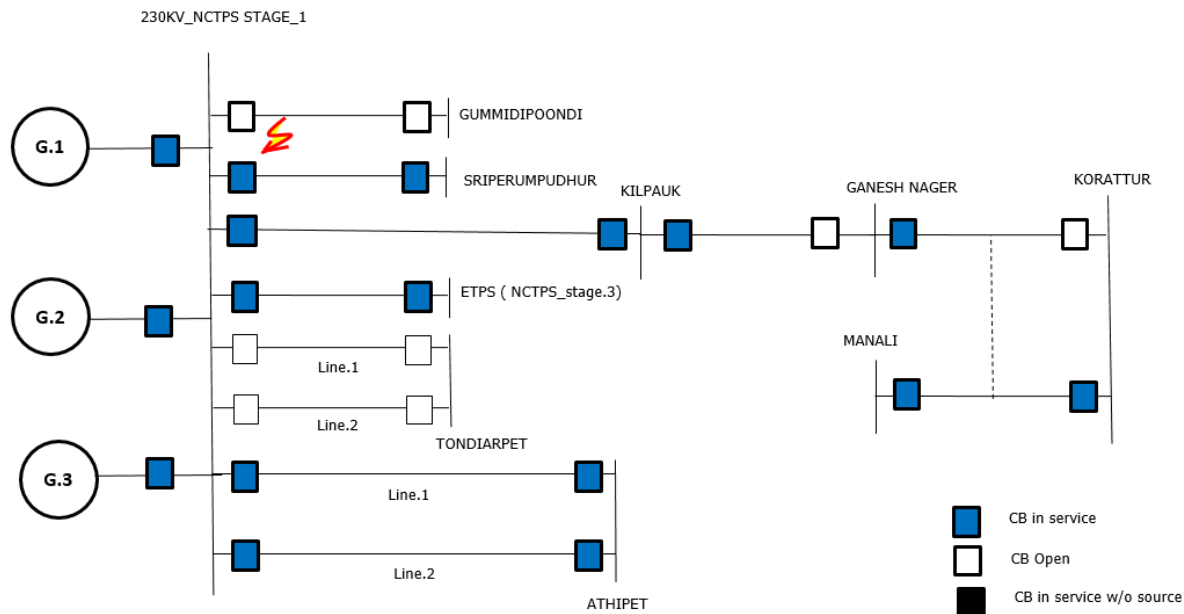
2. TANTRANSCO stated that 230KV-GUMMIDIPOONDI-NCTPS-1 tripped at 08-07-2026 07:20:34:53 and restored at 08-07-2026 17:36 \_ R phase line cut in between Gantry Tower and wall through Bushing at NCTPS switchyard.

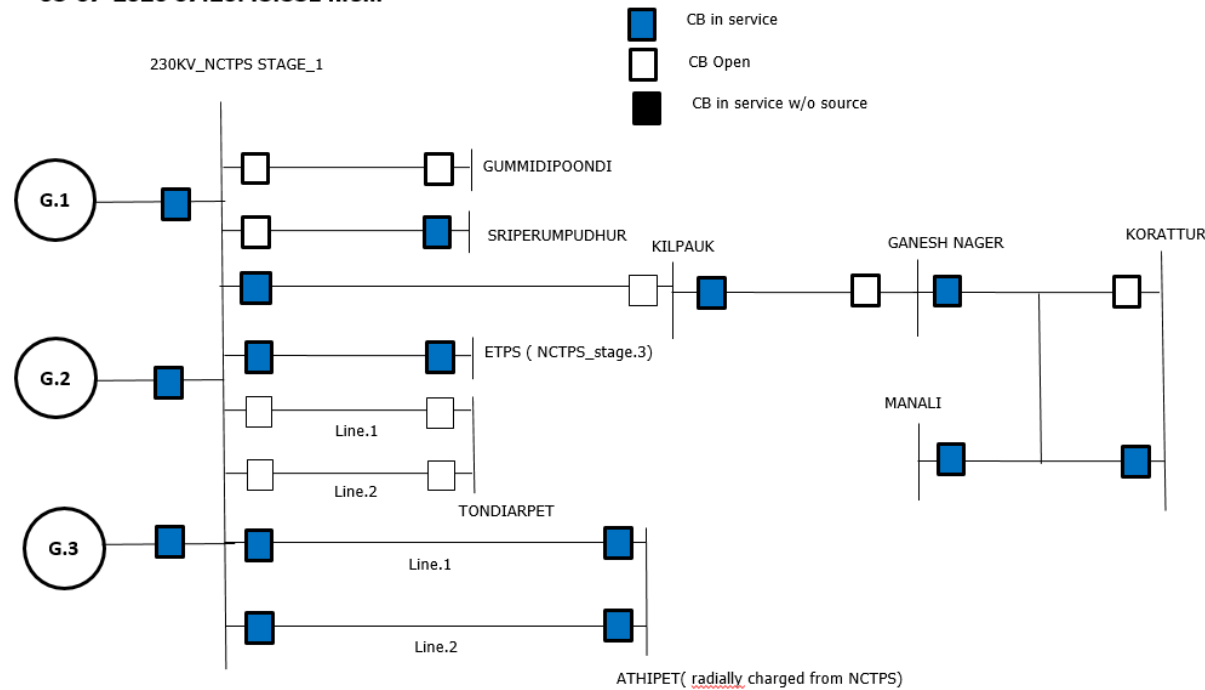
08-07-2026 07:20:48:881 hrs...

5. Further at 07:20:48:881 110kV Manali – Melur (30MW) feeder (Loc.19 Y phase jumper cut). 07:21:01:798 110kV Athipet- Melur feeder (35 MW) near CPCL Y phase Line cut hence Athipet end over current protection operated. 110kV Melur -sothuperumpedu & Panjetty radial charged condition hence no source condition at Melur 110kVSS. Load Loss: 65 MW.

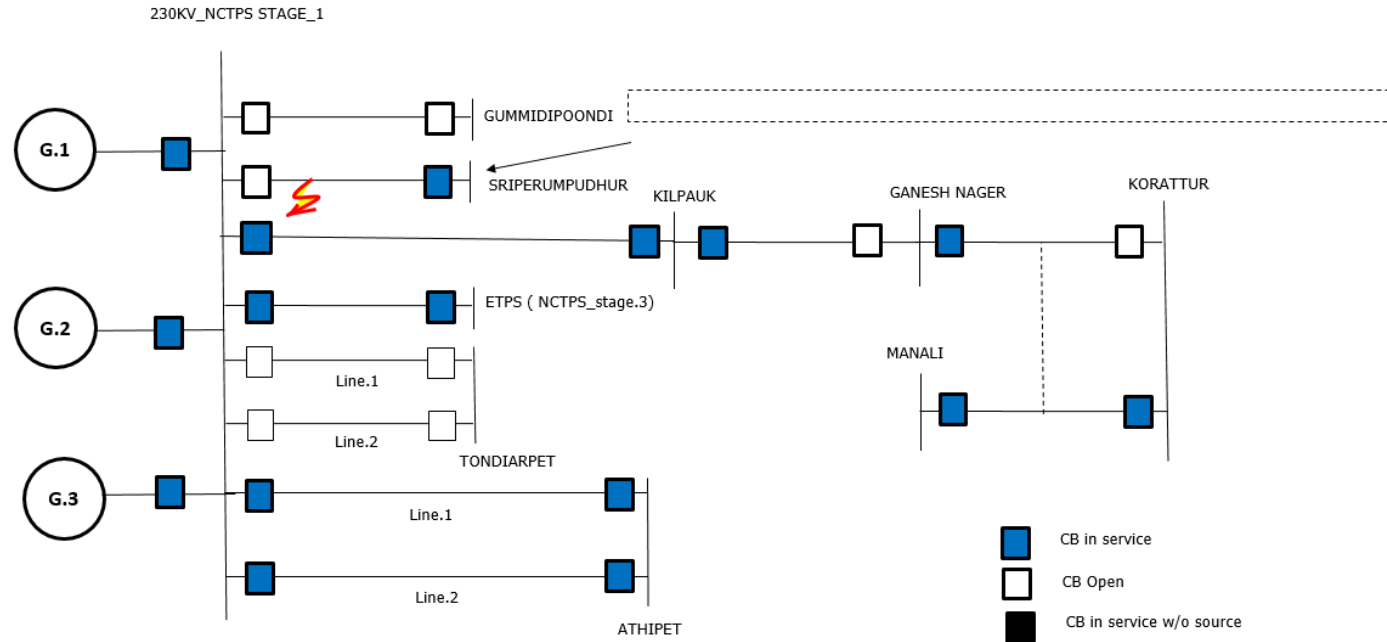
6. After this 230KV-NCTPS-SRIPERUMBADUR\_TN-1 tripped at 08-07-2026 07:20:49: and restored at 08-07-2026 13:40 AR found successful at Sriperumpudhur end. R phase jumper was cut at location No 36.

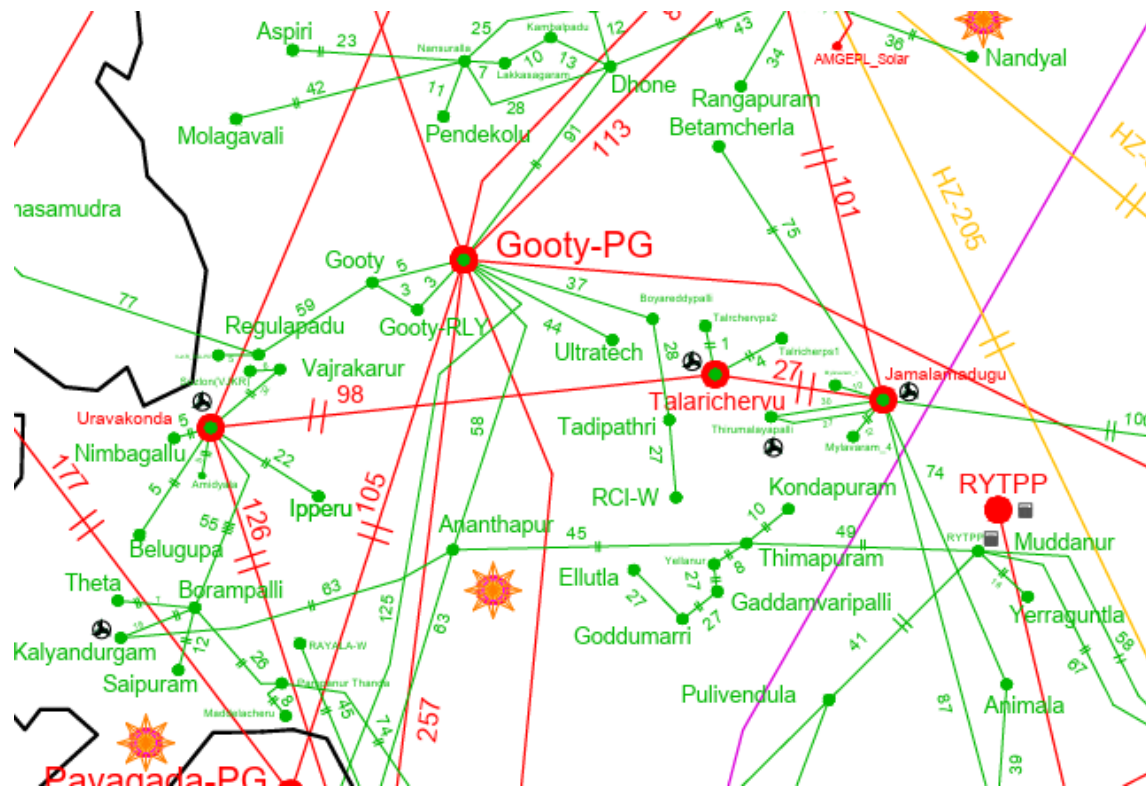
Immediately, 220kV Bus-2 BBP operated and trip signal was extended to all the elements connected to 220kV Bus-2. However, B-phase limb of 220kV Gooty SwS Dhone Line-2, Y-phase limb of 220kV Gooty SwS Boyareddypalli line failed to open at Gooty end due to failure of TC-1 and TC-2 trip contacts of the 96 trip relays. After around 700ms, the faulty section of 220 kV Bus-2 R-phase has fallen on the ground as well as on the bus jumpers of the 220 kV Shapuram line resulting in grounding of all three phases of 220 kV Bus-2 causing RYBG fault in 220kV Bus-2. During this fault LBB initiated in 220kV Gooty Dhone Line-2 and 220kV Gooty Boyareddypalli lines and LBB operated again in 220kV Bus-2. However DT was not extended to remote ends of these lines. This fault was sensed in zone-2 in the remote ends of 220kV Gooty Dhone Line-2 and 220kV Gooty Boyareddypalli lines. This led to loss of power supply to 220kV Bus-2 odf 220kV Gooty SwS.

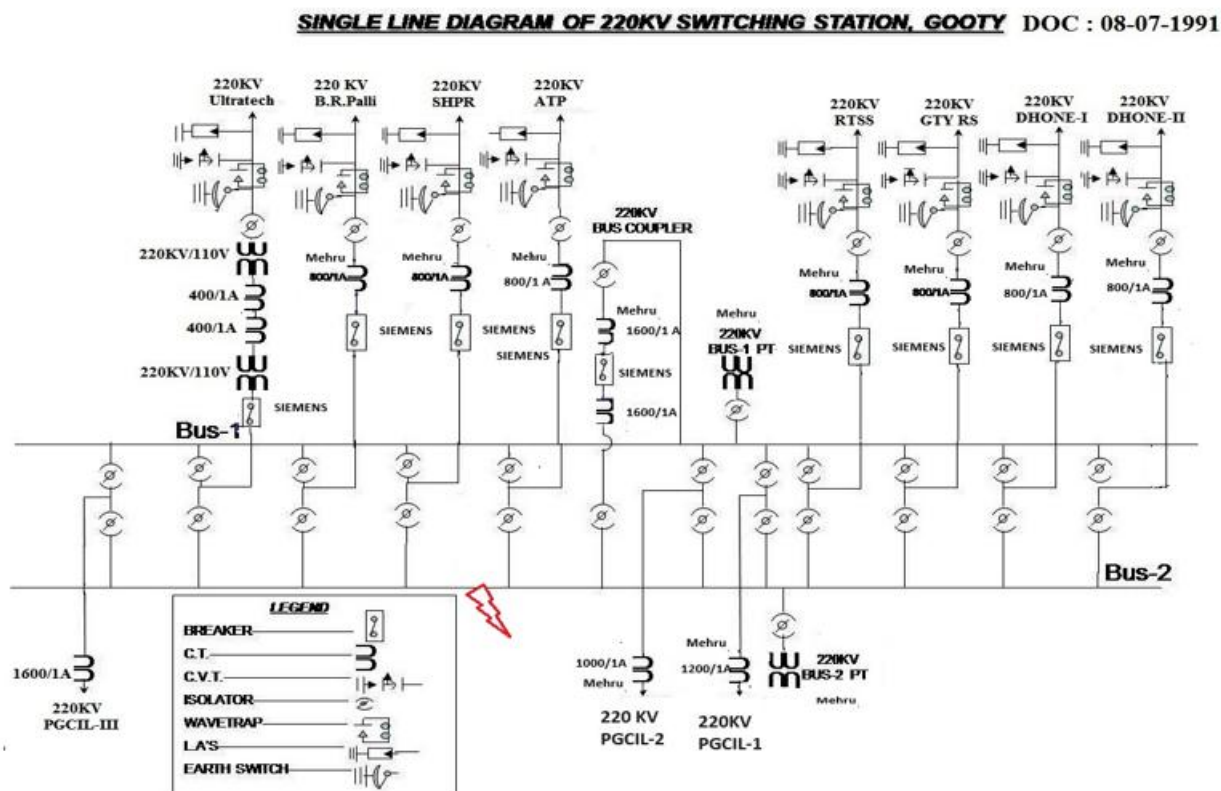
1. APTRANSCO stated that in the Antecedent conditions: Bus-1 elements : Dhone-1 , Gooty RS , Anantapur, ICT-3 Bus-2 elements : Dhone-2 , Gooty RTSS , ICT-1&2, Shapuram, Boyareddypalli , Ultratech . BUS coupler is in closed condition.

2. APTRANSCO stated that the Triggering incident occurred at 07:38 Hrs. 220 kV Bus-2 R-phase fault occurred due to flashover of the disc insulator string in 220 kV Bus-2 protection zone (between 220kV Shapuram and 220kV Boyareddypalli feeders).

3. APTRANSCO stated that for the above fault, 220kV Bus-2 Bus bar protection was operated and trip extended to all the connected elements. Y-ph circuit breaker limb of 220 kV Dhone-2 line at 220 kV SWS Gooty end did not trip due to failure of Y-phase TC-1 and TC-2 trip contacts of the 96-trip relay pertaining to 220 kV Dhone-2 line in the 220 kV busbar protection panel.

4. The B-ph circuit breaker limb of 220 kV Boyareddypalli line at 220 kV SWS Gooty end did not trip due to failure of B-phase TC-1 and TC-2 trip contacts of the 96-trip relay pertaining to 220 kV Boyareddypalli line in the 220 kV busbar protection panel.

9. Remedial action taken:
  - The damaged disc insulator string and bus jumpers were replaced.
  - The faulty busbar trip relays (96) pertaining to 220 kV Dhone-2 line and 220 kV Boyareddypalli line were replaced with the available spare relays in the 220 kV busbar protection panel after testing by availing line clear on the respective lines.

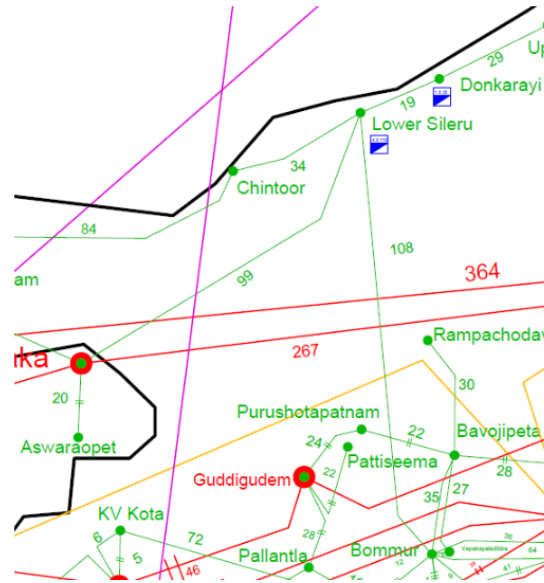
As per the reports submitted, the triggering incident was a circuit breaker closure after hand tripping within around 150-200ms during de-paralleling of Unit-

4 at the LOWER SILERU end. Since hand tripping of the units have been mapped to LBB initiation, and due to the current after the breaker closure led to the Local Breaker Backup (LBB Zone-2) protection operation and all the elements connected to Bus-2 got tripped (220kV Asupaka–Lower Sileru-1, and 220kV Lower Sileru–Chinturu-1) at Lower Sileru end. From the DR data, DT was sent to Asupaka end for 220kV Asupaka–Lower Sileru-1. At the ASUPAKA end, DT was not received and the line was holding. There was no load loss or generation loss during the event.

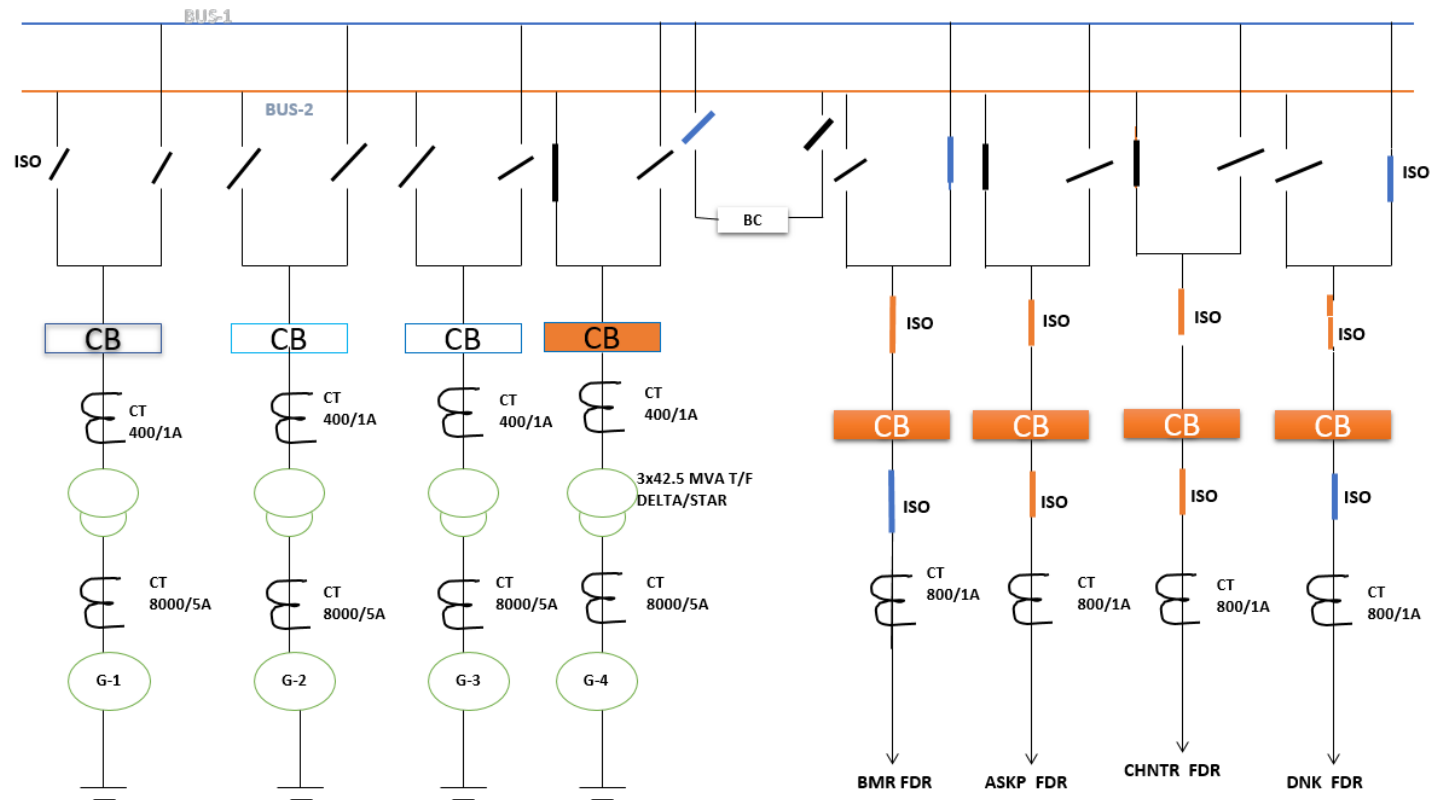
#### **BUS CONNECTED ELEMENTS DURING ANTECEDENT CONDITION**

1. APGENCO stated that in the Antecedent condition the Bus-Coupler Breaker in open Condition. The 220 KV Bommuru and Donkarayi feeders on Bus-1, The 220 KV Asupaka feeder, Chinthuru feeder and Unit-4 on Bus-2.

2. APGENCO stated that as per APLD instructions following sequence of operations are carried out
  - At 00:21 Hrs., the Unit-3 de-paralleled.
  - At 00:53 Hrs., the Unit-2 de-paralleled.
  - At 01:33 Hrs., the Unit-4 de-paralleled.
  - While hand tripped the Unit-4 Breaker, LBB Zone-2 Protection Operated at Lower Sileru end causing 220 KV Lower Sileru-Chinthuru and Lower Sileru-Asupaka feeders tripped at Lower Sileru end.
3. APGENCO stated that restriking current was observed within 150–200 ms, following which the backup trip operated. SRPC enquired about the non-

operation of the Re-trip function. APGENCO clarified that the LBB timer is initiated following any trip command and, since the current was observed after approximately 150 ms, the Re-trip timer had already elapsed, resulting in direct operation of the backup trip.

4. Remedial action taken: Since a spare breaker was not available, maintenance of the Unit-4 breaker was carried out and its opening and closing operations were checked and found satisfactory.

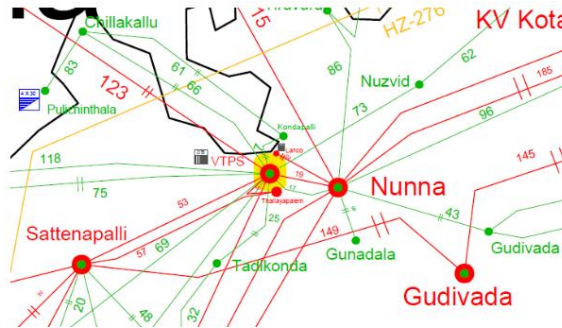
As per the reports submitted, the triggering incident is R-G fault on 220KV-VTPS-CHILLAKALLU-2 line. At VTPS end, the fault was detected in Z1 and breaker auxiliary contacts of all three phases indicated open status, however it failed to interrupt the fault current which persisted for more than 200ms. LBB operated after around 260 ms and gave trip command to CB of all bays of 220kV Bus-2 of VTPS. However, CB of 220KV-VTPS-NUZVID-1 line failed to open and was feeding the fault on 220KV-VTPS-CHILLAKALLU-2 line. After another 800ms, 220KV-VTPS-NUZVID-1 was tripped from remote end suspectedly on Z3 trip based on the time delay. During the same time units connected to (Unit-2,3 and 6) also tripped and further Unit-5 tripped on Flame Failure leading to a generation loss of around 620MW.

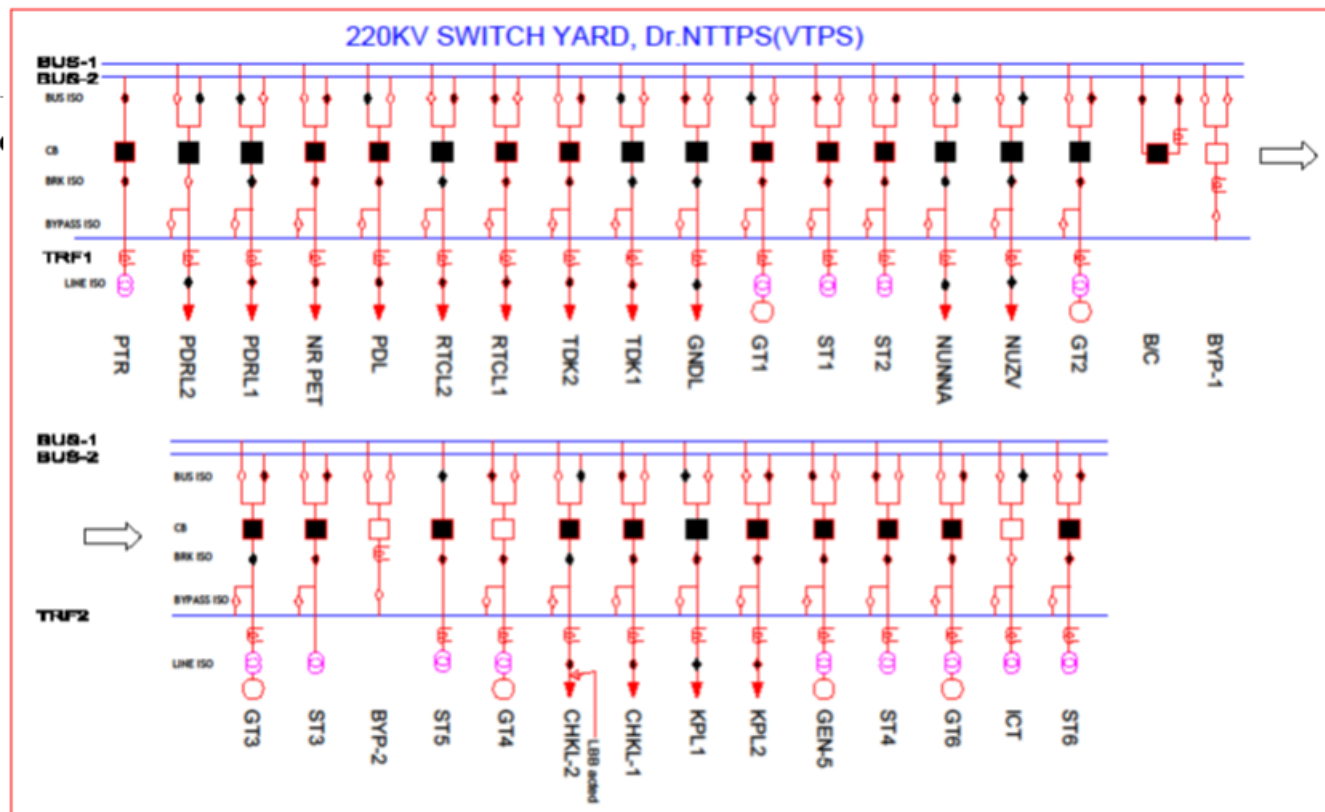
1. APGENCO stated that in the antecedent conditions at 220KV VTPS they have Two Main BUS with Bus coupler and Transfer Bus arrangement. Always the Bus coupler is in closed condition.

2. APGENCO stated that on 21.06.2026, R-G fault occurred in 220kV VTPS Chillakallu-2 Line. At VTPS end, R-pole open feedback has come but current in the R-phase persisted for more than 200msec.Hence LBB to operated and all elements connected to the Bus-2 tripped. This led to the Tripping of 220kV Bus-2.
3. Remedial action taken:
  - The Chillakallu-2 feeder kept on Transfer bus on 21.06.2026 at 14.54Hrs. The faulty CB has to be replaced with new CB.
  - The SF6 gas quality is being tested for the remaining CBs with the SF6 gas quality analyzer.
  - Wherever SF6 gas quality is found abnormal, SF6 gas will be replaced with fresh gas.
  - New CBs procurement is under process. CBs which are working for more than 20 years will be replaced with new CBs

4. SRPC enquired about the non-issuance of Direct Trip (DT) to the remote end. APGENCO stated that OP Relay-3 had been assigned instead of OP Relay-4 in the Busbar Bay Unit. The configuration has since been rectified and OP Relay-4 has been assigned.

5. SRPC enquired about the delayed opening of the Nuzvid feeder breaker. APGENCO stated that a delay in opening of the R- and Y-phase poles of the Nuzvid feeder breaker was observed. The circuit breaker was overhauled, during which the valve seats, rollers and O-rings of all phases were replaced, and the mechanism was lubricated. Further, the SF6 gas quality was checked and the circuit breaker was tested by initiating protection trip commands and verifying the breaker operating times. The breaker was found to be healthy.

***✚ APGENCO requested to expedite the Breaker replacement.***

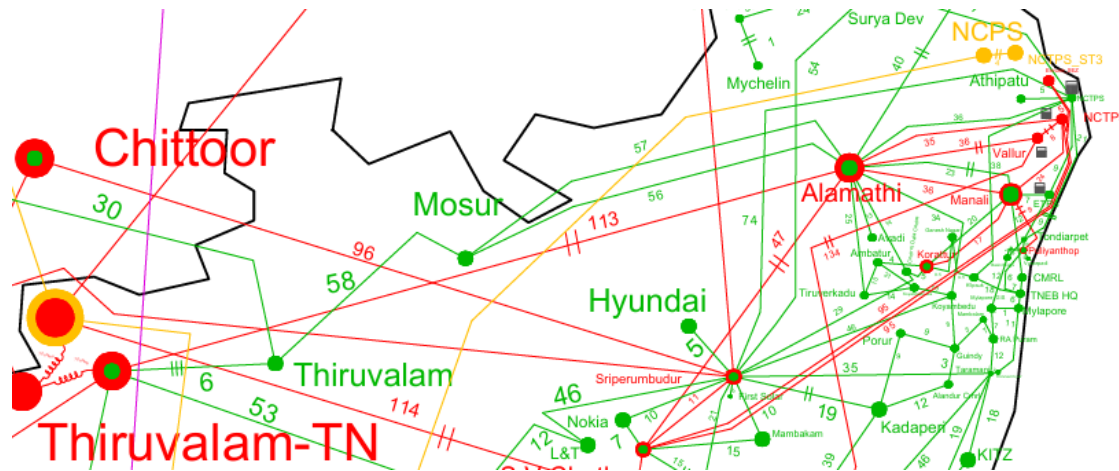
As per the reports submitted, the triggering incident is the operation of the 400 kV Bus Bar Protection (High Impedance Scheme) at 400 kV Alamathy Substation. Before the event, the Main CB of the 400KV-ALAMATHY-SUNGAVARACHATRAM-2 was out of service due to a bus isolator defect, and the line was kept in service through the Tie CB. During the event, the Bus Bar Protection operated and only the Main CB of Bus-B tripped. All other elements remained in service through the Tie CB. No visible fault was observed at the substation.

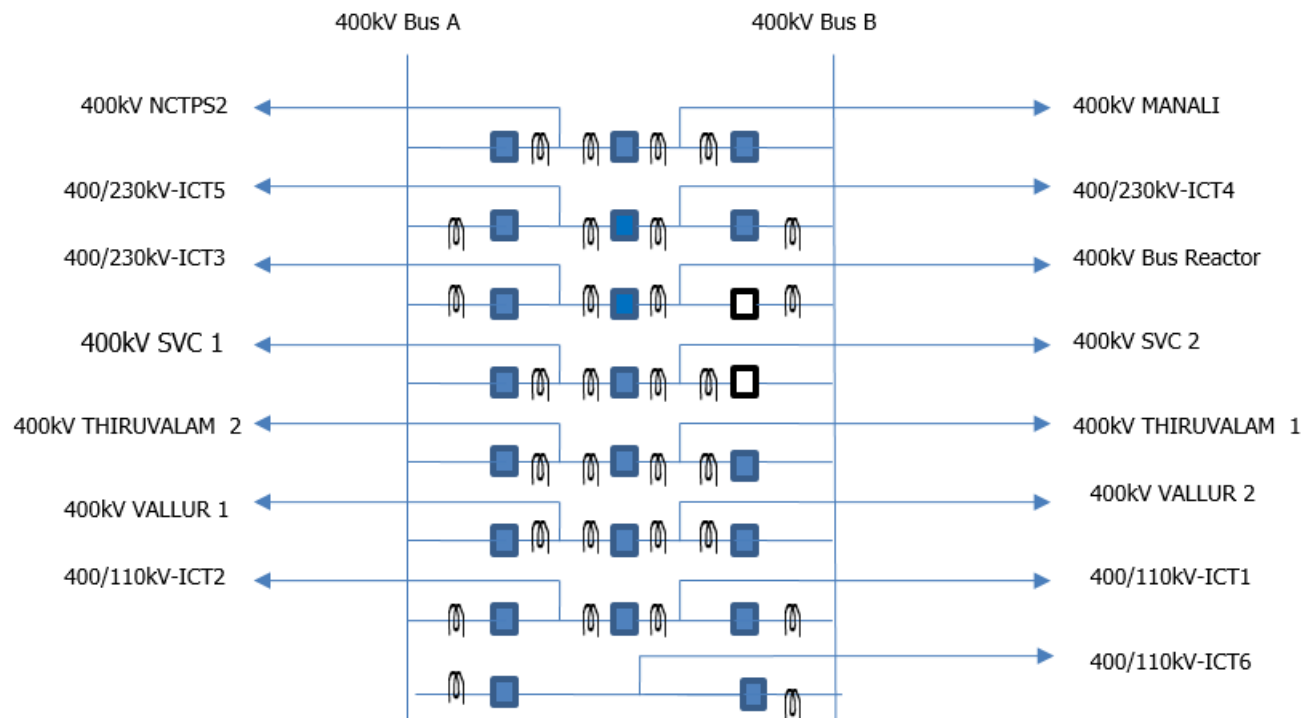
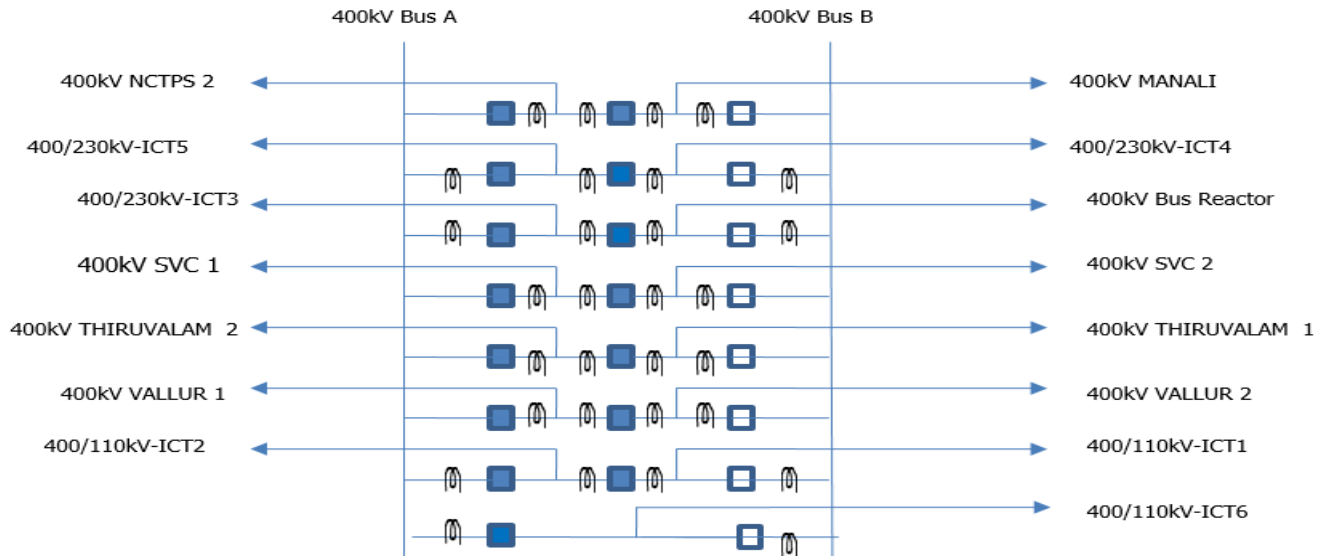
2. TANTRANSCO stated that on 26-06-2026 at 19:22 hrs spurious tripping of high Impedance BBP.2 observed in 400kV Bus B. During the incident No fault was observed. All elements were in service through Tie breaker. ICT 6 was in service through main breaker of Bus A.

- Yard condition checked and no visible fault Noticed.
- 400kV Bus B test charged through 400kV Thiruvallam.1 on 26-06-2026 at 23:41 hrs & stood OK
- Numerical BBP relay allotted , Configuration completed & Cable laying pending addressed to System operation wing.

**TANTRANSCO to expedite the replacement of static relay with numerical relay.**

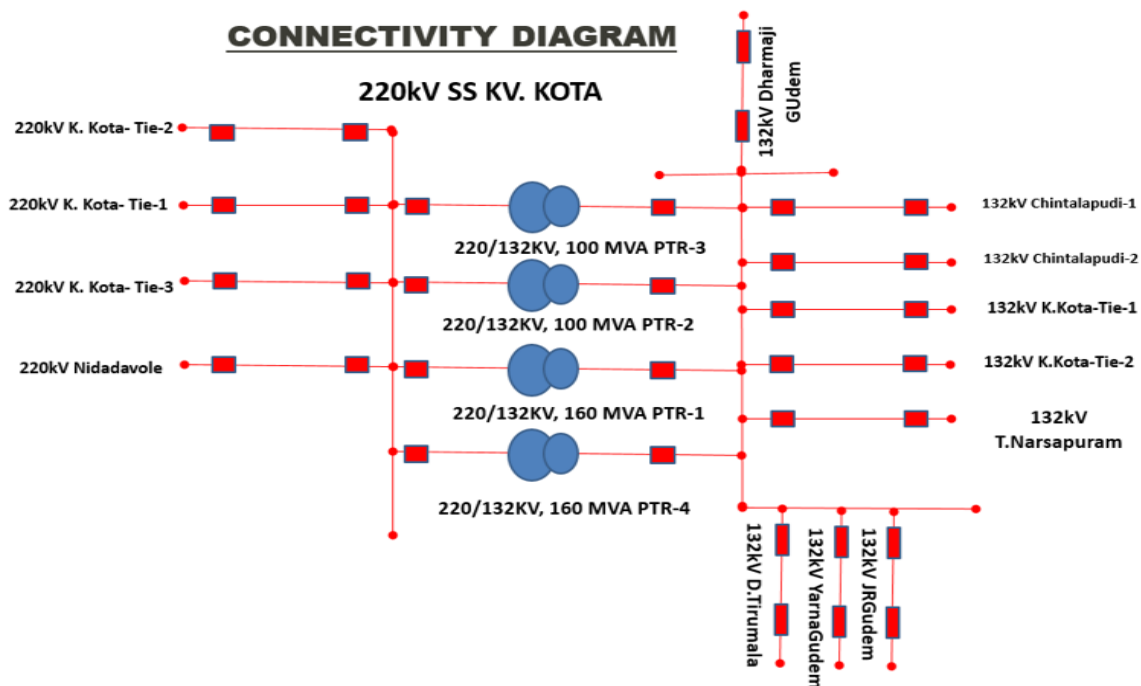
## SLD OF 220kV SS, KV KOTA

2. APTRANSCO stated that there was no fault in Bus protection zone. Failure of CT cable pertaining to the 220kV Nidadavolu feeder bay resulted in operation of B-Ph Bus bar protection. For this 220kV Bus bar protection operated and tripped all the connected elements.
3. Remedial Action taken: Failed CT cable was replaced with healthy cable. Ensured healthiness of BBP.
4. SRPC enquired the reason for single bus configuration at KV Kota SS. APTRANSCO stated that due to space constraints double bus configuration is not feasible.
5. SRPC requested APTRANSCO to verify the healthiness of control cables at KV Kota SS.

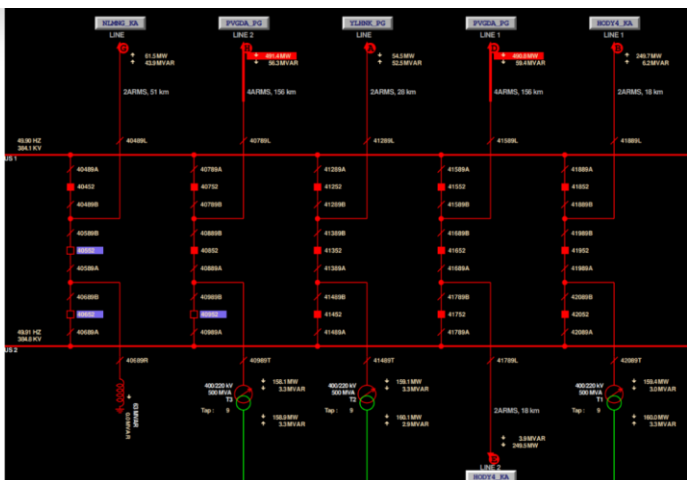
400kV Devanahalli SS is equipped with one and half breaker scheme with the configuration as shown above. As per the reports submitted, 400/220kV ICT-2 was under maintenance for relay calibration. During testing activity and current injection in the differential relay where in the differential protection operated and since the current was persisting during testing, LBB bus trip command operated (which should have been disabled during testing) and tripped all the main breakers connected to Bus-2 and further also tripped the tie breaker of ICT-3. This led to the Tripping of 400kV Bus-2 at Devanahalli of KPTCL and 400/220kV ICT-3 at Devanahalli. 400kV Bus-1 was in service and due to one and half breaker scheme, all elements other than 400/220kV ICT-3 were in service during the event.

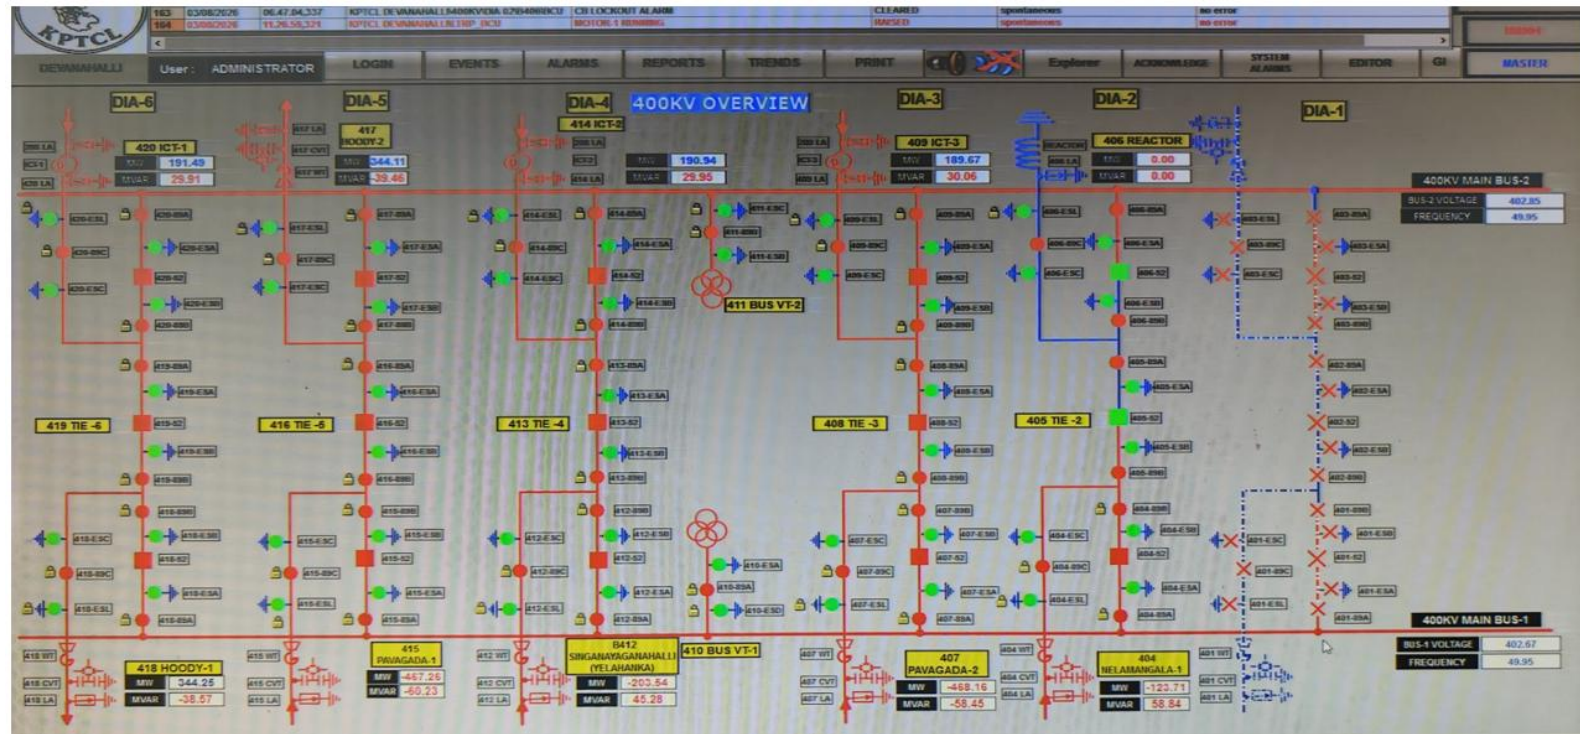
**Elements under Scheduled Outage:** ICT-2, 400kV Main & Tie CBs (414 & 413) were kept open due to scheduled outage availed for maintenance work. All other main CBs and Tie CBs were in closed condition.

2. KPTCL stated that on 05-07-2026 at 12:03 Hrs; Restoration time: 05-07-2026 12:32 Hrs. Main and Tie CBs of 500 MVA ICT-2 were kept open due to scheduled outage taken for regular maintenance works. While testing the differential relay of ICT-2, LBB operated and tripping was extended to all the Main CBs of 400KV Bus-2. Tie CB of ICT-3 also tripped during the incident resulting in outage of 500MVA ICT-3, however no load was affected since ICT-1 and 3 were operating in parallel.
3. **Remedial Measures taken Details:**
  - At Devanahally, LBB is enabled through the main protection relays of individual relays. Directions have been given to the concerned testing team to take appropriate measures while carrying out testing of relays during switchyard in live condition. SOP to be followed and adequate checks to prevent

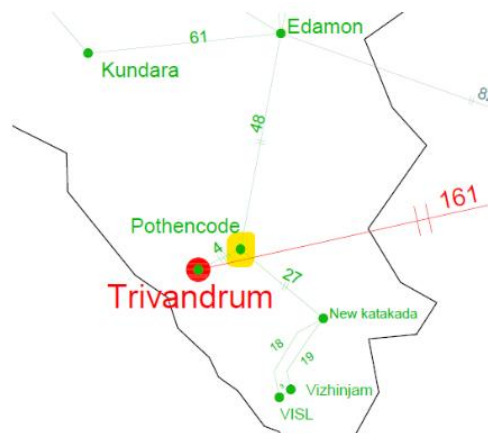
As per the reports submitted, the triggering incident is Y-G fault caused by flashover of Y-phase tension insulator of 220kV Bus-1 (near 220KV-TRIVANDRUM-POTHENCODE-1 feeder). This resulted in the operation of busbar differential protection and tripped all elements connected to 220kV Bus-1 (including Bus-3 which is permanently coupled to Bus-1) of POTHENCODE SS of KSEB. 110kV was in service during the event. Therefore no load loss is observed.

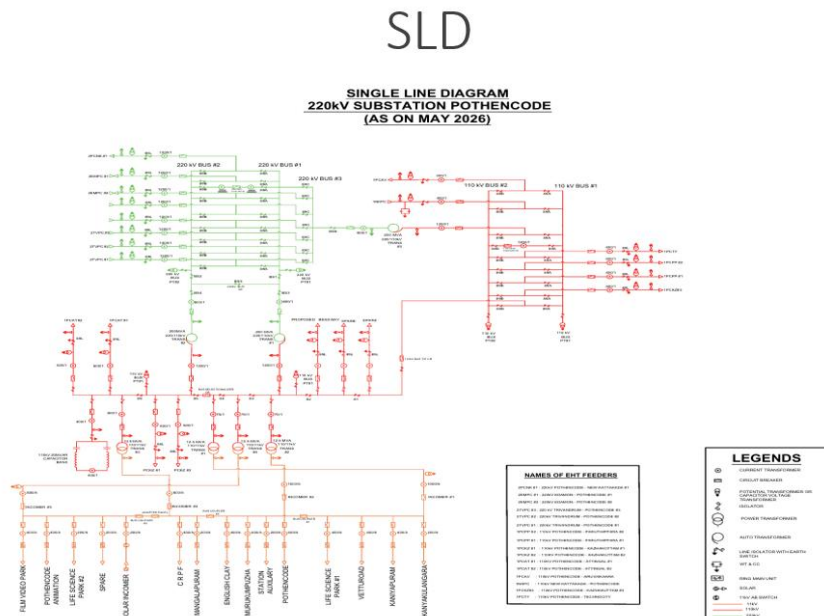
2. KSEBL stated that a Grid Incident of 220kV Busbar operation resulting in a partial outage of 220 kV Substation Pothencode occurred on 05.07.2026 at 16:59 hrs. The incident was initiated by the flashover of the Y-phase tension insulator of 220 kV Bus #1, located near the 220 kV Trivandrum–Pothencode #1 feeder bay, flashed over at 220 kV Pothencode Substation.

3. The fault resulted in the operation of the 220 kV Bus Bar Protection Scheme (Bus bar Zone 1) at Pothencode Substation and subsequent tripping of all connected transmission elements, causing a partial outage of the substation.

4. KSEBL stated that the operation of the 220 kV Busbar Protection was found to be correct. The fault occurred in the vicinity of the 220 kV PGCIL Trivandrum Pothencode No. 1 feeder due to the flashover of the Y phase tension insulator. Since the fault was located within the protection boundary of 220 kV Busbar Zone 1, the Busbar Protection correctly identified the fault and tripped all the elements connected to the affected zone, thereby successfully clearing the fault.

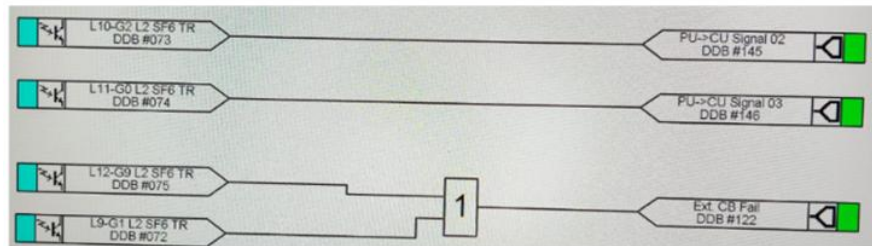
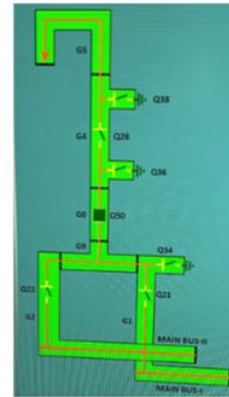
In the antecedent conditions, due to Bus split and idle charging of the lines on power regulation, the connectivity at NNTPP is as shown above, where in the region in yellow is being fed through NNTPP ICTs and each ICT was loading around 360MVA (around 76%) each. As per the reports submitted, during the testing of SF6 gas pressure interlock checks in 400 kV GT-2 (G0) bay at NNTPP during SAS upgrade works, during which due to a logic mapping error in the GT-2 bay relay, where in the feedback which has to be sent as LBB initiation (External CB Fail) but sent the signal to BBP CUB as BBP operation as shown below.

Hence due to the BBP operated in 400kV Bus-2 and all the elements connected to Bus-2 (400 kV NNTPS–Ariyalur-2 feeder, 400 kV NNTPS–Pondy feeder, ICT-2, and the 400 kV Bus Coupler).

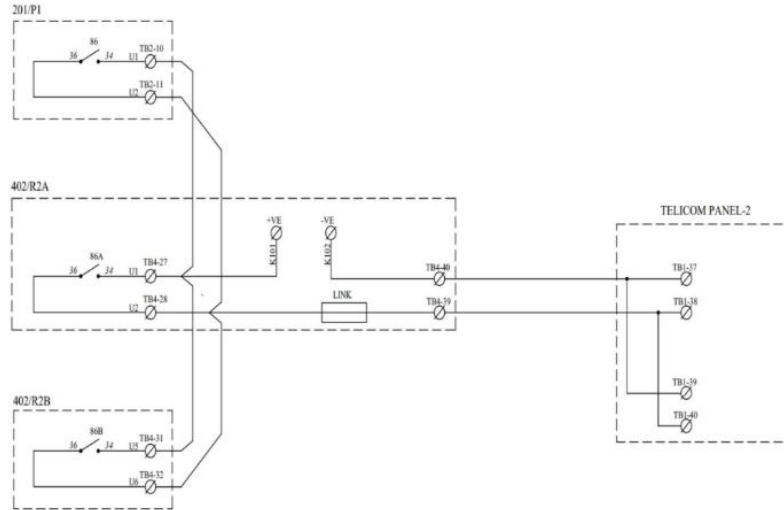
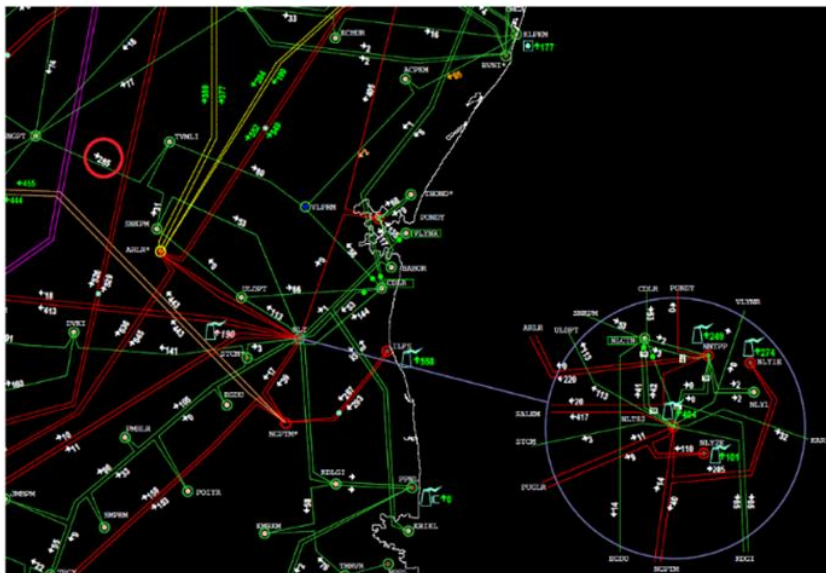
However, it is to note that the SPS envisaged for the over loading of NNTPP did not operate during the event.

The Special Protection Scheme (SPS) failed to operate as the mapping was only through 86, and since BBP operated, the SPS failed to operate.

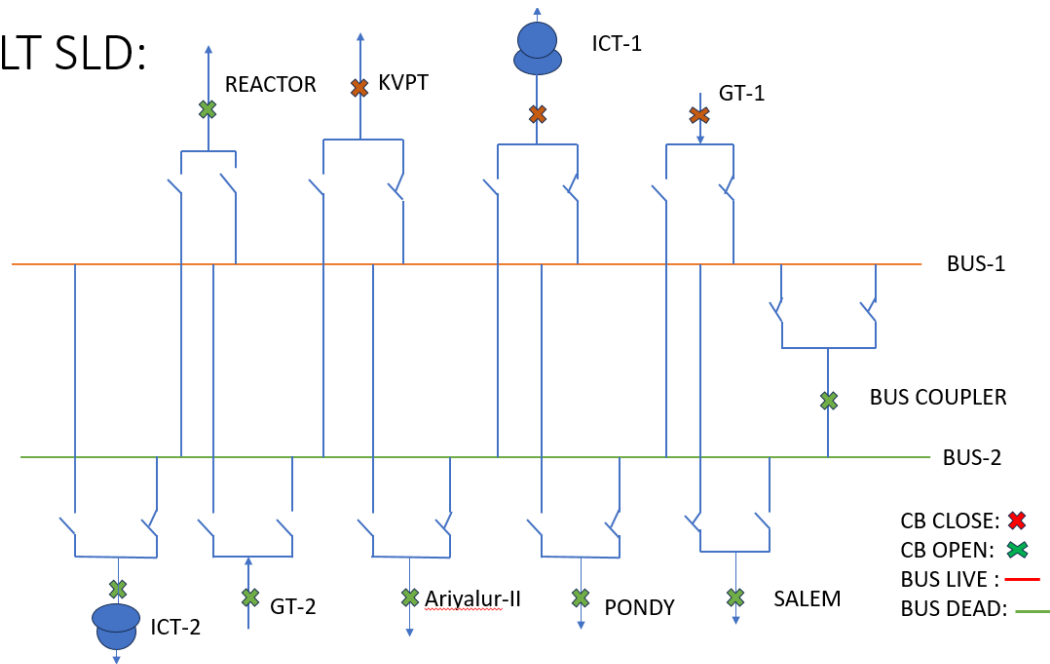
## FAULT SLD:

2. NNTPS stated that At 13:03hrs on 10-07-2026 bus-2 cleared due to bus bar protection During the SAS upgradation works in the 400 kV GT-2 bay, SF6 gas pressure interlocks were being checked in the G0 compartment (Circuit Breaker compartment).
3. While carrying out the pressure interlock testing, a busbar trip command was inadvertently generated from the CUB relay upon receiving a signal from the PUB relay of the GT-2 bay, resulting in the tripping and clearance of 400 kV Bus-2
4. The feeders (ICT-2, Pondy & Ariyalur-II) which are connected to BUS-2 are tripped and BUS coupler tripped.Following the tripping of ICT-2, its entire load was transferred to ICT-1. Due to the sudden increase in loading, ICT-1 became overloaded and subsequently tripped. The cascading tripping resulted in the complete blackout of the 220 kV system.

- Checked the relay events and DR it was found that G0 compartment SF6 L2 trip signal is wrongly mapped.
- PSL logic was modified and system restored in both 400 & 220kV.
- ICT-2 tripped due to Busbar Protection operation through the 96 Lockout Relay. Since the 96 Lockout Relay contact was not incorporated in the existing SPS logic, the SPS scheme did not operate following the ICT-2 trip.
- Consequently, the required load shedding was not initiated, resulting in the entire load of ICT-2 being transferred to ICT-1.
- The sudden increase in loading caused ICT-1 to become overloaded and subsequently trip, leading to a cascading disturbance and blackout of the 220 kV system
- In Modified SPS scheme, 96 relay contacts and breaker open contacts also considered.
- SPS system wiring modifications will be completed during the upcoming ICT shutdown planned for SAS upgradation works

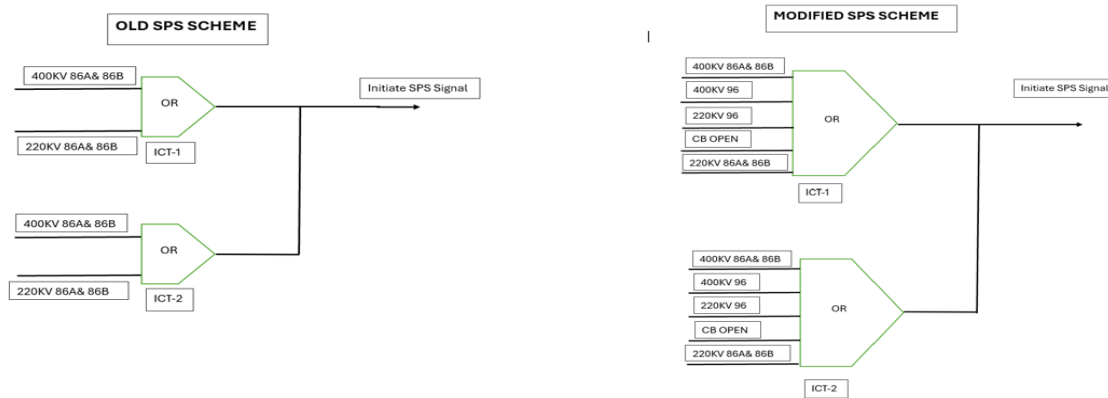
# SPS SCHEME

- SRPC enquired whether the SPS operation is verified after logic change. NNTPS stated that the SPS system wiring modifications will be completed during the upcoming ICT shutdown planned for SAS upgradation works and will update the forum after completion.
6. SRPC requested NNTPS for strict adherence to SOP during testing and maintainance activities.

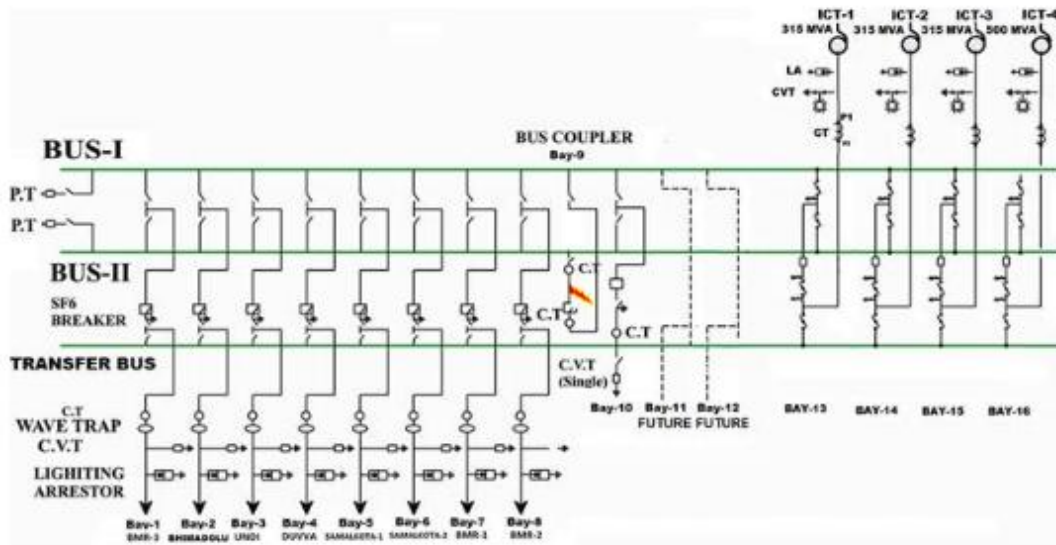
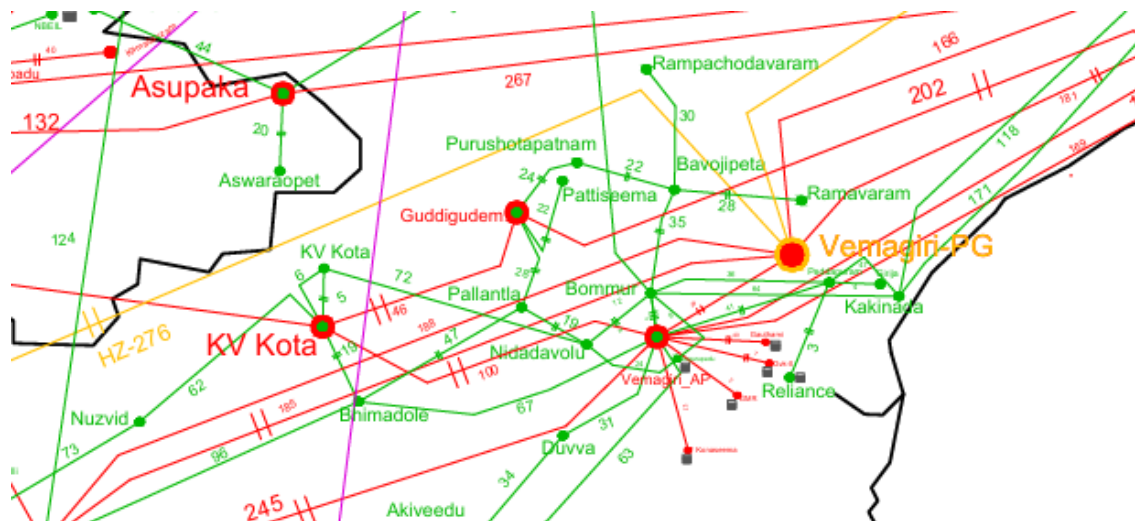
As per the submitted reports, the triggering incident was an R-G fault on the 220 kV Bommuru–GVK feeder at 11:52.13hrs . At Bommuru end, the fault was sensed in zone-1 with a fault current of 21kA. A/R operated and was unsuccessful. During the fault, a major portion of the fault current was contributed by the Vemagiri 220 kV bus through the 220 kV Vemagiri Bommuru Line-1 Line-2, and Line-3 feeders. Consequently, at 11:52:49hrs, the quad moose jumper between the CB and the Bus-2 CT in the 220 kV Bus Coupler bay of 220kV Vemagiri SS became disconnected from the CT stud along with its metal clamp and fell onto the supporting structure of the post-type insulator, resulting in an R-phase bus fault. As a consequence, the 220 kV BBP operated, tripping both Bus-1 and Bus-2 along with all the elements connected to the respective bus sections including 400kV/220kV Vemagiri ICT-1,2,3&4. This led to tripping of 220kV Bus-1 & Bus-2 of 220kV Vemagiri SS.

Tripping of the Vemagiri ICTs led to over loading of 400kV/220kV Guddigudem ICT-1 and ICT-2, which subsequently tripped on three-phase overcurrent protection.
