## Grid Occurrences – 145

### I. Details of Grid Disturbances

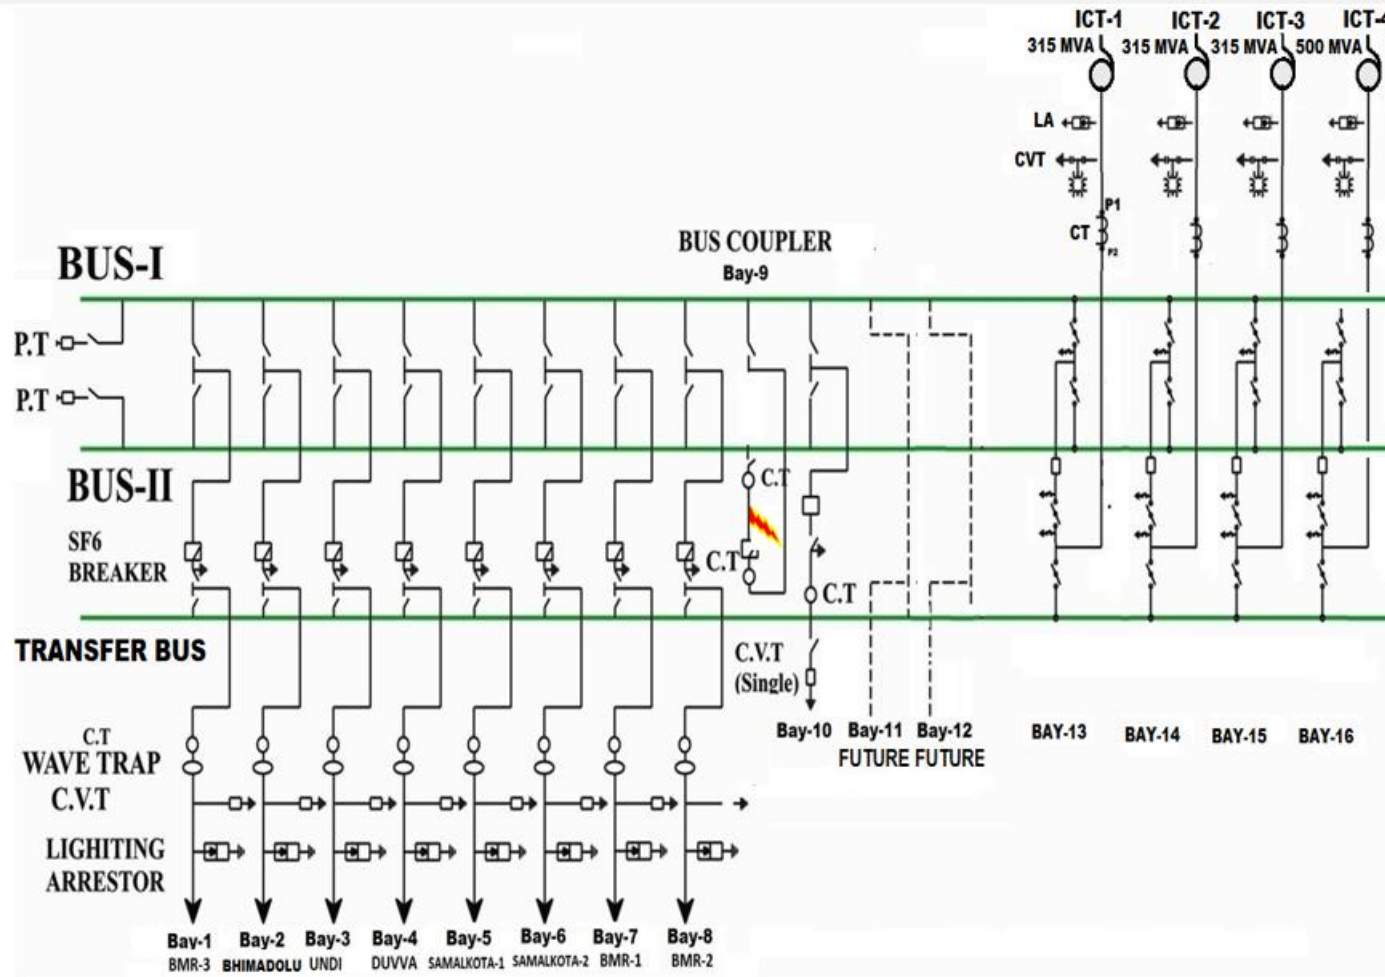
## FAULT LOCATION IN SLD OF 220kV VEMAGIRI SWITCH YARD

2. APTRANSCO stated that at 11:52:10.559 Hrs, R-Ph fault occurred in 220kV Bommuru-GVK feeder and AR was unsuccessful.
3. Further, at 11:52:49Hrs, R-G fault occurred (jumper between CB and Bus-2 CT of Bus coupler bay disconnected alongwith melted clamp and fell onto the bus post insulator support structure) in overlapping zone of both Bus-1 & 2.

4. For the above fault, Bus bar protection of 220kV Bus-1 & 220kV Bus-2 were operated and tripped all the connected elements. Consequent to the trippings of all the elements connected to 220kV Bus-1&2 at Vemagiri SS, load drawl (from 400kV grid) at 220kV level increased on ICTs at 400kV Guddigudem and 400kV Kota respectively. Subsequently, 400kV SS, Guddigudem SS, 315MVA ICT-1&2 were tripped on operation of HV side Over current protection due to increase in loads.

5. Remedial action taken: At 400/220kV Vemagiri SS, in 220kV Bus coupler bay, damaged jumper alongwith the clamp was replaced with spare on the same day.
