## III. Single/Multiple Element Tripping with Protection Violation

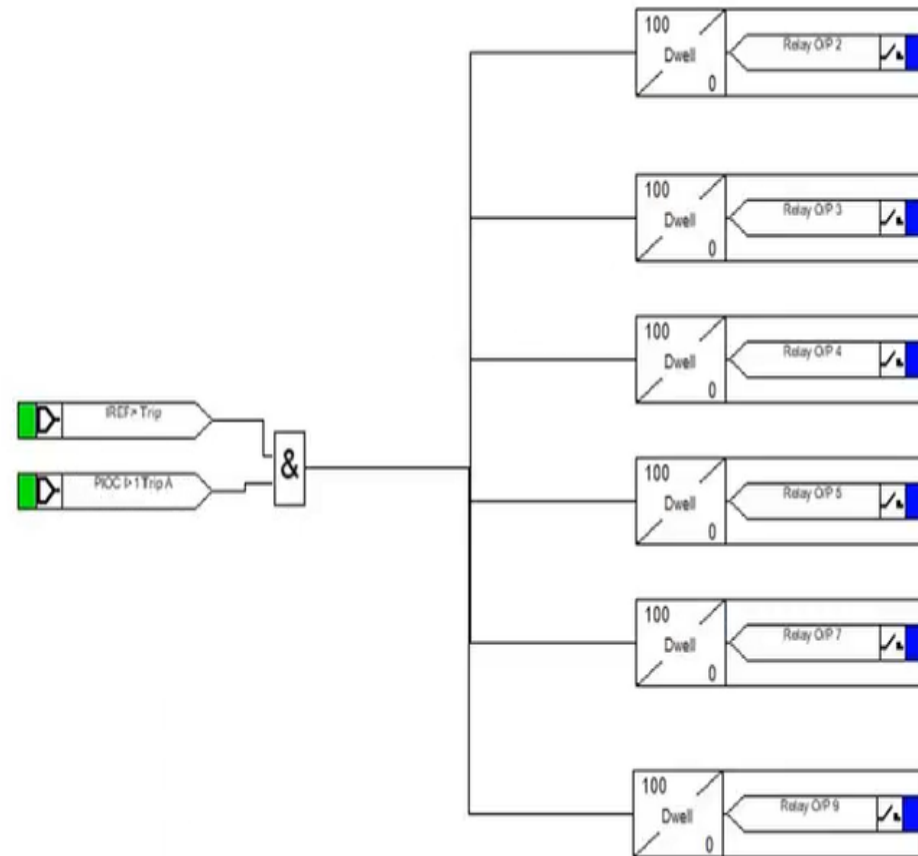
| S. No. | Event | Event Analysis | Outage Date & time | Points for Review | Remedial Actions Furnished |
|---|---|---|---|---|---|
| 9 | 400KV-MAMIDAPALLI-CHOUTUPPAL-1 | As per the reports submitted, the triggering incident is the PRV Relay maloperation in the 63MVAR line reactor which is kept in OFF condition at MAMIDAPALLI end in 400KV-MAMIDAPALLI-CHOUTUPPAL-1 and the line got tripped suspectedly due to the climbing of peacocks (as per FIR) and DT was sent to remote end. At Choutuppal end, DT was received and the line 3ph tripped. | 01-07-2026<br>08:20 | <b>TGTRANSCO:</b> 1. Tripping of the line due to PRV maloperation in the line reactor needs review<br>2. Non availability of SCADA SOE at CHOUTUPPAL end needs review | |

| | MAMIDAPALLI | CHOUTUPPAL |
|---|---|---|
| FIR | Tripped on operation of PRV protection on 63MVAR line reactor which is kept in OFF condition. Direct trip command was sent to other end<br><br>Observed PRV operation on line reactor due to climbing of peacocks. | Tripped on Direct trip received indications at Choutuppal end. |

**From the PMU data, 400KV-MAMIDAPALLI-CHOUTUPPAL-1 3phase tripping can be observed and there was no fault during the event.**

1. TGTRANSCO informed that the triggering incident was maloperation of the Pressure Relief Valve (PRV) relay associated with the 63 MVAR line reactor at Mamidipally end of the 400 kV Mamidipally–Choutuppall-1 line. The line reactor was kept in OFF condition due to the reconfiguration of the line.
2. It was suspected that the PRV relay operated due to peacocks climbing on the equipment, resulting in initiation of the Direct Transfer Trip (DT) command to the remote end. At Choutuppall end, the DT command was received and the line tripped three-phase.
3. TGTRANSCO informed that the DC supply to the line reactor, which is kept in OFF condition, was isolated to prevent recurrence of such unwanted tripping.

- ✚ TGTRANSCO to review the operation of PRV in the line reactor
